# Feasibility Study

## Town Hall - Police - Fire Complex

Project Number: 1302.00

May 2013

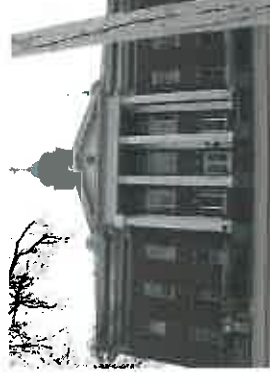
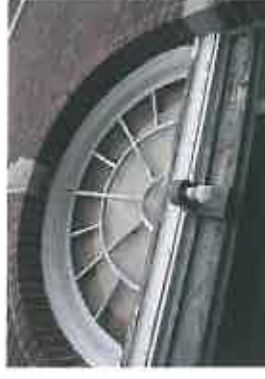
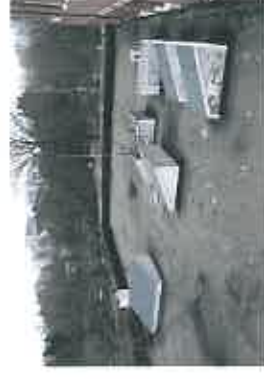
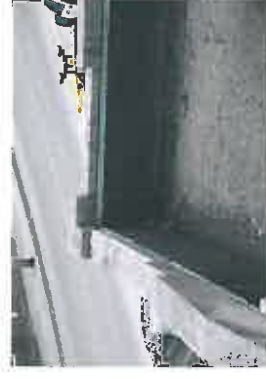
- A brick parapet is present along the west, south, and east sides of the 1920 structure's low roof. According to town personnel, this parapet once had a stucco veneer that was recently removed. The brick was deteriorated at numerous locations where this stucco veneer was removed.
- The wood fascia along the hip roof of the 1920 structure is rotted in various

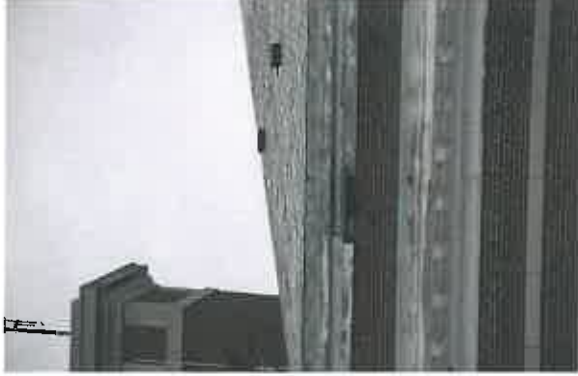
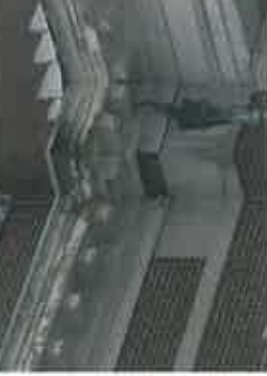
- One item to repair immediately is the missing downspout on the north east corner adjacent to the portico.
- Above the portico roof, there are several pieces of through wall flashing which are turned upwards. These should be fastened down to ensure that moisture is being properly diverted.

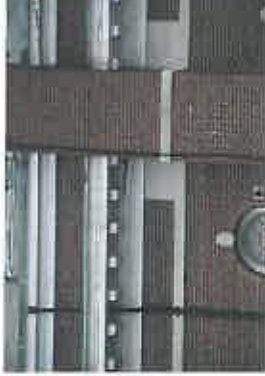
The existing modified bitumen ballasted roof over the one story police and fire apparatus room is showing signs of its age.

- The vertical surface of the parapet has severely deteriorated from our visible observation.
- Debris is observed on this roof and should be cleared to maintain proper drainage. Note that it appears slate roof tiles have fallen onto this lower roof, and it should be noted that this has the potential to puncture the roof membrane and create potential locations for moisture to enter the building. There also appears to be abandoned wire and or cable which should be removed.

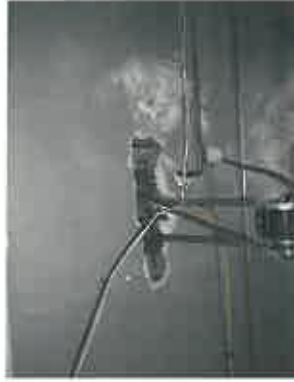
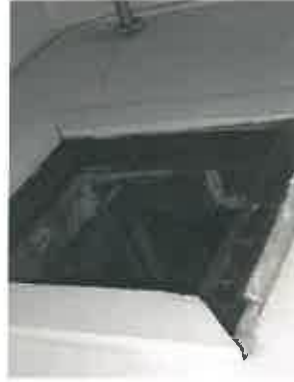
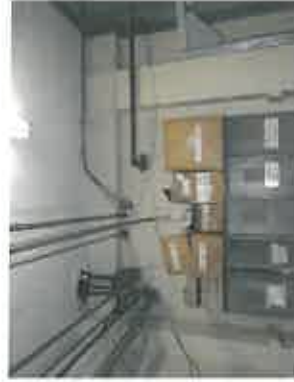
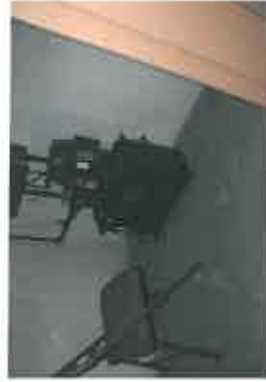
- At Fire Chief's car garage corridor- no handrails at steps. This is a code item.
- Fire area: unsealed opening to over framed (wood) skylight.
- Roof vent penetration in attic does not appear to be properly sealed from weather as water staining is visible and apparent.

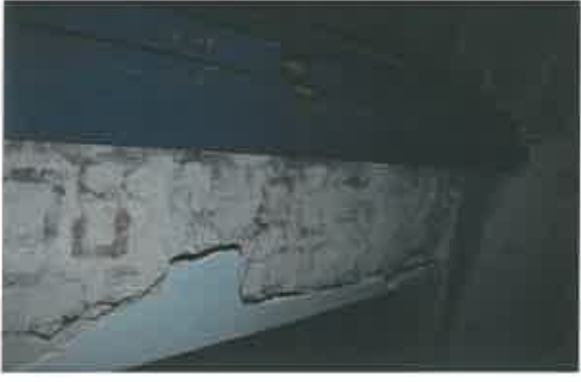
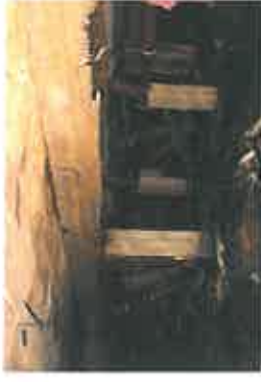
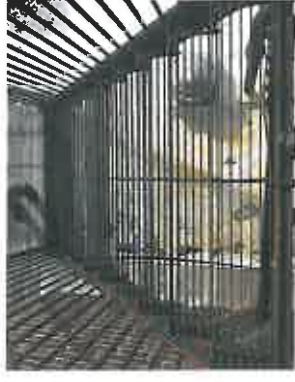
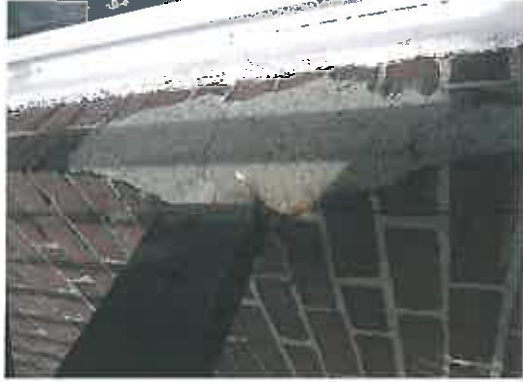
- Various structural deficiencies were observed along a metal fire escape providing access from the second floor of the 1920 structure to the roof of the 1970 addition. These deficiencies include:
  - o Approximately 3 treads are deteriorated or no longer securely attached to the escape stringers.
  - o The angle securing the south side of the bottom of the escape to the low roof is deteriorated.
  - o The north side of the bottom of the escape rests on a piece of rebar on the building's coping. The rebar is not attached to the coping.
  - o Cracking was observed along the building's exterior brick wall at anchorage points supporting the escape.
  - o Steel shims between the parapet coping and a column baseplate are deteriorated.
  - o The guardrail is detached at the top of the fire escape.
  - o Two anchor bolts securing the escape frame to the exterior brick wall are missing.

- **Fire Escape:** Various structural deficiencies (described above) were observed along a metal fire escape providing access from the second floor of the 1920 structure to the roof of the 1970 addition. The recommended repairs are as follows:
  - o Deteriorated or detached treads should be removed and replaced.
  - o The angle securing the south side of the bottom of the escape to the low roof should be removed and replaced in-kind. A similar support should be installed at the north side of the bottom of the escape.
  - o Two missing anchor bolts along the escape frame should be replaced.
  - o The guardrail should be removed and replaced where detached or

- o Deteriorated steel shim plates should be removed and replaced with non-shrink grout.
- o Brick cracks at escape support locations should be repaired with a structural adhesive, such as epoxy injection.
- o The fire escape should be cleaned of all rust/corrosion and painted.

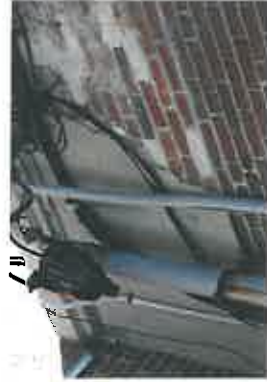
- **Basement Concrete Framing:** Based on limited observations made during the survey and digital photographs provided by town personnel, significant spalling with exposed steel reinforcement is present along some concrete beams, columns, and the underside of the slab. PARE recommends that spalled or deteriorated areas of concrete be removed to sound concrete. Exposed reinforcement shall be cleaned and/or replaced. The repair areas should be patched with a polymer-based repair mortar (small or overhead areas) or cast-in-place concrete (larger areas), as appropriate.

While the exact limits of repair are not known, an opinion of the probable construction cost for a repair of this type is \$1,500 to \$3,000 per beam or column repair and \$50 to \$100 per square foot for slab repairs.

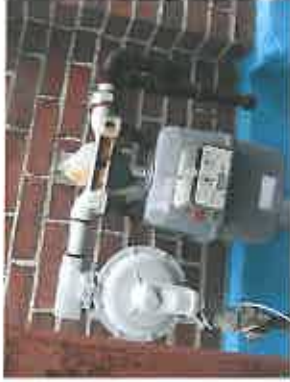
- a. Natural gas is supplied to the Town Hall from meter #05471473, size 560 installed on the Atlantic House Road side of the building. The incoming service pipe is a 1" and a 2" pipe services the building. From this meter location the gas enters the building and feeds the emergency generator in the rear garage of the Town Hall and a unit heater in the Fire Department. The Fire Department unit heater is a Modine, NG, model PA225AF, ser 15012020488, 225 MBH in, 173.3 MBH out.
- b. A second natural gas service meter, Actaris, 12/07, # 14548500, is located outside of the garage area for the Police Department. The inlet pipe is a 3/4" and a 1" serves the building. This natural gas services the Police building rooftop air-handling unit, boiler, water heater, and Break Room 4-burner stove.

- a. Install new natural gas meter and service pipe from the existing main pipe in the street. New piping and meter shall be capable of servicing all new and existing natural gas equipment in the building.

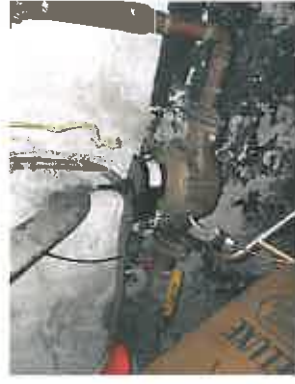
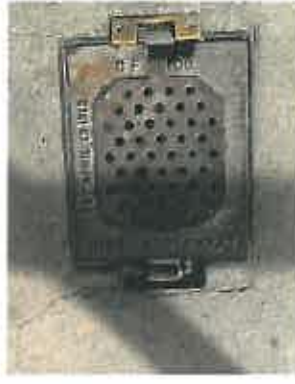
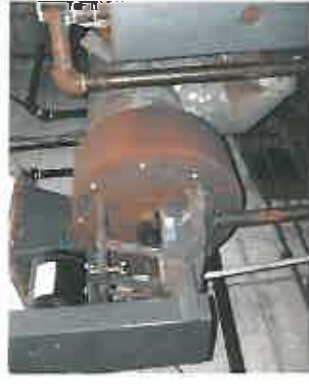
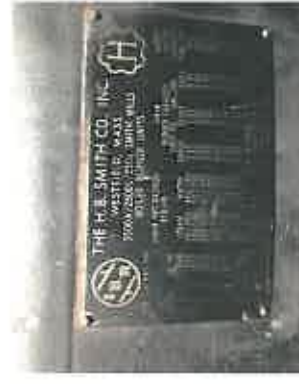
- f. The condensate flows back to the Boiler Room from all of the wall radiators

installed in the Town Hall building. The condensate is routed to a condensate tank located in the basement Boiler room. The original 50-gallon tank has been replaced in the past. There are two, Marathon, Jet Pumps, 1/3 HP, model JQM56C34D1200HK, condensate pumps installed to deliver the returning condensate to the boilers.
