Proj.: Historic Fort Revere Water Tower Rehabilitation  
Re: Preliminary Assessment Report  
CBI Job No.: CB191842

Per our agreement, CBI Consulting, LLC, a Vidaris company (CBI), has completed a limited existing conditions assessment of the Historic Fort Revere Water Tower in Hull, MA. The purpose of our evaluation is to review the condition of the 117-year-old structure and to provide recommendations for repairs required to extend the useful life of the facility.

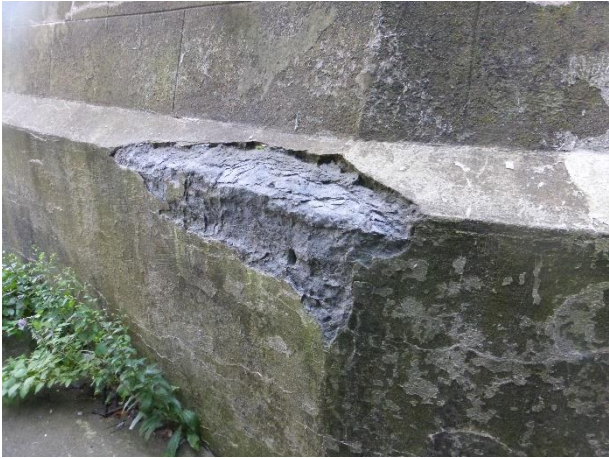
| 3. | | View of deteriorated concrete patch at the base of the tower. |

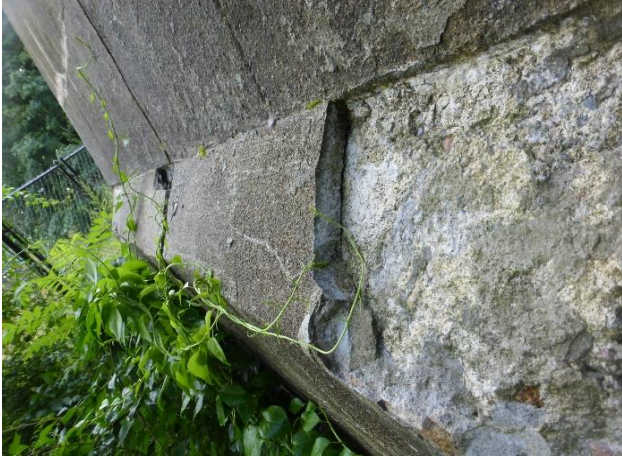
| 4. | | View of deteriorated concrete patch at the base of the water tower. |

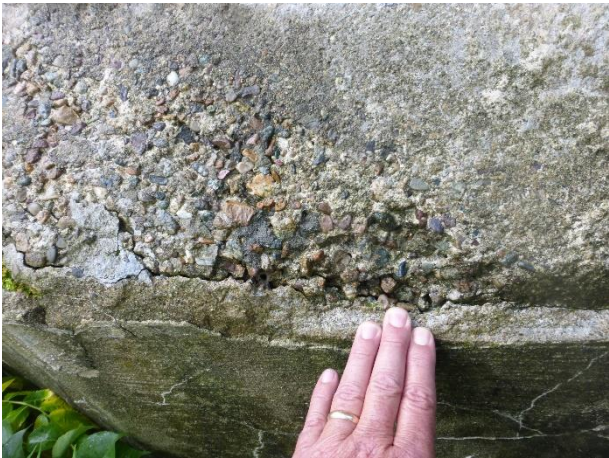
| 5. | | View of deteriorated concrete patch at the base of the water tower. |

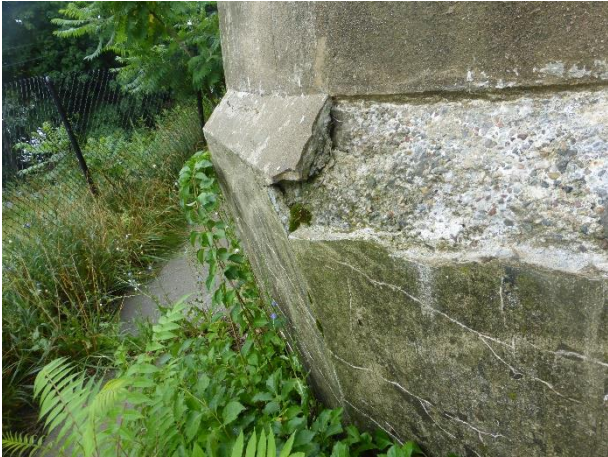
| 6. | | View of deteriorated concrete patch at the base of the water tower. |

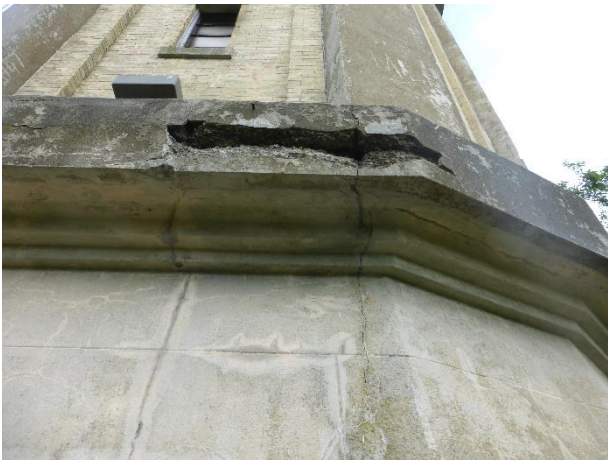
| 7. | | Photo of spalled and loose concrete at the lower decorative band. |

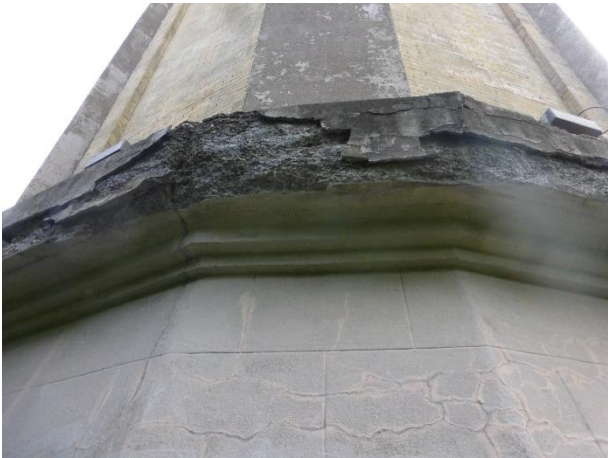
| 8. | | View at spalled and loose concrete at the lower decorative band. |

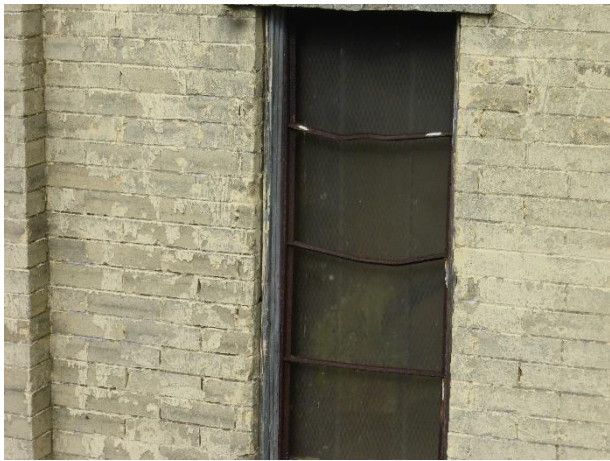
| 10. | | Typical view of a dilapidated window possibly original to the construction of the water tower. |

The deteriorated windows should be removed and replaced, to reduce water infiltration to the interior of the tower.

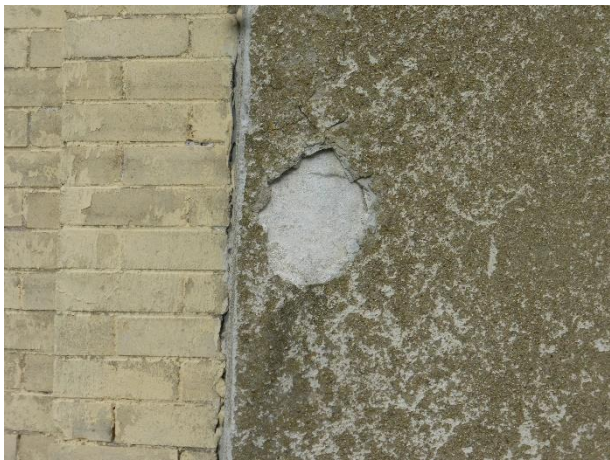
| 11. | | View of a section of failed cementitious skim coat.<br><br>All columns have a shallow layer of cementitious skim coat. |

Areas of delaminated and/or debonded cementitious skim coat shall be removed and a new skim coat applied to match the surface concrete profile.

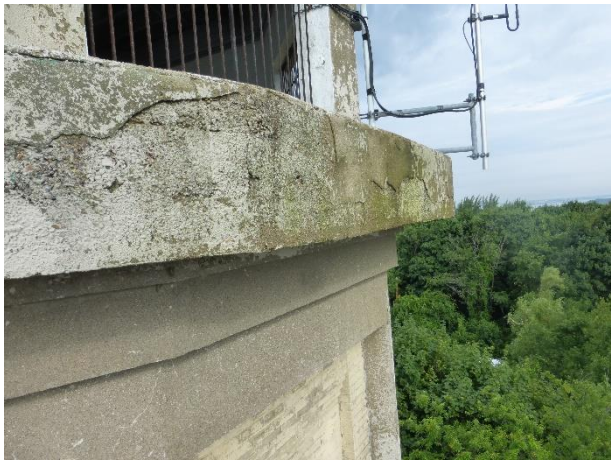
| 13. | | View of cracked concrete at the upper decorative band at the observatory level. |

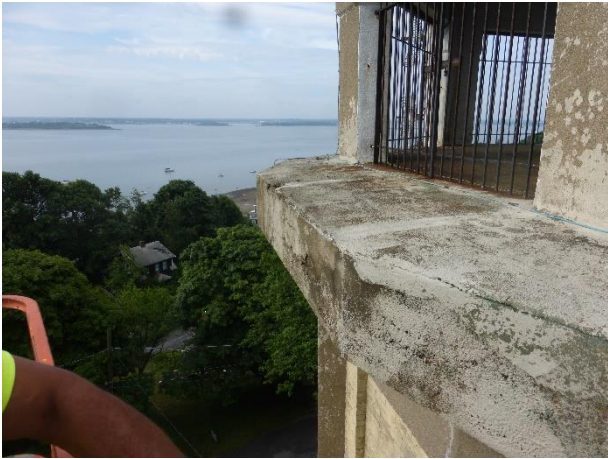
| 16. | | View of the delaminated concrete at the observatory level. |

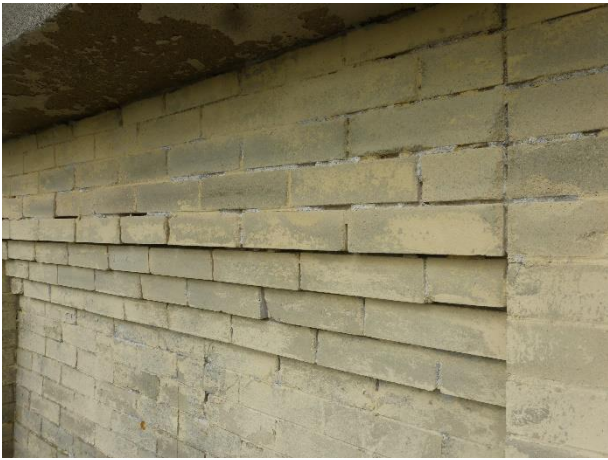
| 17. | | Photo of failed and eroded mortar joints below the upper decorative concrete band. |

The brick masonry will require isolated rebuilding at areas of loose masonry. The interior and exterior brick surfaces will require cutting and re-pointing of failed mortar joints. Vertical brick cracks shall be routed and sealed with a high-quality sealant compatible with the breathable waterproof coating. The intersection of the brick masonry and concrete will receive at a high-quality sealant to reduce water infiltration.

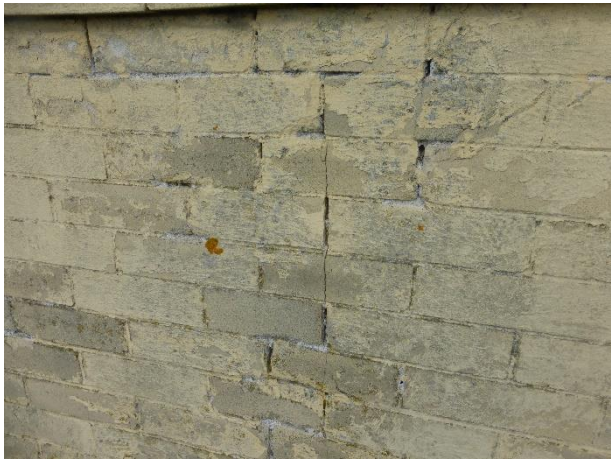
| 18. | | Vertical hairline crack at the coated concrete brick masonry. |

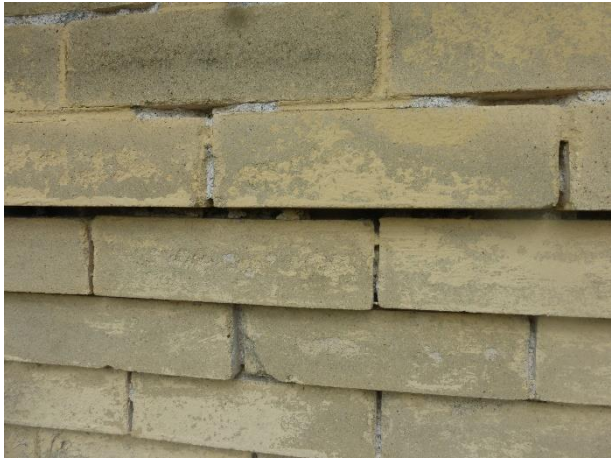
| 19. | | View of eroded mortar joints at the coated concrete brick masonry. |

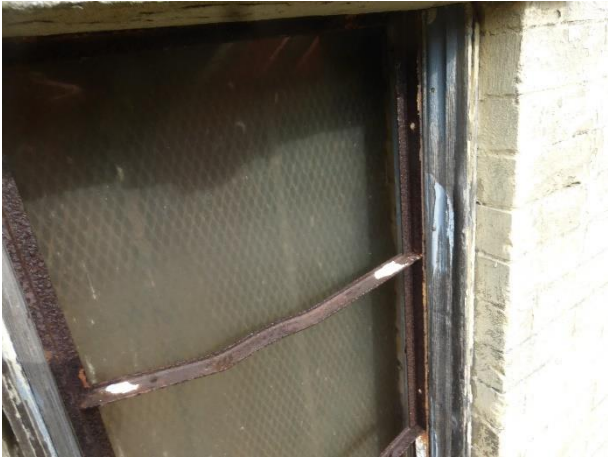
| 21. | | Close-up of a typical window with a corroded window frame and rotted wood trim. |

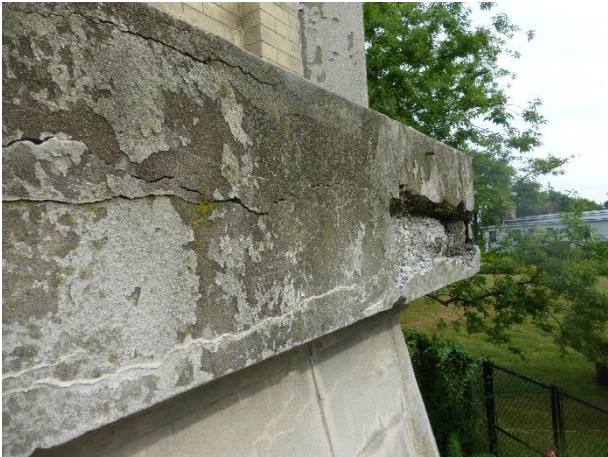
| 22. | | Spalled concrete at the lower decorative concrete band. |

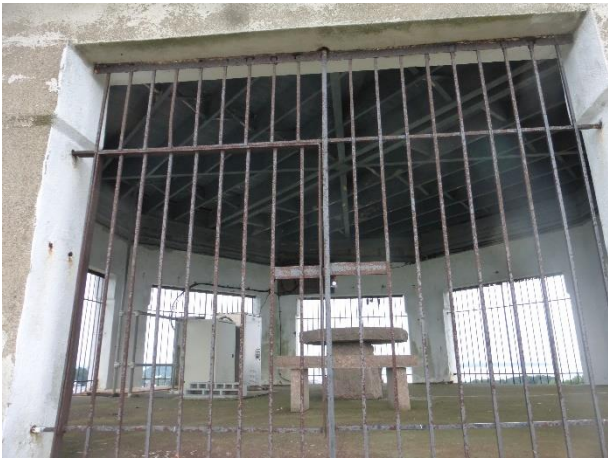
The existing metal fences around the observatory are corroded and anchorage is questionable. The metal access stair to the observatory level above the reinforced concrete stairs, is corroded with steel sections failed.

| 23. | | <p>Photo of the exterior security fence typical at all eight faces of the water tower at the observation level.</p> <p>Note steel is corroded and anchorage is questionable.</p> |

The metal fences around the observatory have outlived their life span due to corrosion and we recommend that a new metal rail, coated with a high-quality marine paint, be installed.

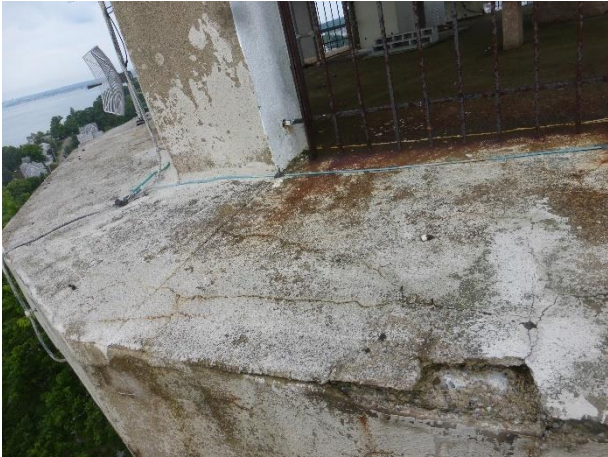
| 24. | | Typical view of the delaminated top surface of the upper decorative concrete band. |

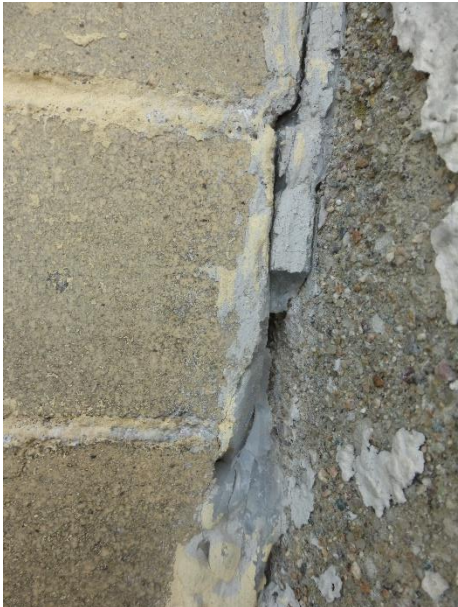
| 25. | | Close-up view at a typical failed sealant at the intersection of the concrete column and coated concrete brick masonry. |

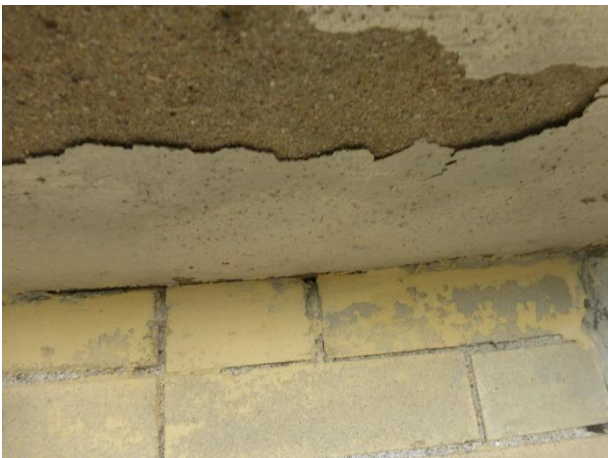
| 26. | | View at the underside of the upper decorative concrete band with loose cementitious skim coat. |

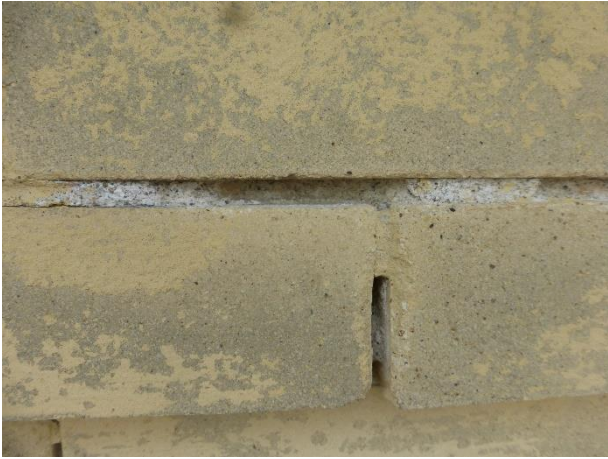
| 27. | | Close-up view of eroded mortar joints |

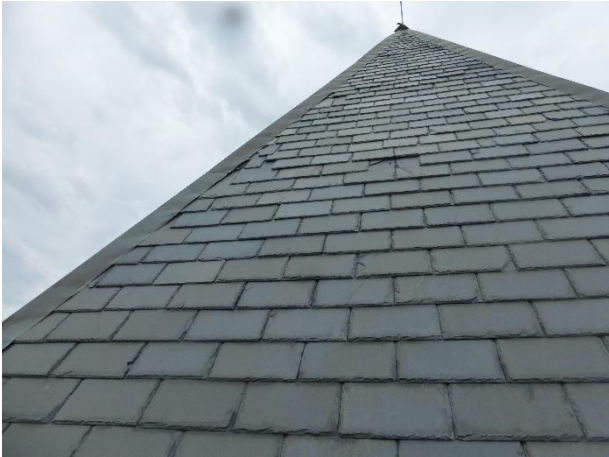
The slate roof of the water tower appears to be in fair to poor condition. Missing and broken slate shingles were observed during our visit. Locations of the roof were noted to be missing underlayment and the top surface of the wood planking was visible.

| 30. | | View of the slate roof of the water tower. Missing and broken slate was observed. |

We recommend the removal and replacement of the existing slate roof and copper work. An adhered membrane should be installed below the slate shingles to improve the water tightness and reduce decay of the wood roof framing below. The wood framing requires further review to assess the condition and to evaluate the hold downs to the concrete structure. Currently the roof structure is concealed with a wood framed ceiling. The worn paint at the ceiling below the roof visible from the observation deck will need to be painted with a high-quality paint to protect against weather.

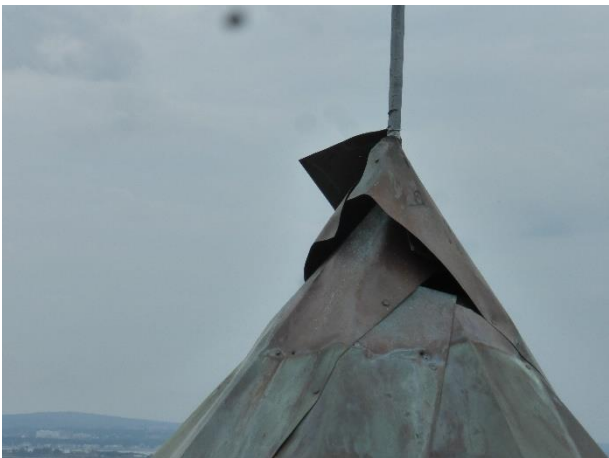
| 32. | | Distorted copper cap. |

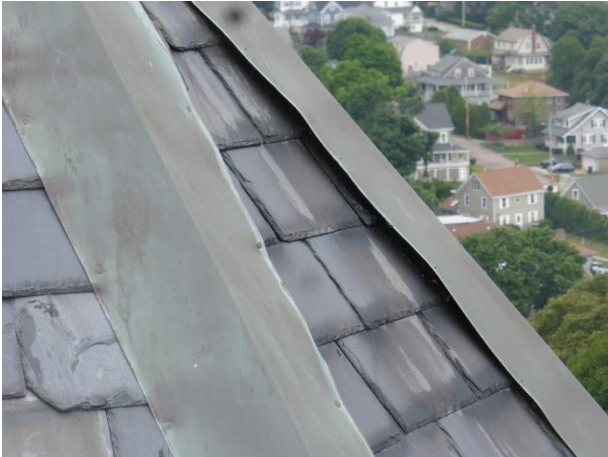
| 33. | | Open gaps at the copper hips and slate roofing shingles. |

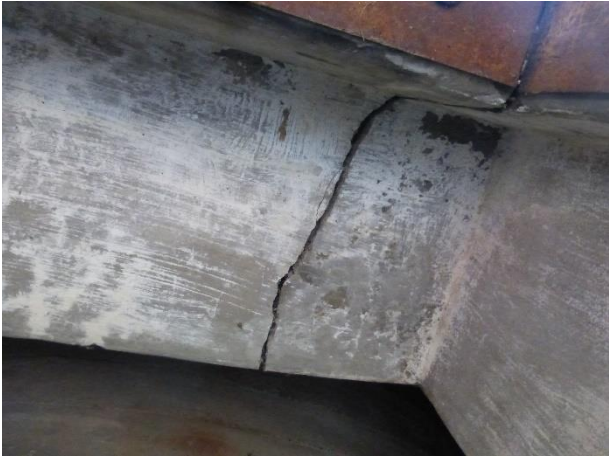
| 36. | | <p>Close-up view of the crack through the door header.</p> |

CBI recommends injection of structural epoxy at wide and deep concrete cracks at the exterior and in some locations, interior of the water tower.

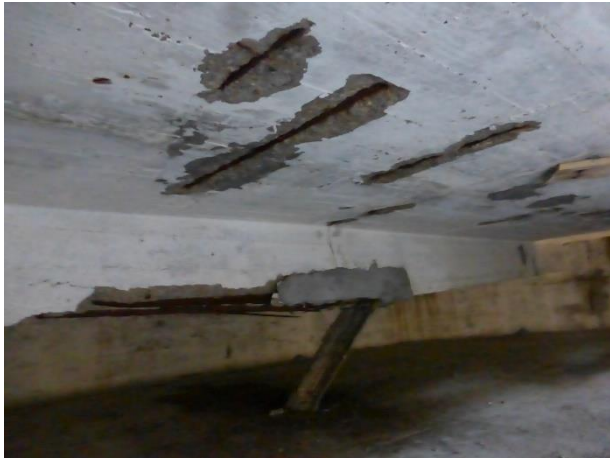
| Photo No. | Interior Review | Description |
|---|---|---|
| 37. | | Photo of spalled concrete and exposed steel reinforcement at the underside of the observatory level. |

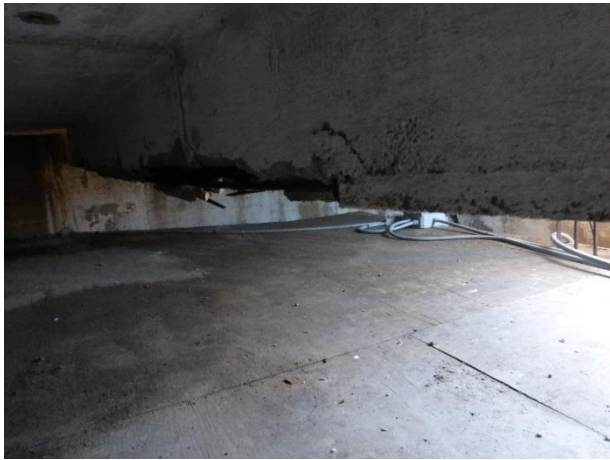
| Photo No. | Interior Review | Description |
|---|---|---|
| 38. | | View of one (1) of two (2) steel reinforced concrete beams below the observatory level.<br>Both reinforced beams are compromised. |

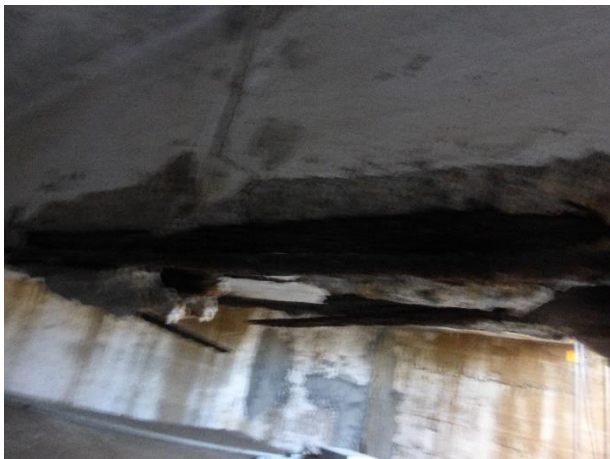
| Photo No. | Interior Review | Description |
|---|---|---|
| 39. | | Close-up view at the beam midspan with failed reinforcing steel. |

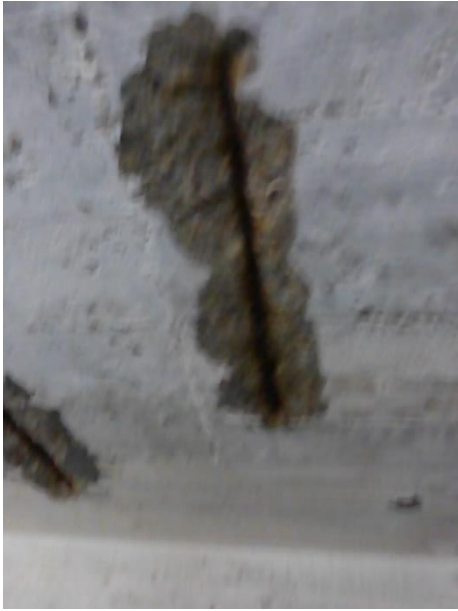
| 40. | | Close-up view of a typical concrete spall and exposed corroded steel reinforcement below the observatory level. |

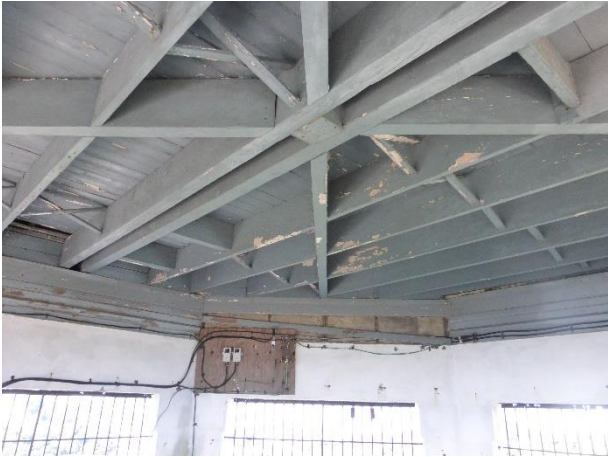
| 41. | | View at the underside of the wood framing below the roof.<br>Note paint is worn. |

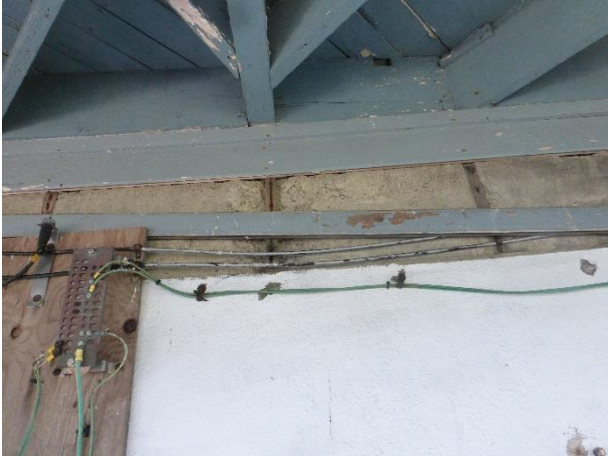
| 42. | | Photo of missing wood boards with concrete beam exposed. |

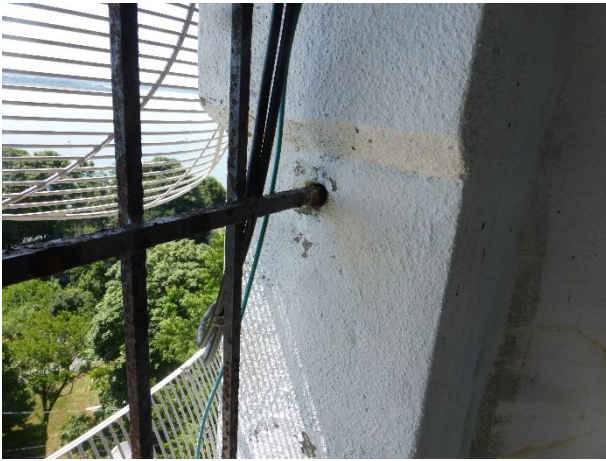
| 43. | | View of a corroded and loose railing connection at the concrete column at the observatory level. |

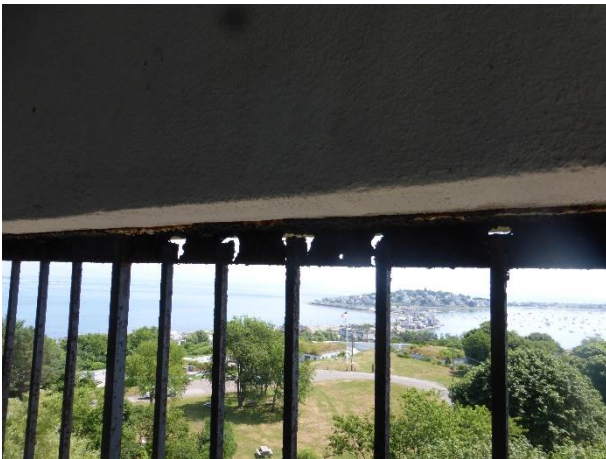
| 44. | | View of the corroded steel angle that connects to the metal railing.<br>Railing connection are compromised. |

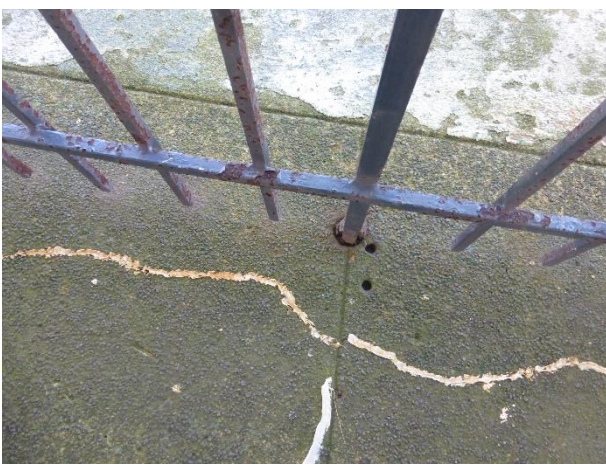
| 45. | | Photo of the base of the railing system with an unsealed hole through the concrete deck at the observatory level.<br>Note failed sealant over concrete crack. |

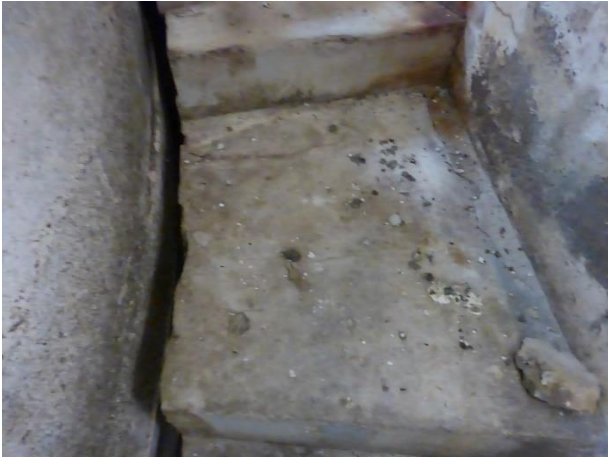
| 46. | | Photo looking down at failed concrete patch at the stair platform. |

In our opinion that the cast in place concrete service stairs and platforms are in poor condition and are unsafe for use. We recommend that the stairs and platforms be removed and replaced. The replacement stairs can be either new cast in place concrete, or a metal stairs system, coated with a marine grade coating.

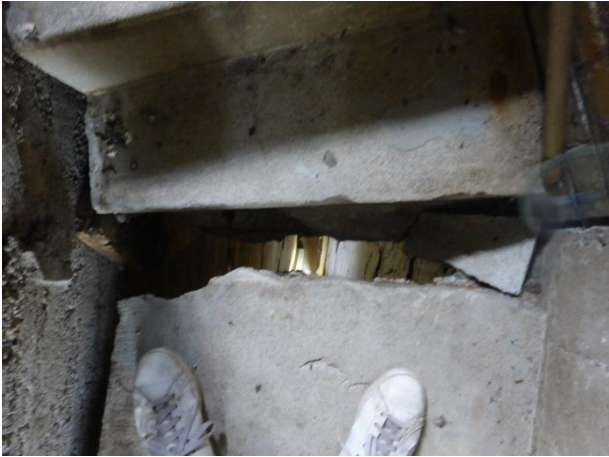
| 51. | | Downward view at the missing stair platform.<br><br>Note the entrance door is below. |

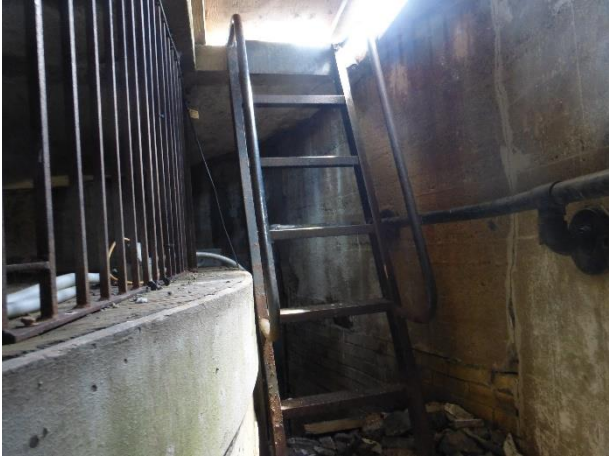
| 52. | | View at the corroded steel stair that accesses the observatory from the concrete stair. |

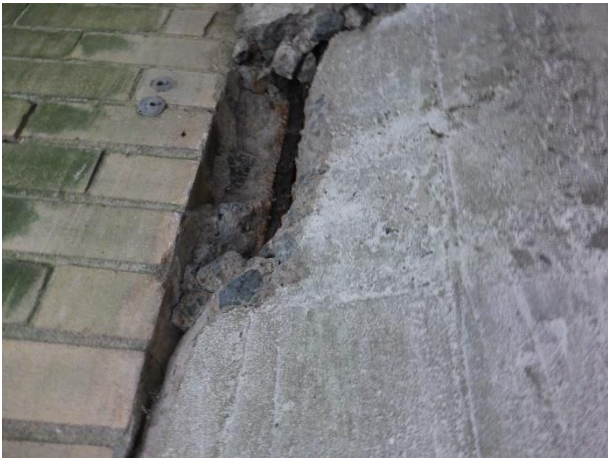
| 55. | | Spalled concrete at the concrete column. |

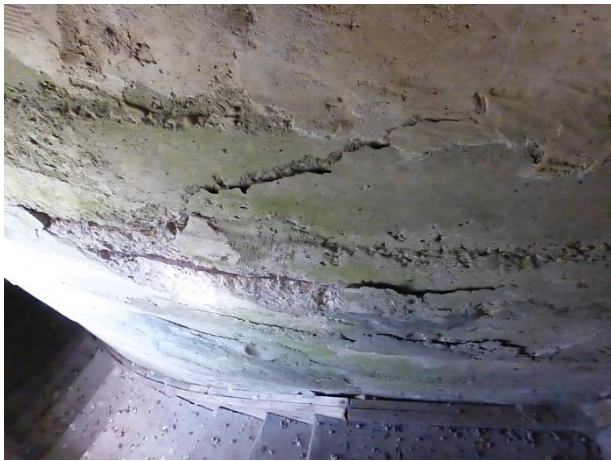
| 57. | | Deteriorated concrete at the water tank. |

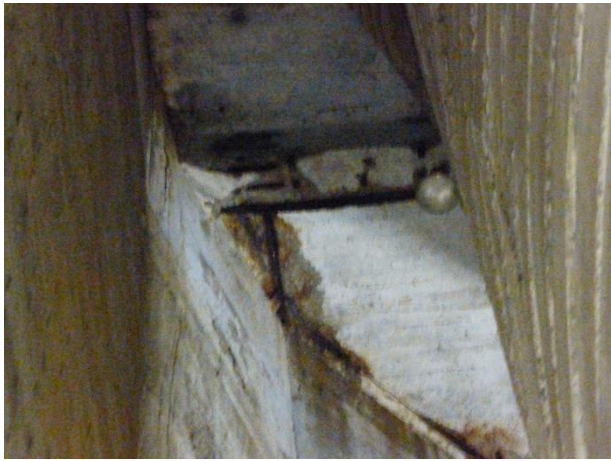
| 59. | | Exposed and corroded steel reinforcement and spalled concrete at the underside of the stairs. |

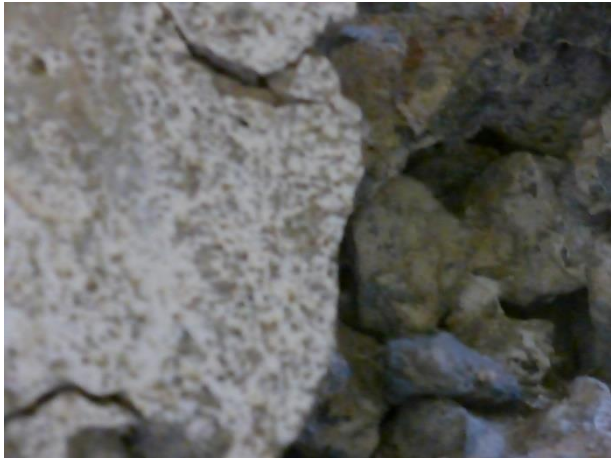
| 60. | | Close-up view of failed concrete at the concrete water tank. |

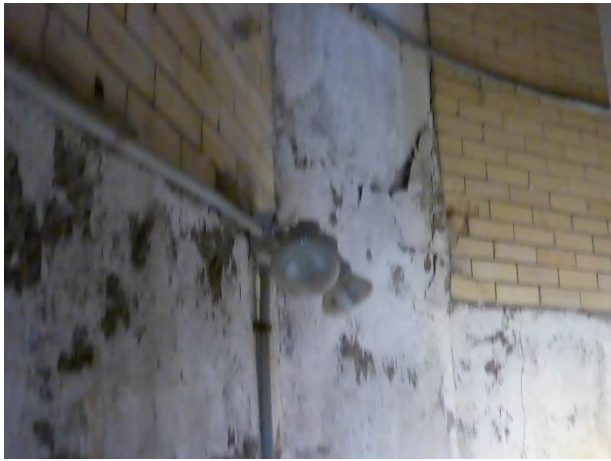
| 62. | | Delaminated concrete spall at the reinforced concrete column. |

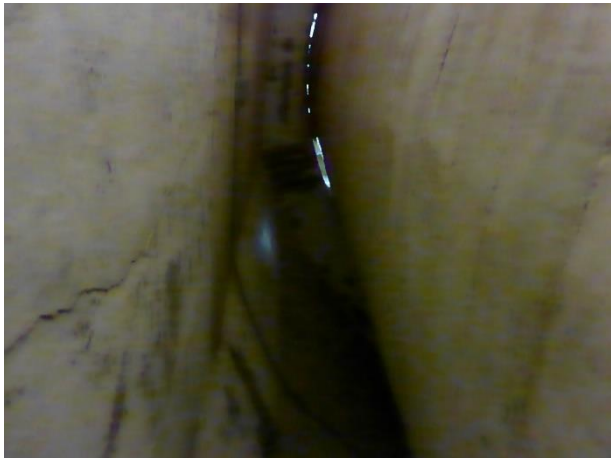
| 64. | | Upward view of the underside of the reinforced concrete stairs with spalled concrete and corroded exposed steel reinforcement. |

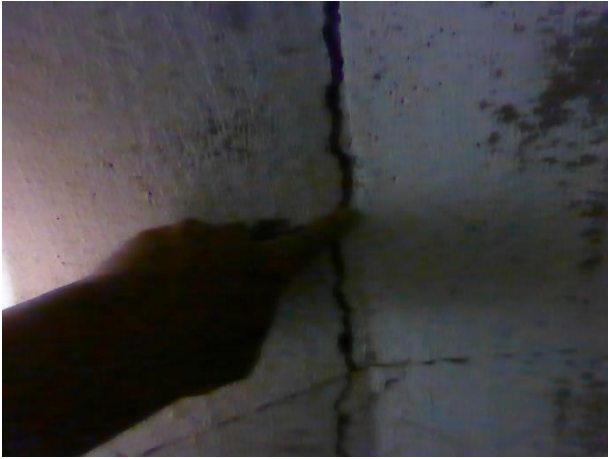
| 65. | | Interior/base of the water tower with a vertical crack between the concrete column and concrete base, typical at all eight columns. |

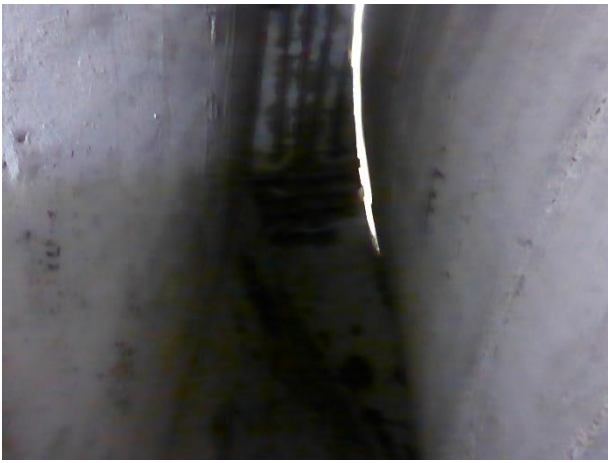
| 66. | | View at exposed corroded steel reinforcement and spalled concrete at the underside of a stair run. |

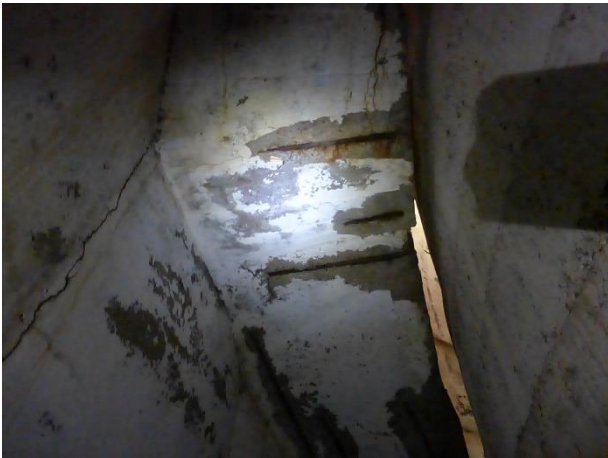
| 67. | | Corroded steel reinforcement and spalled concrete at the underside of a stair platform. |

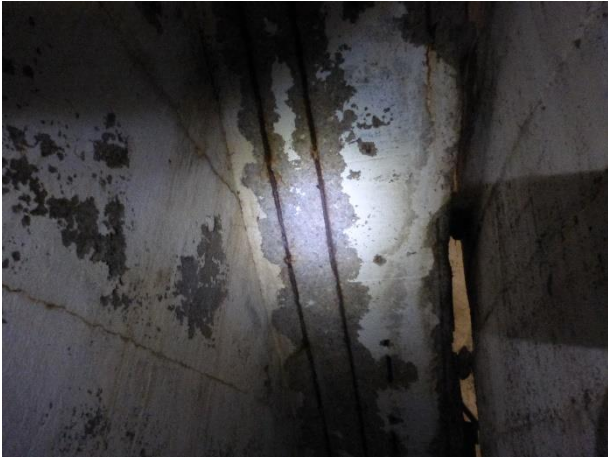
| 68. | | View of exposed corroded reinforcement and spalled concrete at the underside of a stair run. |

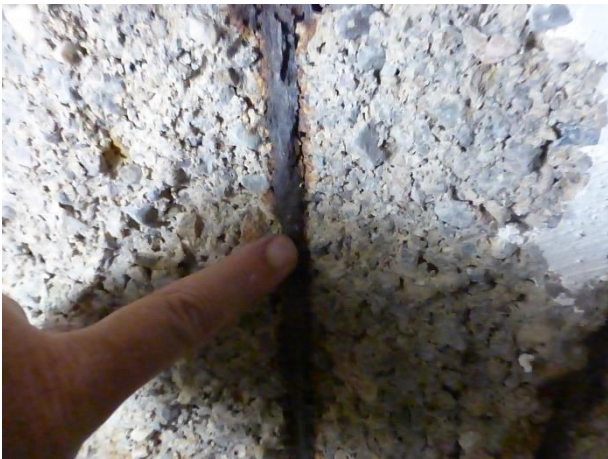
| 69. | | Close-up view of a severely corroded reinforcement at the underside of a stair run. |

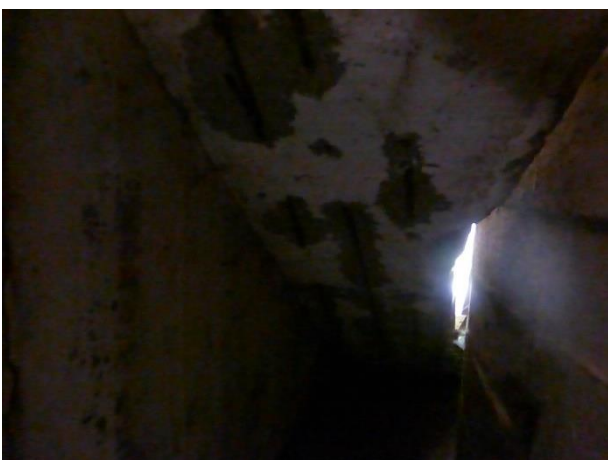
| 70. | | Photo of exposed corroded steel reinforcement and spalled concrete at the underside of a stair run. |

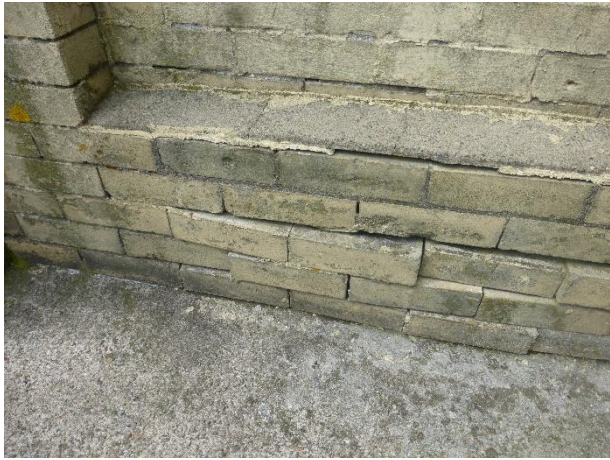
| Photo No. | Investigation | Description |
|---|---|---|
| 71. | | Laterally displaced concrete brick masonry above the lower decorative band. |

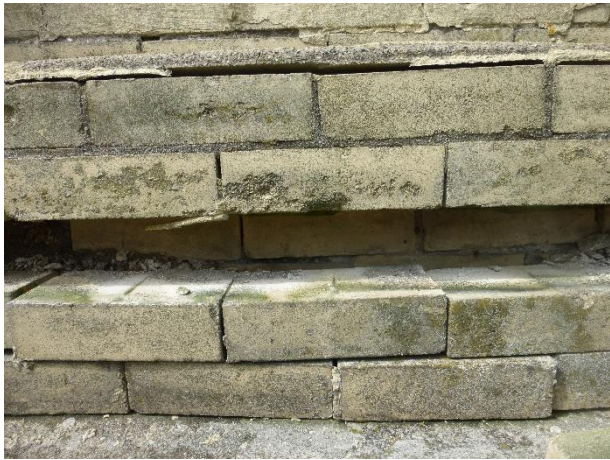
| Photo No. | Investigation | Description |
|---|---|---|
| 72. | | View at loose bricks removed by hand. |
