Proj.: Historic Fort Revere Water Tower Rehabilitation
Re: Preliminary Assessment Report
CBI Job No.: CB191842

**Historic Fort Revere Water Tower Rehabilitation
Photo Index
CBI Job No.: CB191842
August 31, 2020**

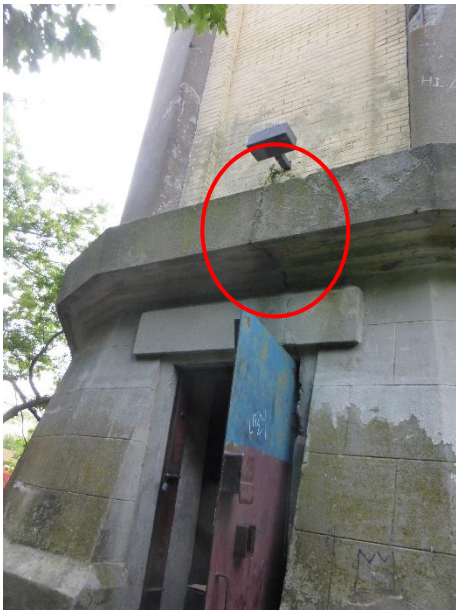
View at the entrance door to the water tower. Note highlight area with structural crack through entire concrete door header and decorative lower band.

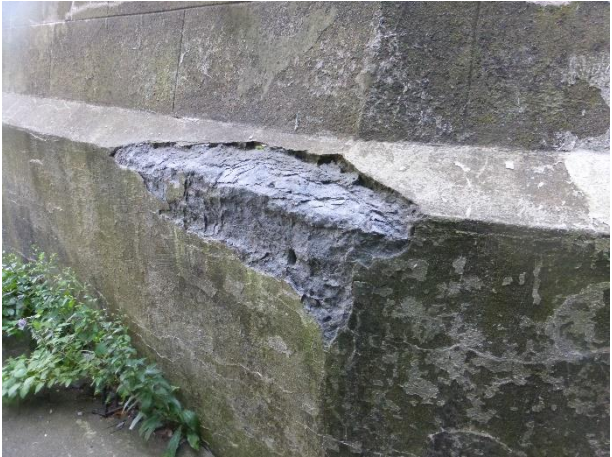
View of deteriorated concrete patch at the base of the tower.
4.

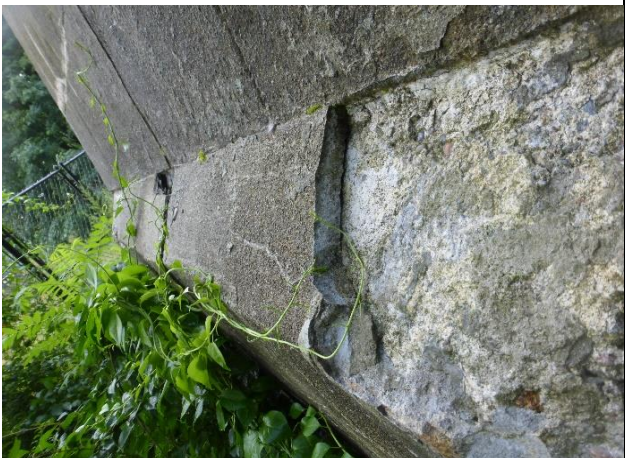
View of deteriorated concrete patch at the base of the water tower.
5.

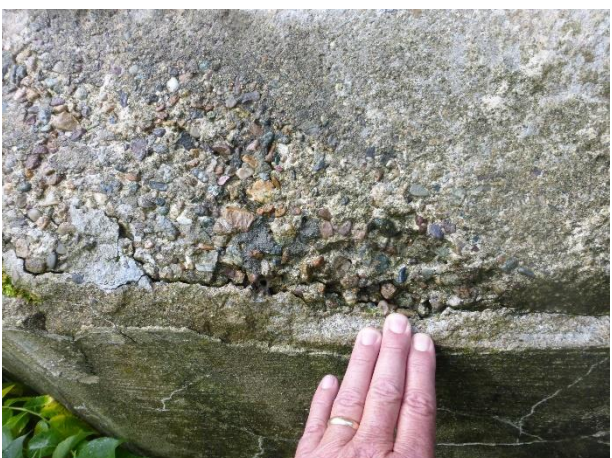
View of deteriorated concrete patch at the base of the water tower.

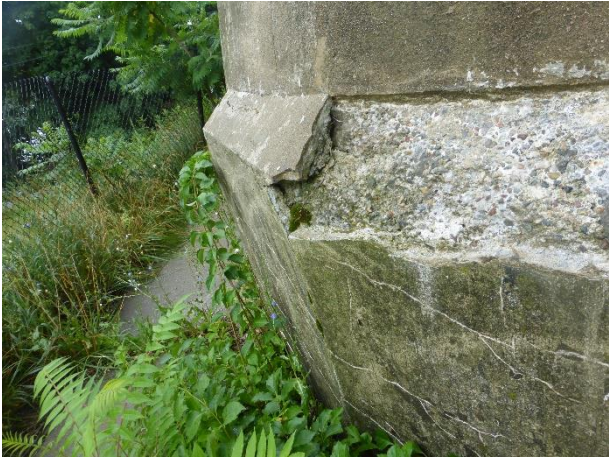
View of deteriorated concrete patch at the base of the water tower.
7.

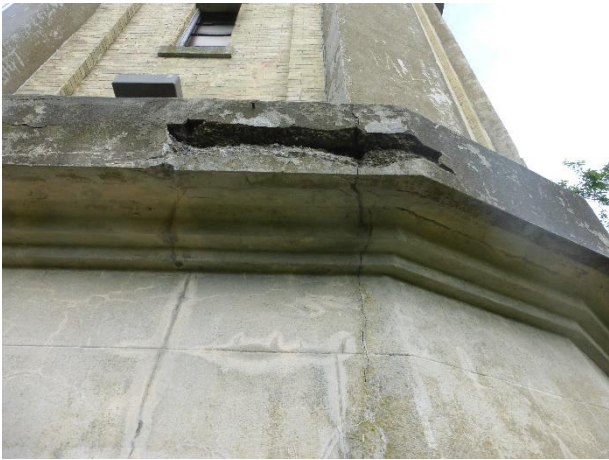
Photo of spalled and loose concrete at the lower decorative band.
8.

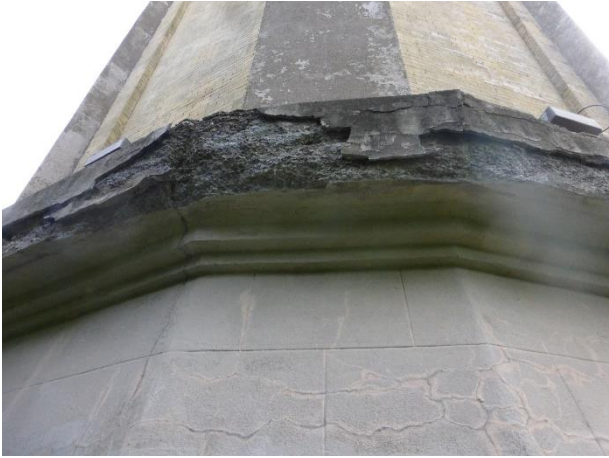
View at spalled and loose concrete at the lower decorative band.

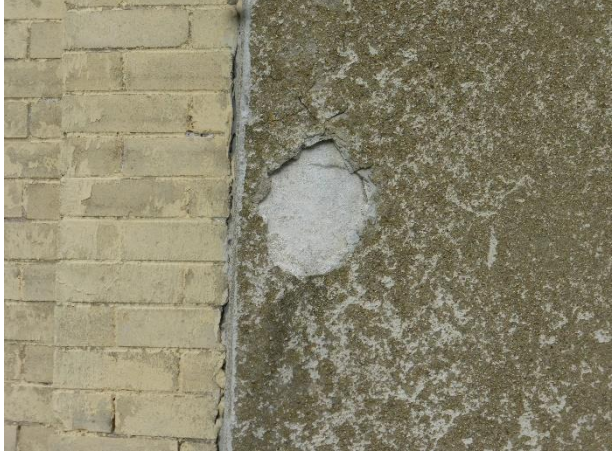
<p>View of a section of failed cementitious skim coat.</p> <p>All columns have a shallow layer of cementitious skim coat.</p>

Areas of delaminated and/or debonded cementitious skim coat shall be removed and a new skim coat applied to match the surface concrete profile.

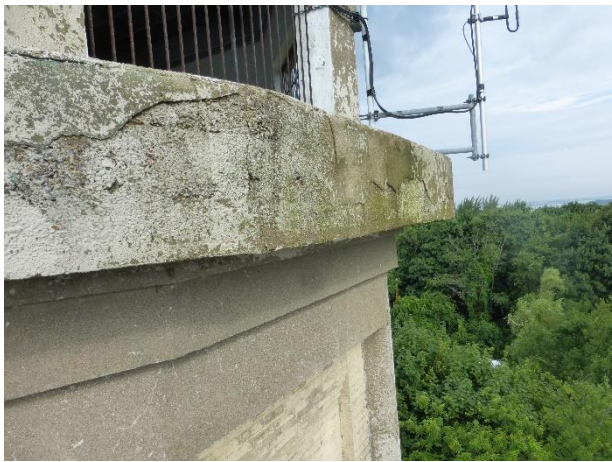
View of cracked concrete at the upper decorative band at the observatory level.
14.

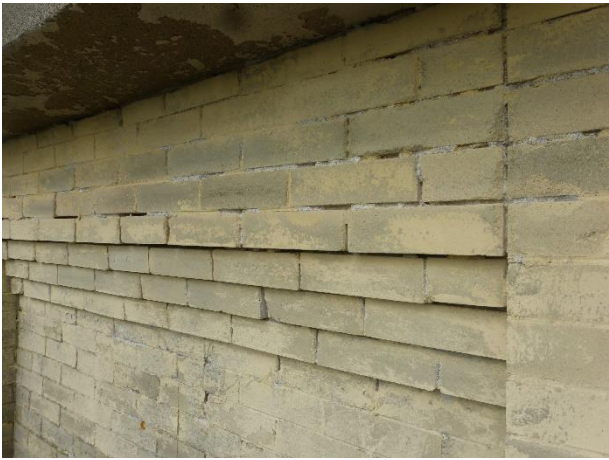
Photo of failed and eroded mortar joints below the upper decorative concrete band.

The brick masonry will require isolated rebuilding at areas of loose masonry. The interior and exterior brick surfaces will require cutting and re-pointing of failed mortar joints. Vertical brick cracks shall be routed and sealed with a high-quality sealant compatible with the breathable waterproof coating. The intersection of the brick masonry and concrete will receive at a high-quality sealant to reduce water infiltration.

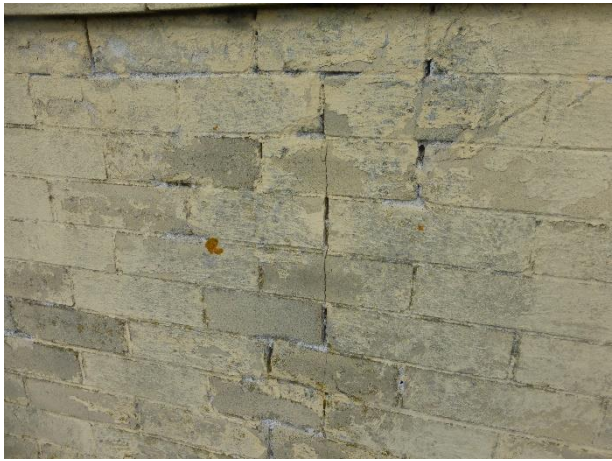
Vertical hairline crack at the coated concrete brick masonry.
19.

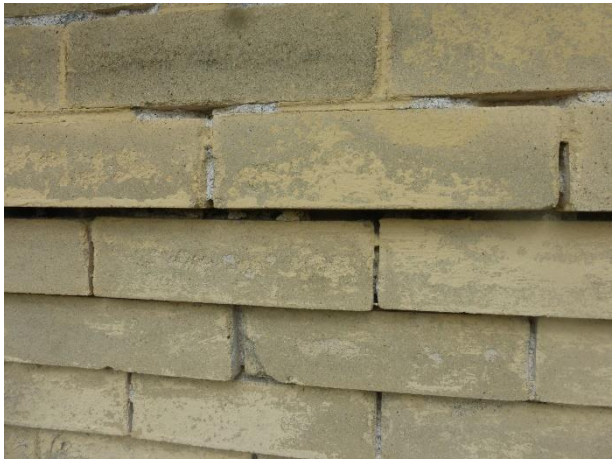
View of eroded mortar joints at the coated concrete brick masonry.
20.

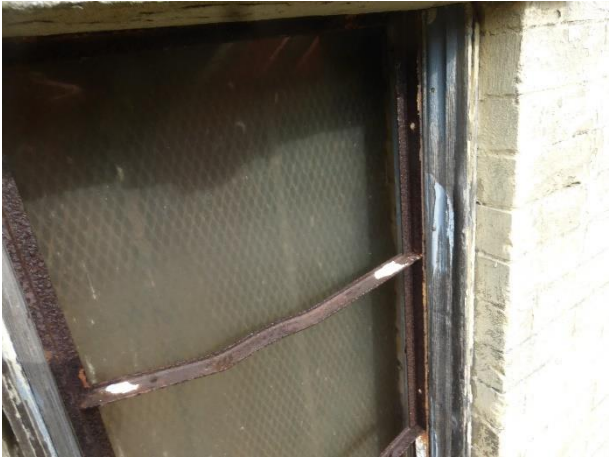
Close-up of a typical window with a corroded window frame and rotted wood trim.
22.

The deteriorated windows should be removed and replaced, to reduce water infiltration to the interior of the tower.

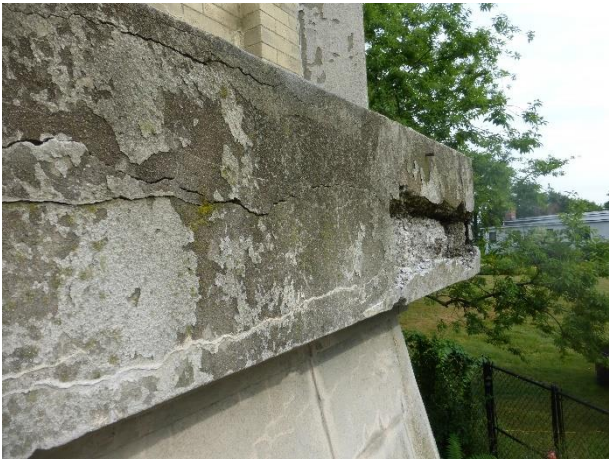
Spalled concrete at the lower decorative concrete band.
23.

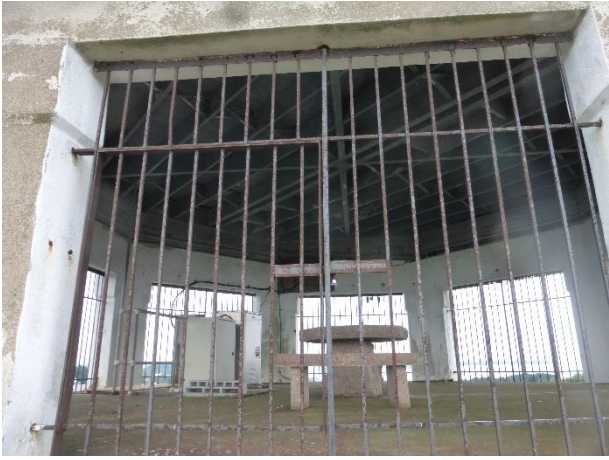
<p>Photo of the exterior security fence typical at all eight faces of the water tower at the observation level.</p> <p>Note steel is corroded and anchorage is questionable.</p>

The metal fences around the observatory have outlived their life span due to corrosion and we recommend that a new metal rail, coated with a high-quality marine paint, be installed.

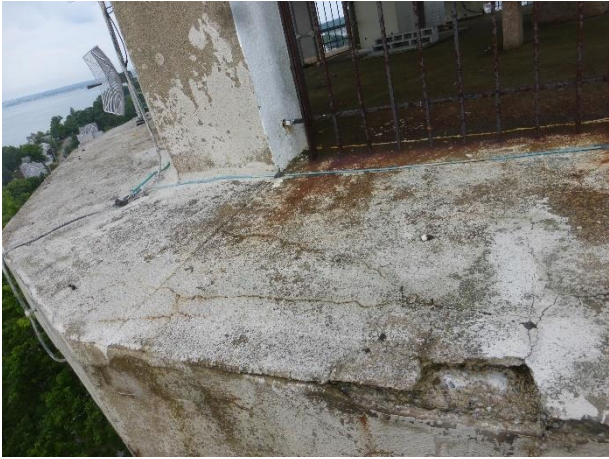
Typical view of the delaminated top surface of the upper decorative concrete band.
25.

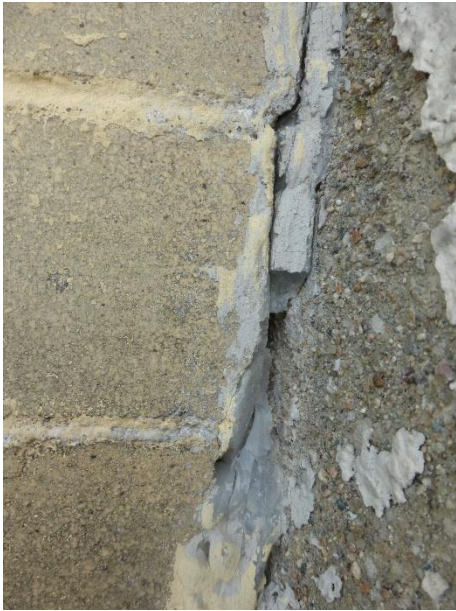
Close-up view at a typical failed sealant at the intersection of the concrete column and coated concrete brick masonry.
26.

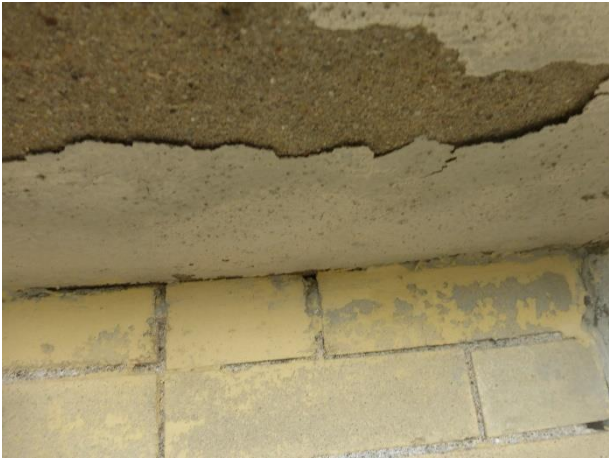
View at the underside of the upper decorative concrete band with loose cementitious skim coat.

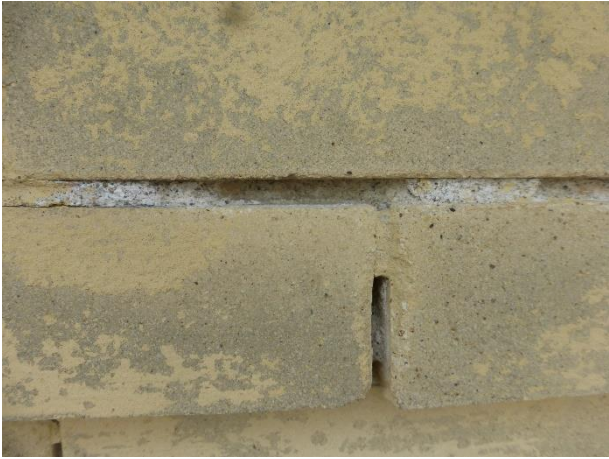
Close-up view of eroded mortar joints
28.

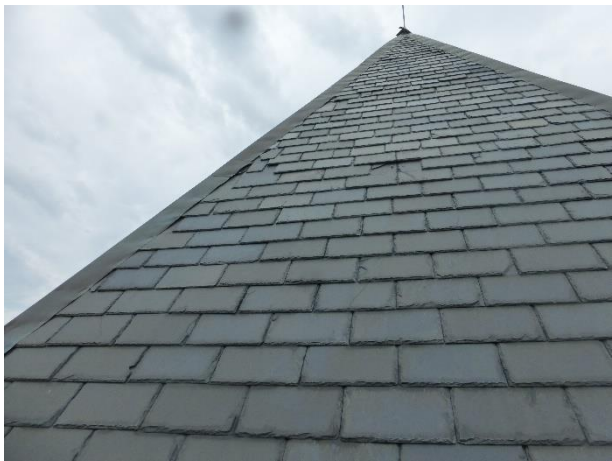
View of the slate roof of the water tower. Missing and broken slate was observed.
31.

We recommend the removal and replacement of the existing slate roof and copper work. An adhered membrane should be installed below the slate shingles to improve the water tightness and reduce decay of the wood roof framing below. The wood framing requires further review to assess the condition and to evaluate the hold downs to the concrete structure. Currently the roof structure is concealed with a wood framed ceiling. The worn paint at the ceiling below the roof visible from the observation deck will need to be painted with a high-quality paint to protect against weather.

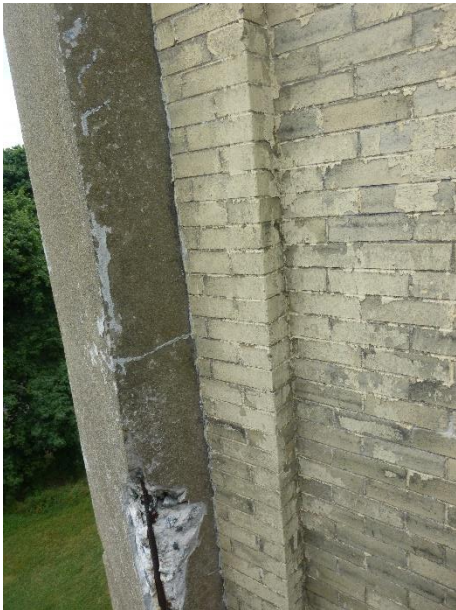
Typical concrete spalls at the steel reinforced concrete column, with exposed corroded reinforcement steel.

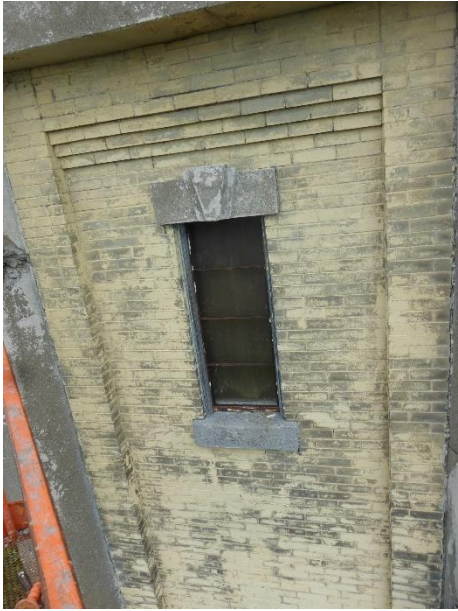
<p>View of the top window below the observatory level.</p> <p>Note most of the brick coating has worn away.</p>
36.

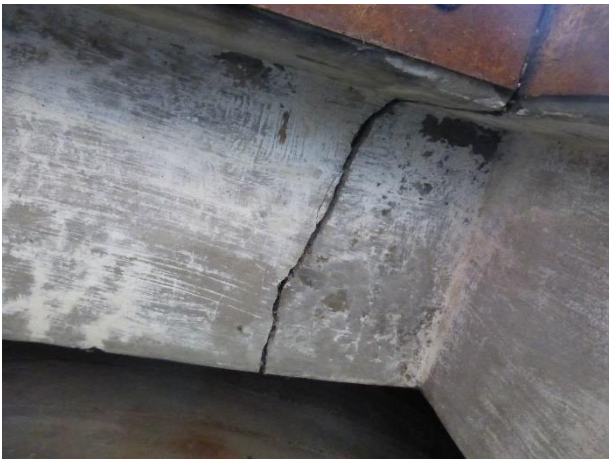
<p>Close-up view of the crack through the door header.</p>

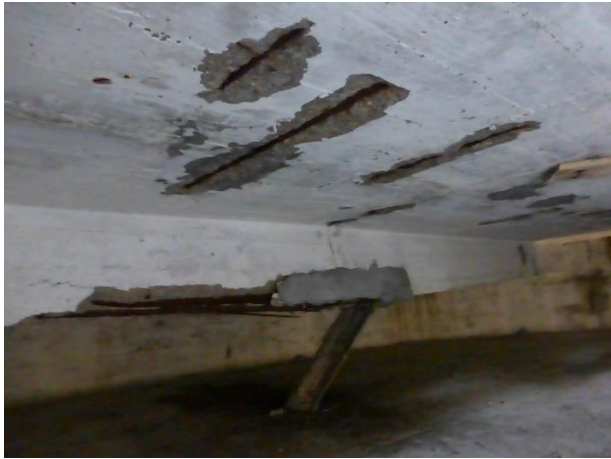
Photo of spalled concrete and exposed steel reinforcement at the underside of the observatory level.
38.

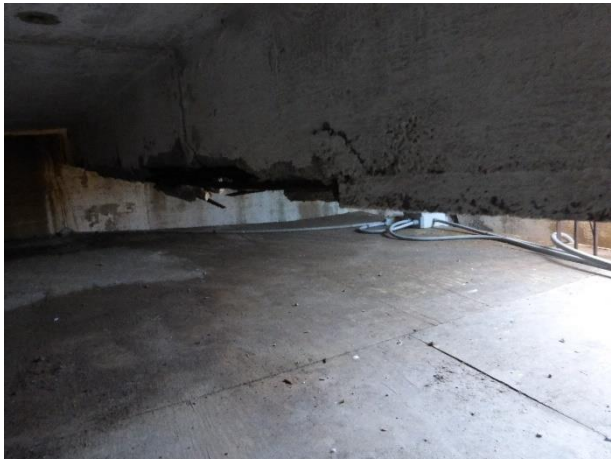
View of one (1) of two (2) steel reinforced concrete beams below the observatory level. Both reinforced beams are compromised.
39.

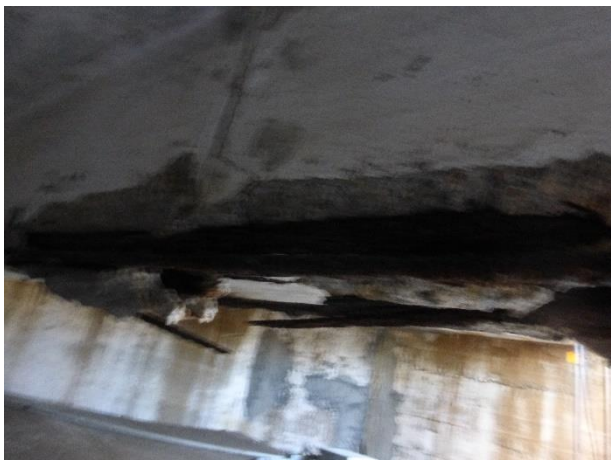
Close-up view at the beam midspan with failed reinforcing steel.

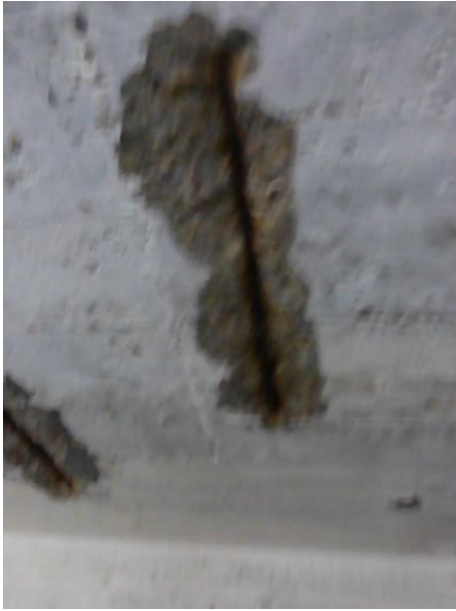
Close-up view of a typical concrete spall and exposed corroded steel reinforcement below the observatory level.
41.

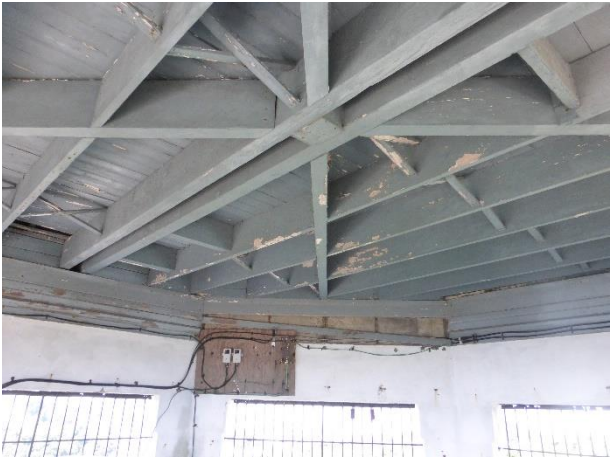
View at the underside of the wood framing below the roof. Note paint is worn.
42.

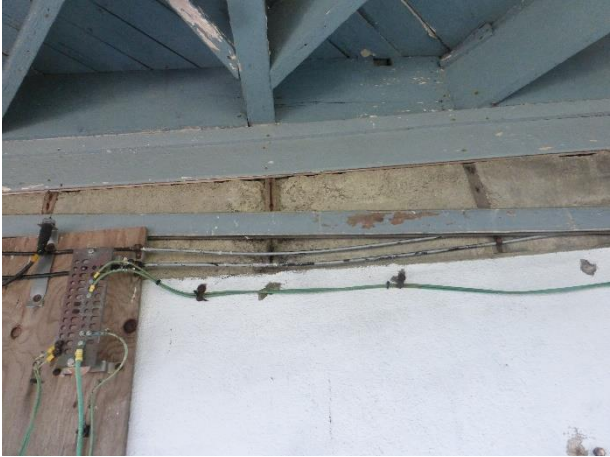
Photo of missing wood boards with concrete beam exposed.

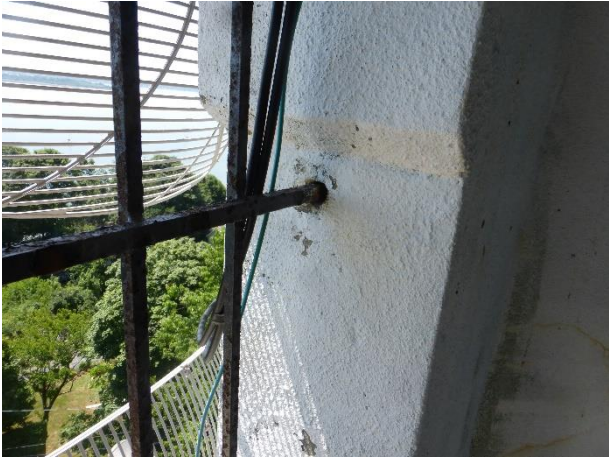
View of a corroded and loose railing connection at the concrete column at the observatory level.
44.

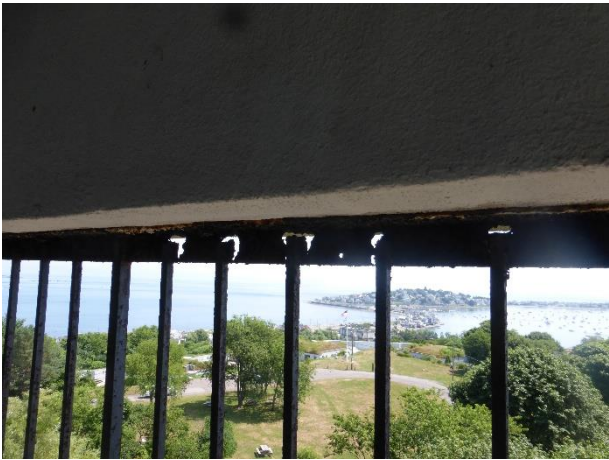
View of the corroded steel angle that connects to the metal railing. Railing connection are compromised.
45.

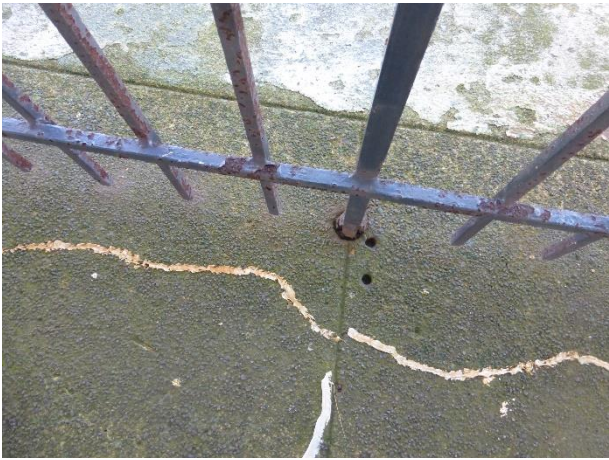
Photo of the base of the railing system with an unsealed hole through the concrete deck at the observatory level. Note failed sealant over concrete crack.

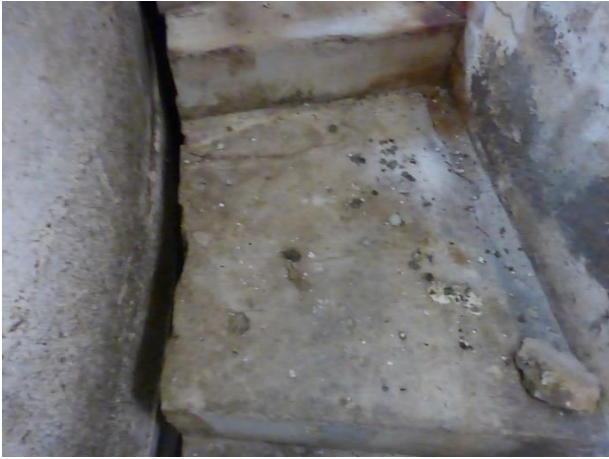
Photo looking down at failed concrete patch at the stair platform.
47.

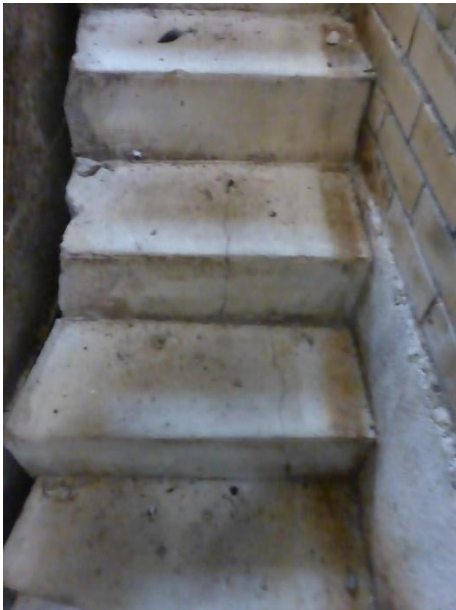
Photo of a continuous crack along a run of steps.

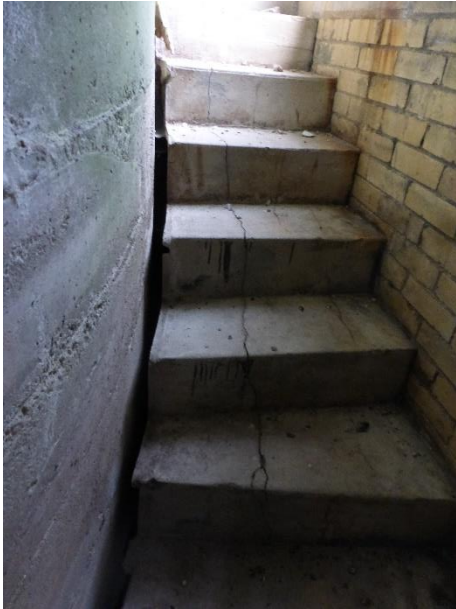
View of a continuous crack along a run of steps.
49.

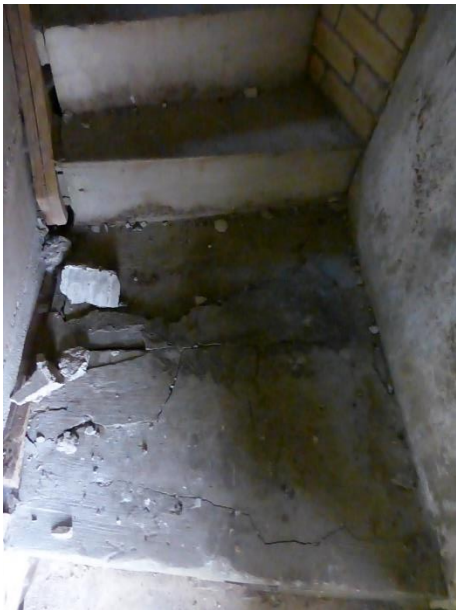
Photo of a failed patch at the stair landing.

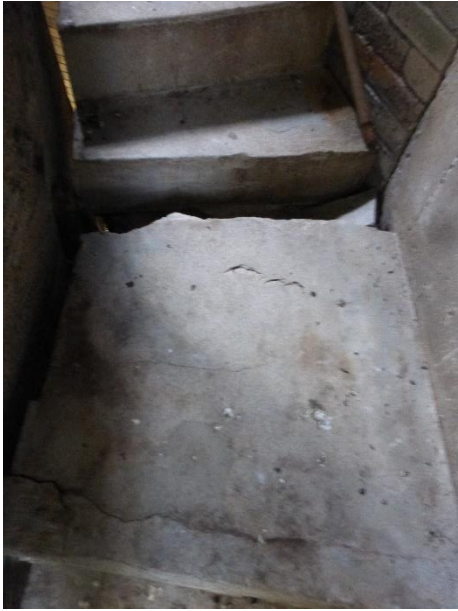
Photo of a missing portion of a stair platform.
51.

In our opinion that the cast in place concrete service stairs and platforms are in poor condition and are unsafe for use. We recommend that the stairs and platforms be removed and replaced. The replacement stairs can be either new cast in place concrete, or a metal stairs system, coated with a marine grade coating.

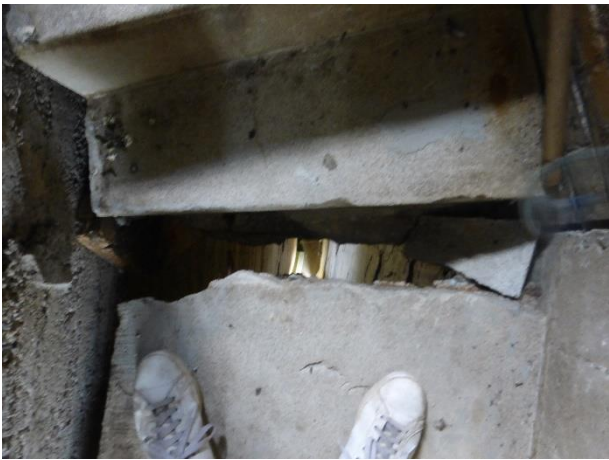
Downward view at the missing stair platform. Note the entrance door is below.
52.

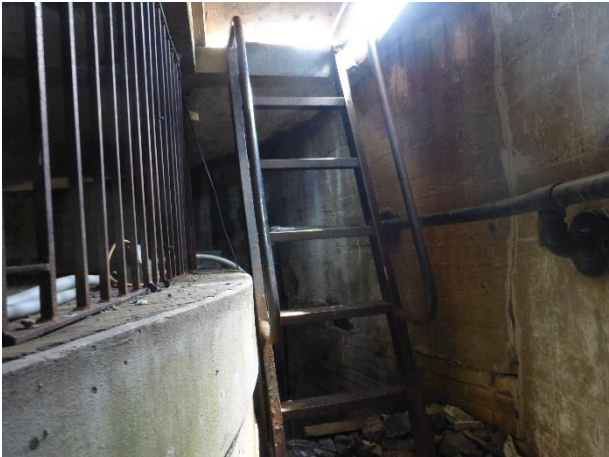
View at the corroded steel stair that accesses the observatory from the concrete stair.

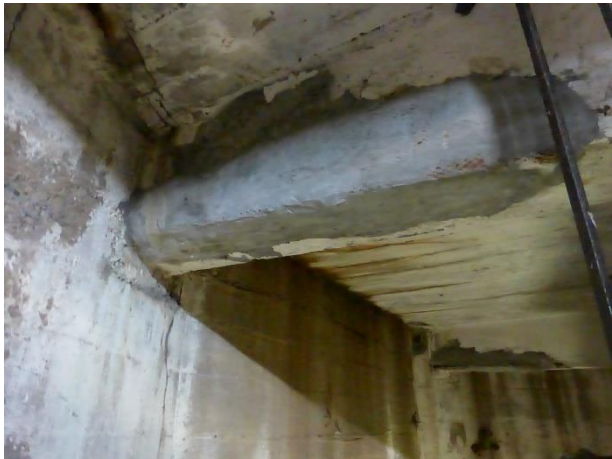
Photo of the delaminated beam end at one (1) of the reinforced beams supporting the observatory level,
54.

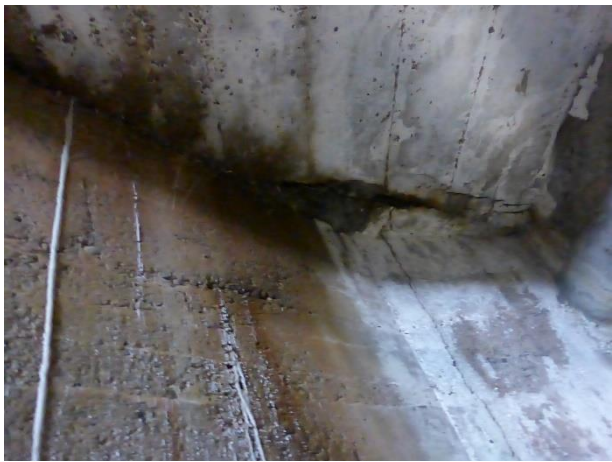
Photo of the underside of the observation level at the perimeter. Note rust staining from steel reinforcement due to water infiltration and salts chlorides.
55.

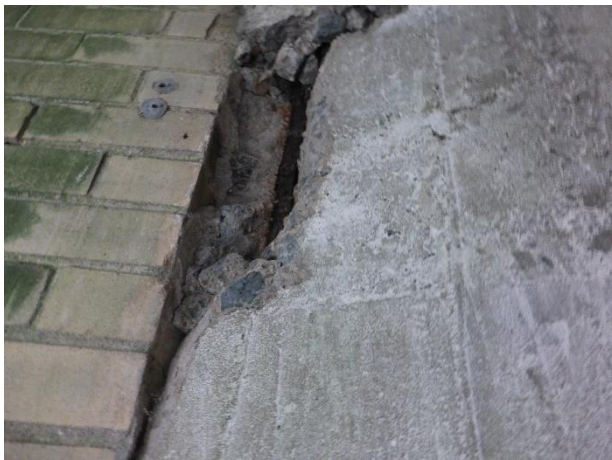
Spalled concrete at the concrete column.

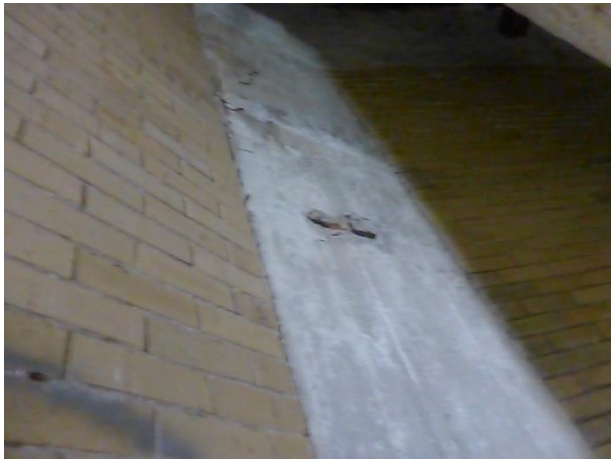
Spalled concrete at the concrete column.
57.

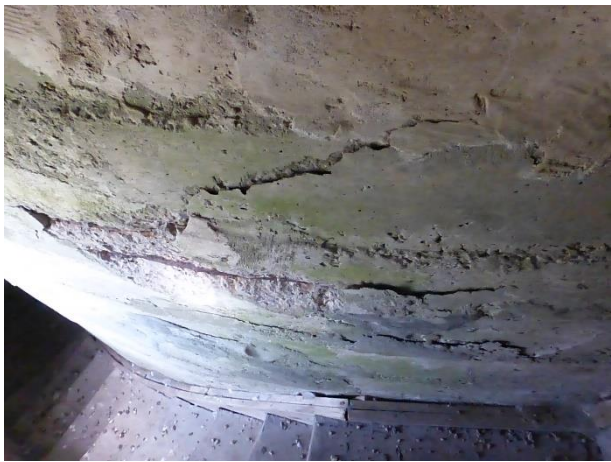
Deteriorated concrete at the water tank.
58.

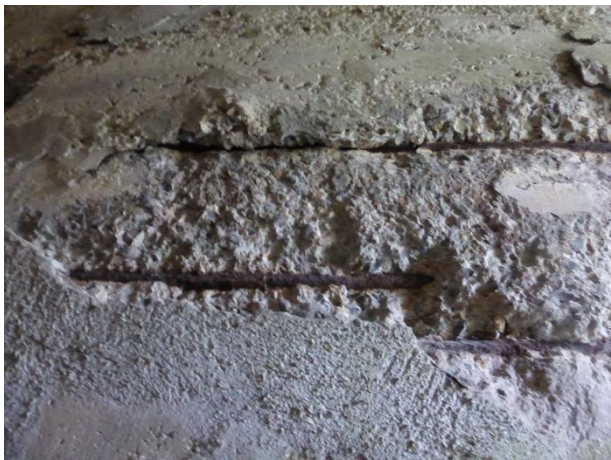
Photo of exposed reinforcement at the concrete water tank.

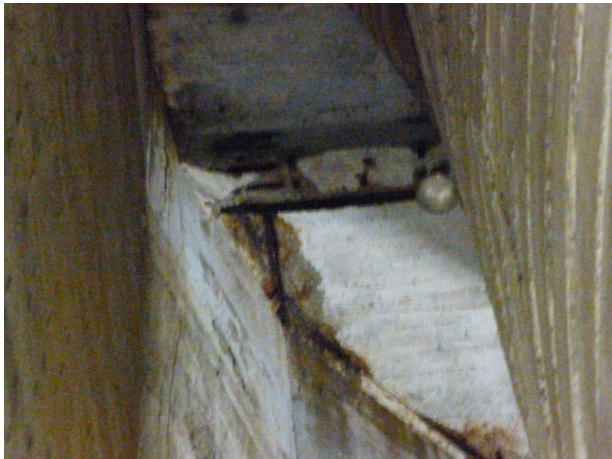
Exposed and corroded steel reinforcement and spalled concrete at the underside of the stairs.
60.

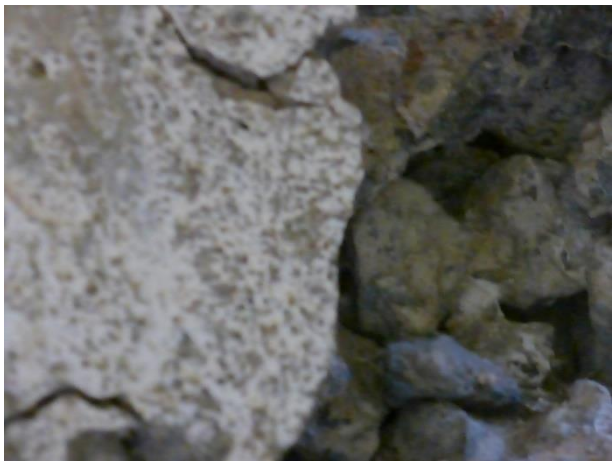
Close-up view of failed concrete at the concrete water tank.
61.

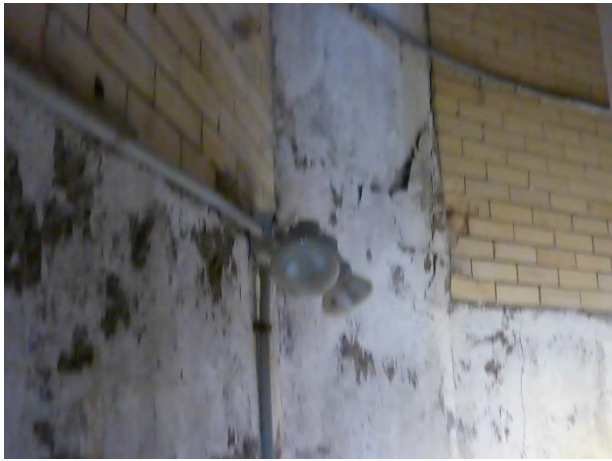
Delaminated concrete spall at the reinforced concrete column.
63.

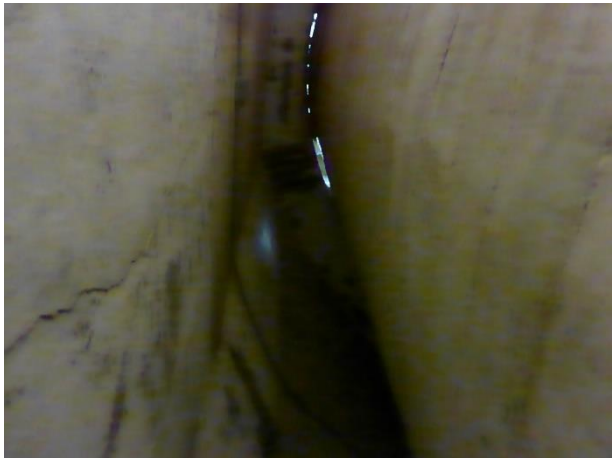
Upward view of the underside of the reinforced concrete stairs with spalled concrete and corroded exposed steel reinforcement.

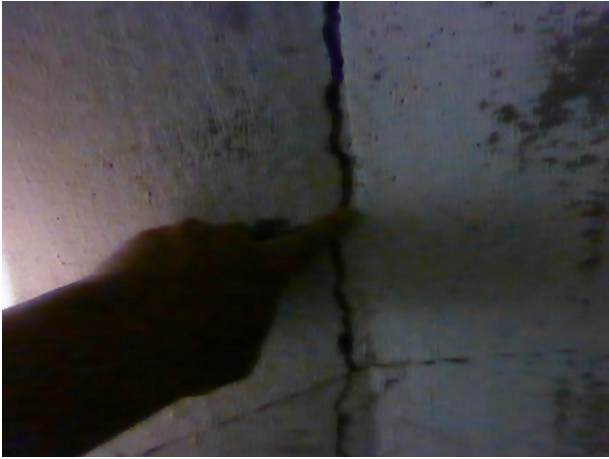
Interior/base of the water tower with a vertical crack between the concrete column and concrete base, typical at all eight columns.
66.

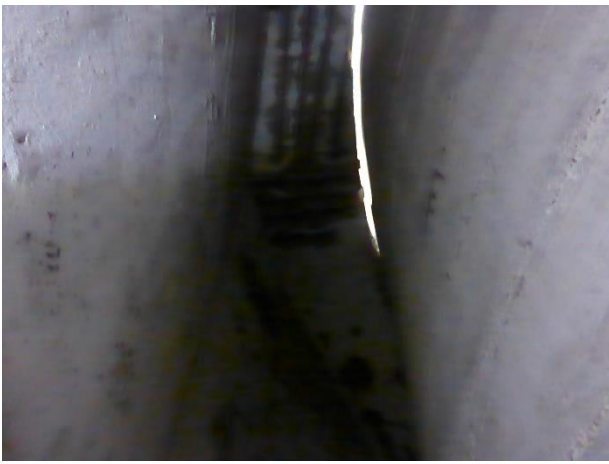
View at exposed corroded steel reinforcement and spalled concrete at the underside of a stair run.
67.

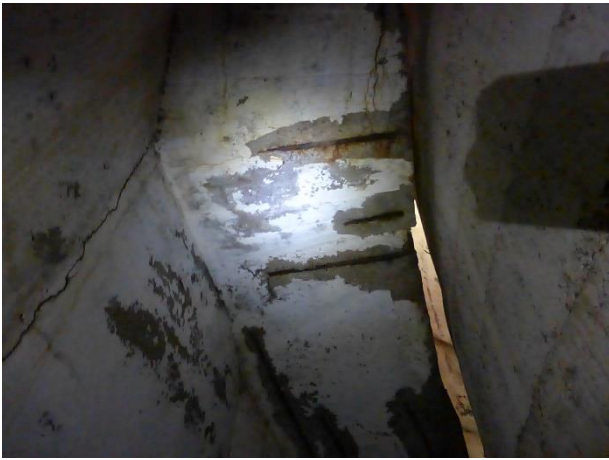
Corroded steel reinforcement and spalled concrete at the underside of a stair platform.

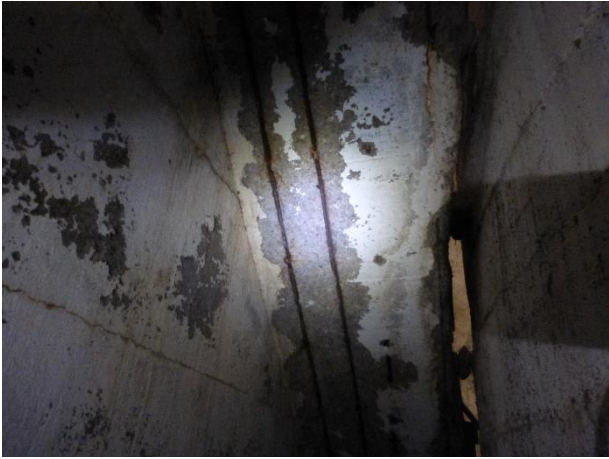
View of exposed corroded reinforcement and spalled concrete at the underside of a stair run.
69.

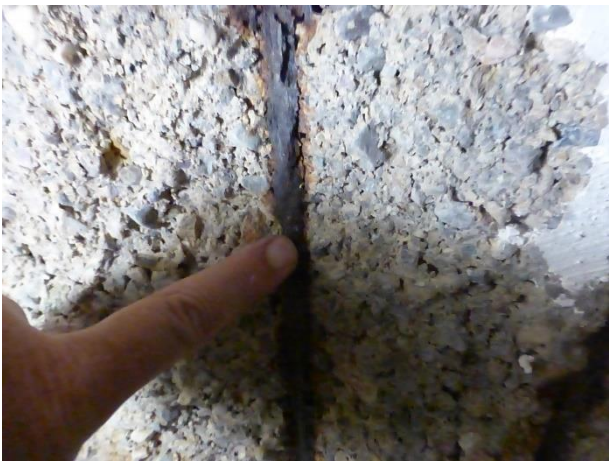
Close-up view of a severely corroded reinforcement at the underside of a stair run.
70.

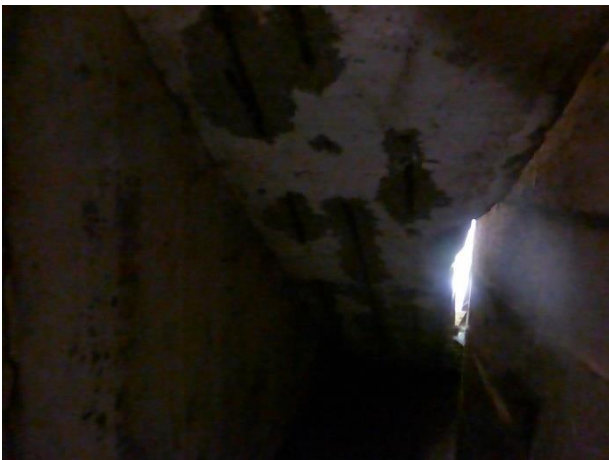
Photo of exposed corroded steel reinforcement and spalled concrete at the underside of a stair run.

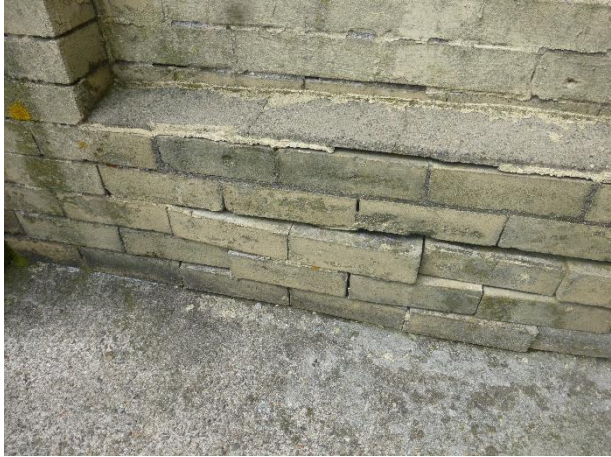
Laterally displaced concrete brick masonry above the lower decorative band.
72.

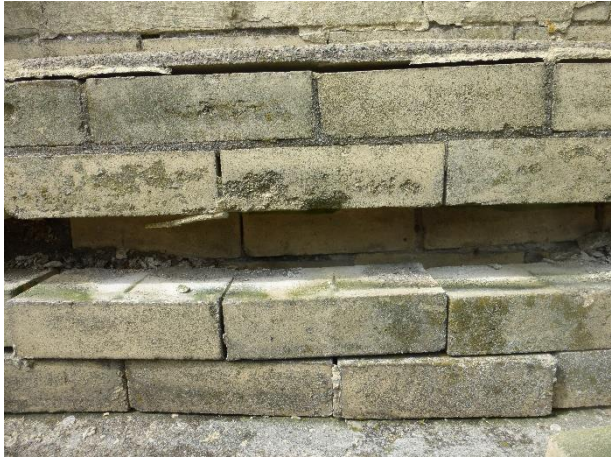
View at loose bricks removed by hand.
73.
