## MEMORANDUM

TO: John Struzziery, P.E.  
CC: Frank Cavaleri  
FROM: Peter Lyons  
DATE: July 19, 2017  
RE: Gunrock Area Sanitary Sewer Rehabilitation Recommendations

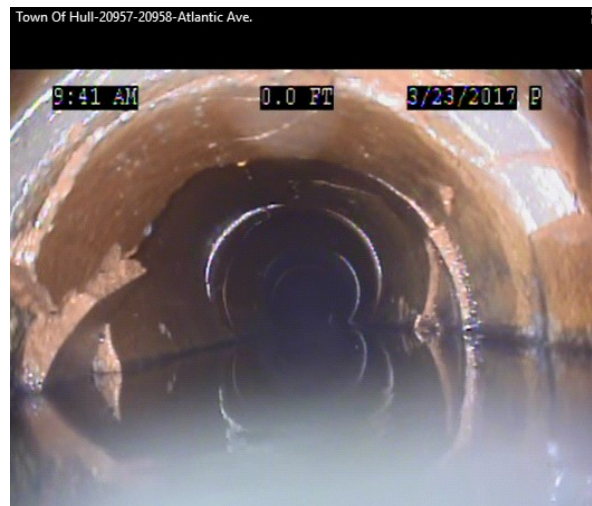
Pipe Segment 20957-20958 (Intersection of Stony Beach Rd. and Atlantic Ave.)

#### **BROKEN PIPE ON ATLANTIC AVENUE, GRADE 5**

| Pipe ID | Street | Size | Material | Length | QSR | QMR | QOR | Overall LOF | Observed Infiltration (gpm) | Comments | Recommended Rehabilitation | Cost |
|---|---|---|---|---|---|---|---|---|---|---|---|---|
| 20957-20958 | Atlantic Ave. | 8 | VCP | 126 | 5132 | 4223 | 5142 | 5 | 0 | FRACTURES THROUGHOUT. BROKEN PIPE AT MH20957 WILL NEED TO BE REMOVED BEFORE LINING. | CIPP, Open Cut | \$10,032 |

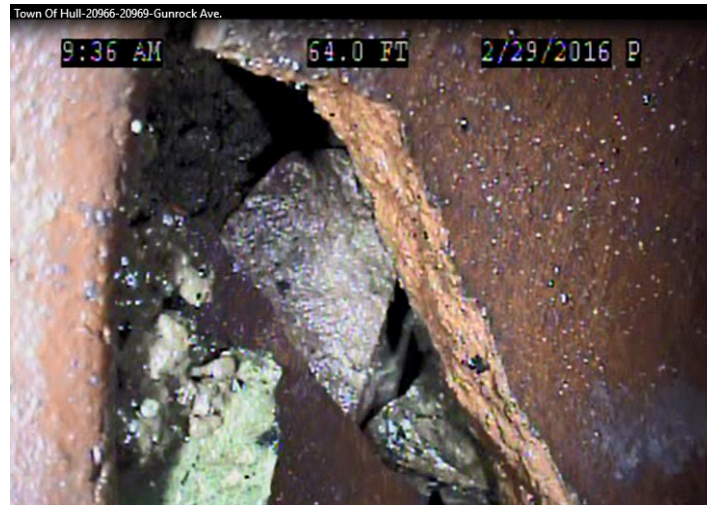
Pipe Segment 20966-20969 (Approximately #18 Gunrock Ave.)

## HOLE WITH VOIDS VISIBLE ON GUNROCK AVENUE, GRADE 5

| Pipe ID | Street | Size | Material | Length | QSR | QMR | QOR | Overall LOF | Observed Infiltration (gpm) | Comments | Recommended Rehabilitation | Cost |
|---|---|---|---|---|---|---|---|---|---|---|---|---|
| 20966-20969 | Gunrock Ave. | 6 | VCP | 360 | 4131 | 5200 | 5241 | 5 | 3 | 20966 BENCH TO BE PARGED. MOST JOINTS LEAKING. 2 PROTUDING SERVICES. FM THROUGHOUT. LATERAL LINE TWO SERVICES | Cut Service, Lateral Line, CIPP | \$30,500 |

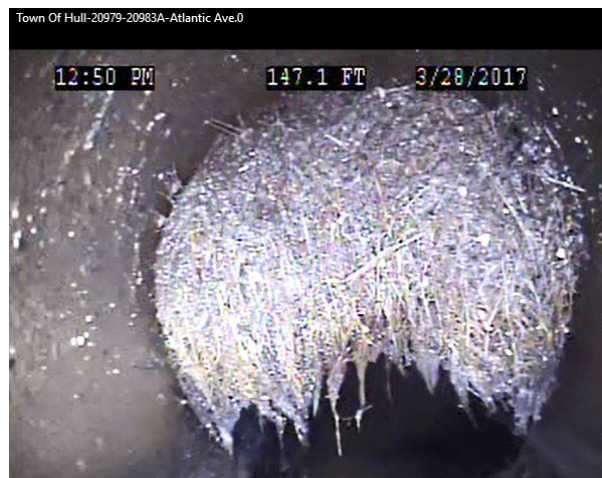
Pipe Segment 30008-20979 (Approximately #40 Atlantic Ave.)

## ROOT BALL LARGE OFF ATLANTIC AVENUE EASEMENT, GRADE 4

| Pipe ID | Street | Size | Material | Length | QSR | QMR | QOR | Overall LOF | Observed Infiltration (gpm) | Comments | Recommended Rehabilitation | Cost |
|---|---|---|---|---|---|---|---|---|---|---|---|---|
| 30008-20979 | Atlantic Ave. | 8 | VCP | 256 | 421C | 5241 | 5243 | 5 | 1 | HEAVY ROOTS. ROOTS COMPRIMISING PIPE INTEGRITY. | Root Treatment, CIPP | \$17,925 |

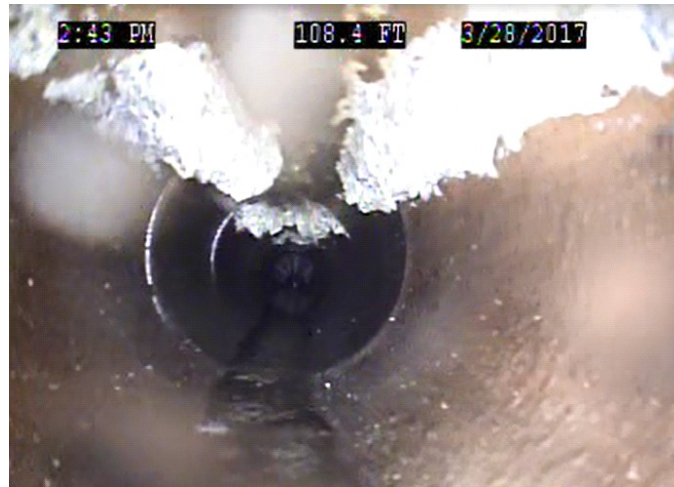
Pipe Segment 20967-20965 (Approximately #146 Atlantic Ave.)

### DEPOSITS ATTACHED GREASE ON ATLANTIC AVENUE, GRADE 3

| Pipe ID | Street | Size | Material | Length | QSR | QMR | QOR | Overall LOF | Observed Infiltration (gpm) | Comments | Recommended Rehabilitation | Cost |
|---|---|---|---|---|---|---|---|---|---|---|---|---|
| 20967-20965 | Atlantic Ave | 10 | VCP | 267 | 2100 | 4121 | 4122 | 4 | 4 | IS THROUGHOUT. HEAVY GREASE. BROKEN LATERALS AT 0+70,0+95, 1+28. HEAVY DEBRIS AND ROCKS. LATERAL LINE TWO SERVICES. | Lateral Line, CIPP, Open Cut | \$36,931 |

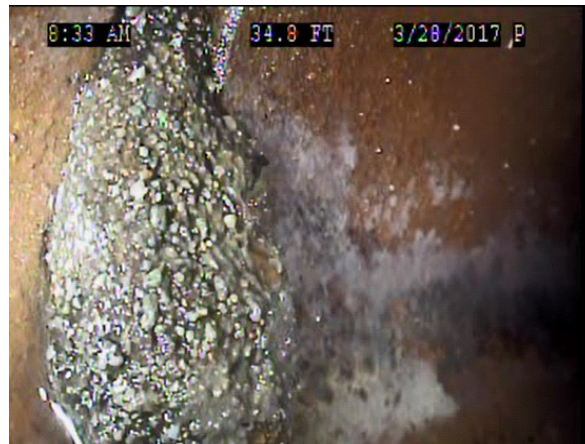
Pipe Segment 20982-20985 (Approximately #18 Summit Ave.)

### DEPOSITS ATTACHED ENCRUSTATION ON SUMMIT AVENUE, GRADE 4

| Pipe ID | Street | Size | Material | Length | QSR | QMR | QOR | Overall LOF | Observed Infiltration (gpm) | Comments | Recommended Rehabilitation | Cost |
|---|---|---|---|---|---|---|---|---|---|---|---|---|
| 20982-20985 | Summit Ave. | 6 | VCP | 296 | 2200 | 4124 | 4126 | 4 | 2 | FRACTURES MOST LENGTH. HOLES. DAE. | CIPP | \$17,766 |

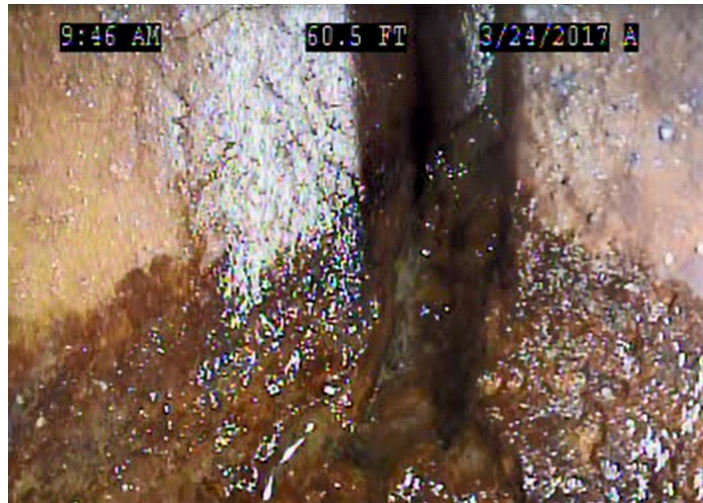
Pipe Segment 20964-20966 (Approximately #22 Gunrock Ave.)

#### INFILTRATION RUNNER AND STAINING, GRADE 4

| Pipe ID | Street | Size | Material | Length | QSR | QMR | QOR | Overall LOF | Observed Infiltration (gpm) | Comments | Recommended Rehabilitation | Cost |
|---|---|---|---|---|---|---|---|---|---|---|---|---|
| 20964-20966 | Gunrock Ave. | 6 | VCP | 123 | 3122 | 5241 | 5241 | 5 | 3 | INTRUDING TAP. HSV. FM THROUGHOUT. LATERAL LINE TWO SERVICES | Cut Service, Lateral Line, CIPP | \$16,280 |

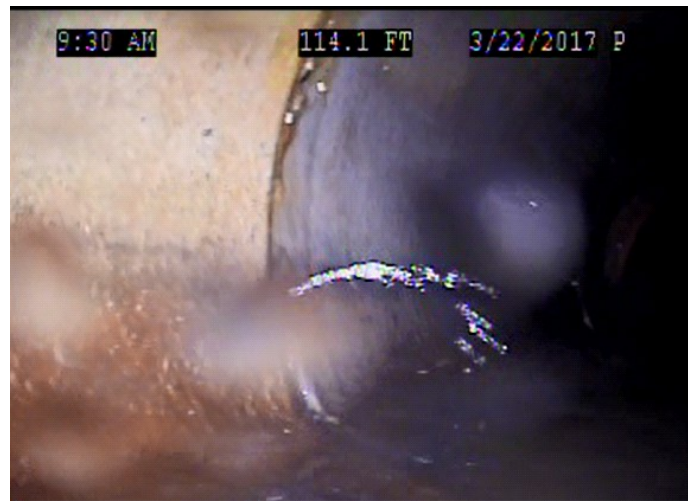
Pipe Segment 20971-20970 (Approximately #120 Atlantic Ave.)

#### INFILTRATION GUSHER, GRADE 5

| Pipe ID | Street | Size | Material | Length | QSR | QMR | QOR | Overall LOF | Observed Infiltration (gpm) | Comments | Recommended Rehabilitation | Cost |
|---|---|---|---|---|---|---|---|---|---|---|---|---|
| 20971-20970 | Atlantic Ave. | 10 | VCP | 373 | 4112 | 5143 | 5144 | 5 | 3 | SMALL HOLES. FM. IG. LATERAL LINE TWO SERVICES. | Lateral Line, CIPP | \$40,449 |

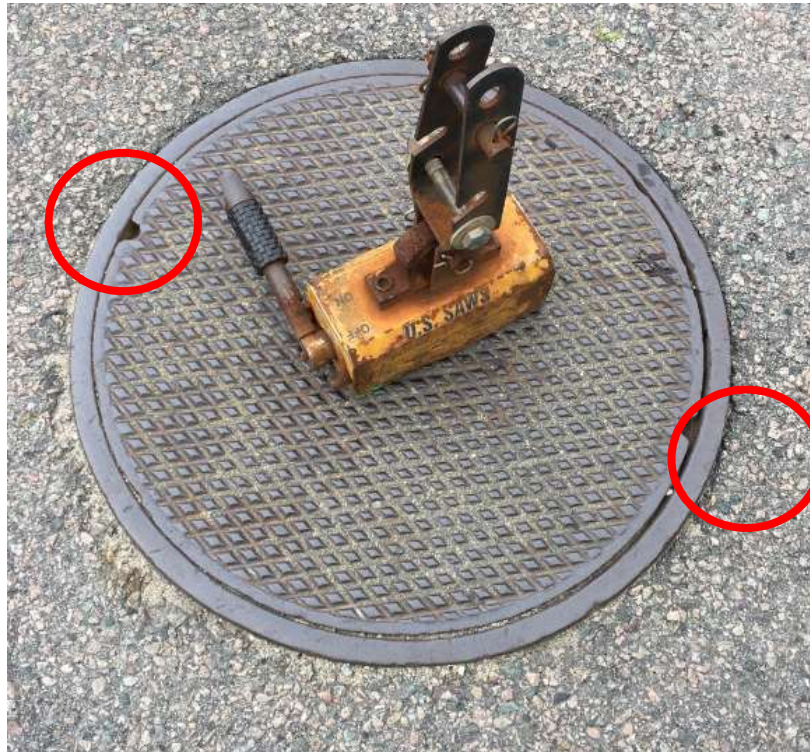
MH 20970 (Approximately #134 Atlantic Ave.)

### MANHOLE RIM WITH PICKHOLES LEADING TO SURFACE INFLOW

| GIS ID | Location | Depth (ft) | Material | LOF | Observed Infiltration (gpm) | Comments | Recommended Rehabilitation | Cost |
|---|---|---|---|---|---|---|---|---|
| 20970 | Atlantic Avenue | 6.7 | Brick | 2 | | Rim inflow. No infiltration | New Watertight Cover | \$600 |

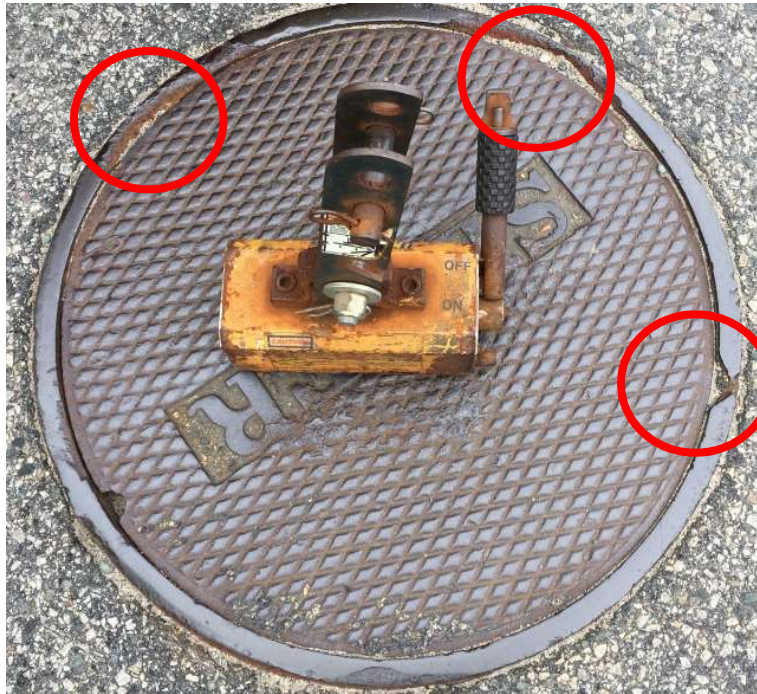
MH 30006 (Intersection of Atlantic Ave and Montana Ave.)

### DAMAGED FRAME AND COVER

| GIS ID | Location | Depth (ft) | Material | LOF | Observed Infiltration (gpm) | Comments | Recommended Rehabilitation | Cost |
|---|---|---|---|---|---|---|---|---|
| 30006 | Atlantic Avenue | 9.5 | Precast Concrete | 2 | | New construction good no issues rim inflow possible. | New Frame & Cover | \$750 |

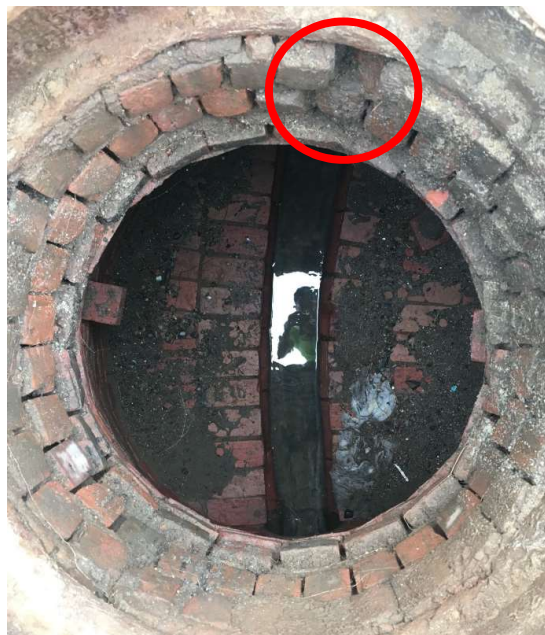
MH 20976 (Approximately #76 Atlantic Ave.)

### DEFECTIVE CHIMNEY

| GIS ID | Location | Depth (ft) | Material | LOF | Observed Infiltration (gpm) | Comments | Recommended Rehabilitation | Cost |
|---|---|---|---|---|---|---|---|---|
| 20976 | Atlantic Avenue | 5.6 | Brick | 3 | | Missing motor thru out chimney. Pick holes will cause inflow. Recommend new frame and cover. | New Watertight Cover | \$600 |

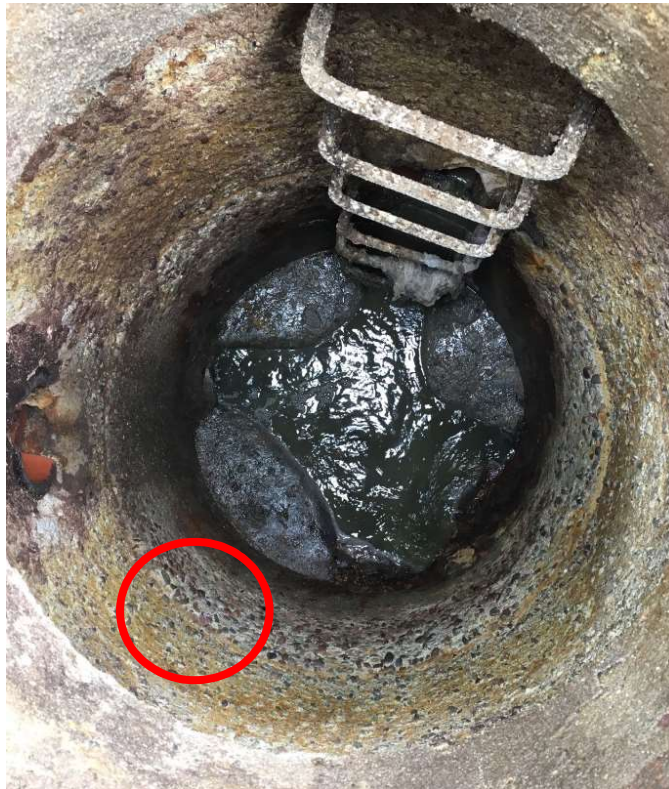
MH 20962 (Intersection of Atlantic Ave and Montana Ave.)

**MH20962 (US OF PS 1) WITH AGGREGATE SHOWING**

| GIS ID | Location | Depth (ft) | Material | LOF | Observed Infiltration (gpm) | Comments | Recommended Rehabilitation | Cost |
|---|---|---|---|---|---|---|---|---|
| 20962 | Atlantic Avenue | 9.8 | Precast Concrete | 4 | 1.00 | PS1 manhole. Agg showing. Inflow cover inserted. Manhole some infiltration. Recommend epoxy line. | Rebuild Bench & Channel, Epoxy Liner | \$6,500 |

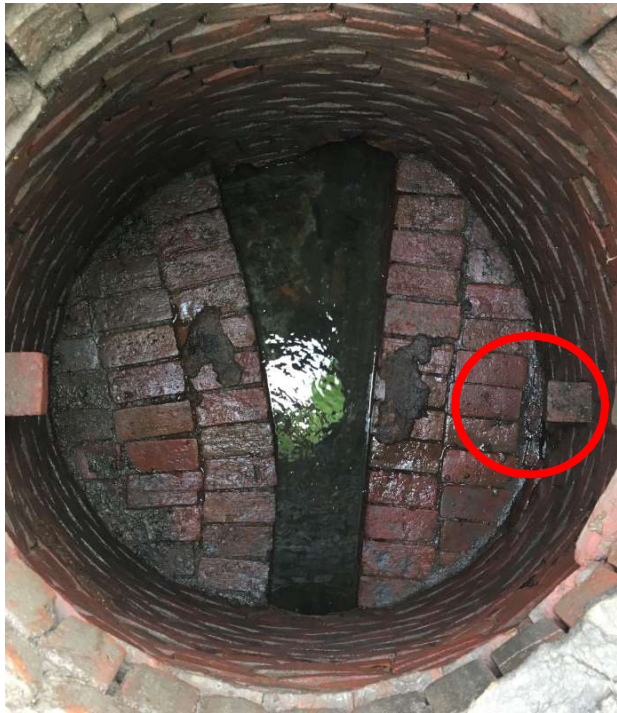
MH 20967 (Intersection of Atlantic Ave and Gunrock Ave.)

**WALL DEFECTIVE (LIGHT INFILTRATION)**

| GIS ID | Location | Depth (ft) | Material | LOF | Observed Infiltration (gpm) | Comments | Recommended Rehabilitation | Cost |
|---|---|---|---|---|---|---|---|---|
| 20967 | Atlantic Avenue | 6.6 | Brick | 3 | 0.50 | Missing mortar in chimney. Rim inflow. Infiltration at wall/bench. | Cementitious Liner | \$1,050 |

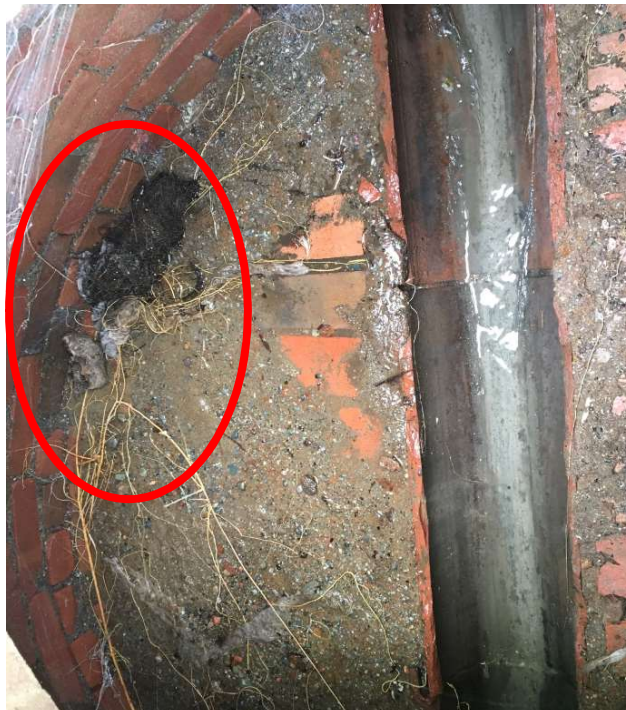
MH 30008 (Approximately #38 Atlantic Ave.)

**MH WALL DEFECTIVE (LIGHT INFILTRATION, ROOTS)**

| GIS ID | Location | Depth (ft) | Material | LOF | Observed Infiltration (gpm) | Comments | Recommended Rehabilitation | Cost |
|---|---|---|---|---|---|---|---|---|
| 30008 | Easement Off Atlantic Avenue | 3.8 | Brick | 3 | 0.50 | Roots at walls and infiltration at walls and bench. | New Watertight Cover, Chemical Root Treatment, Cementitious Liner | \$3,200 |

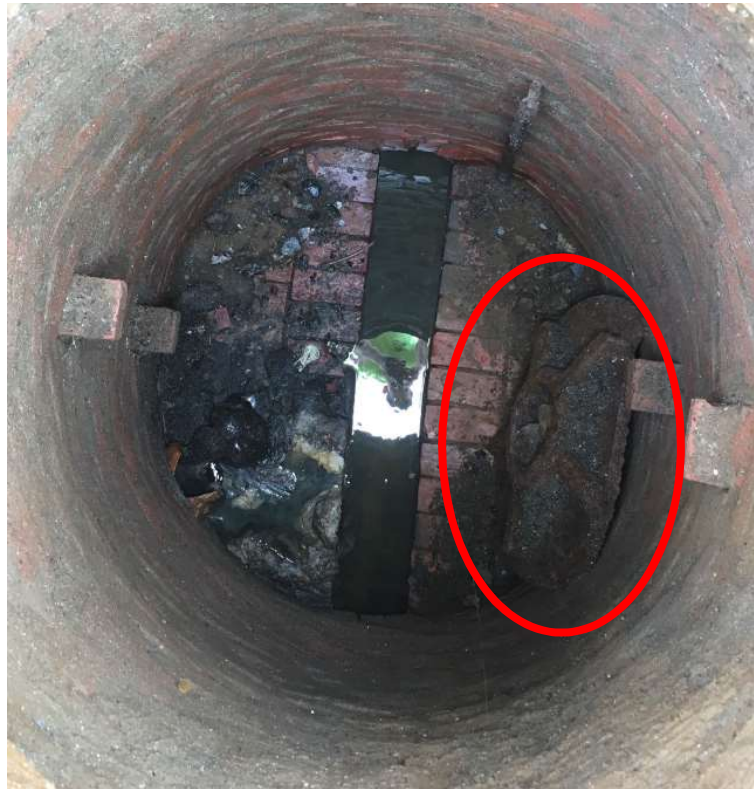
MH 20957 (Intersection of Atlantic Ave and Stony Beach Rd.)

## MH WITH DEFECTIVE BENCH & DEBRIS

| GIS ID | Location | Depth (ft) | Material | LOF | Observed Infiltration (gpm) | Comments | Recommended Rehabilitation | Cost |
|---|---|---|---|---|---|---|---|---|
| 20957 | Atlantic Avenue | 8.2 | Brick | 2 | | Remove cover on manhole bench. Rebuild bench for connection. | Clean, New Frame & Cover, Rebuild Bench & Channel | \$3,250 |
