MEMORANDUM

Date: January 18, 2024

Re: 51 Harborview Road NOI Peer Review

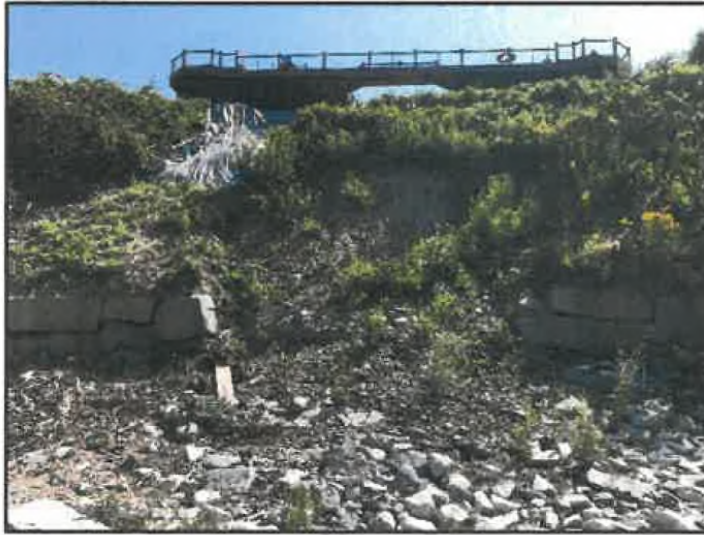
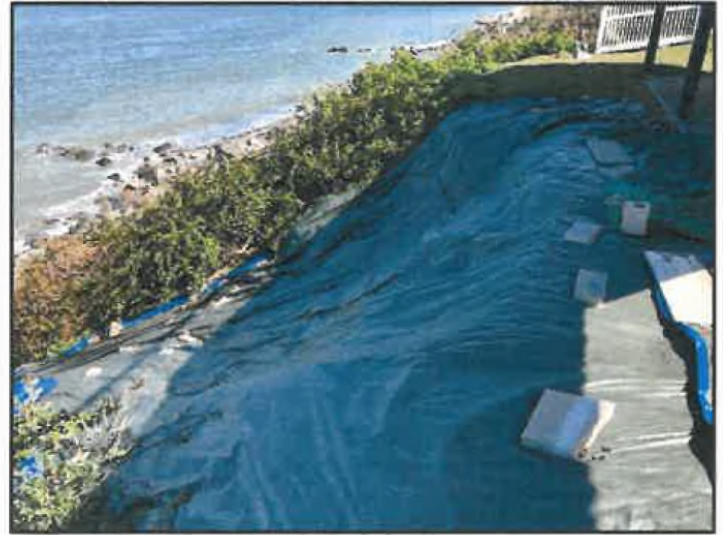
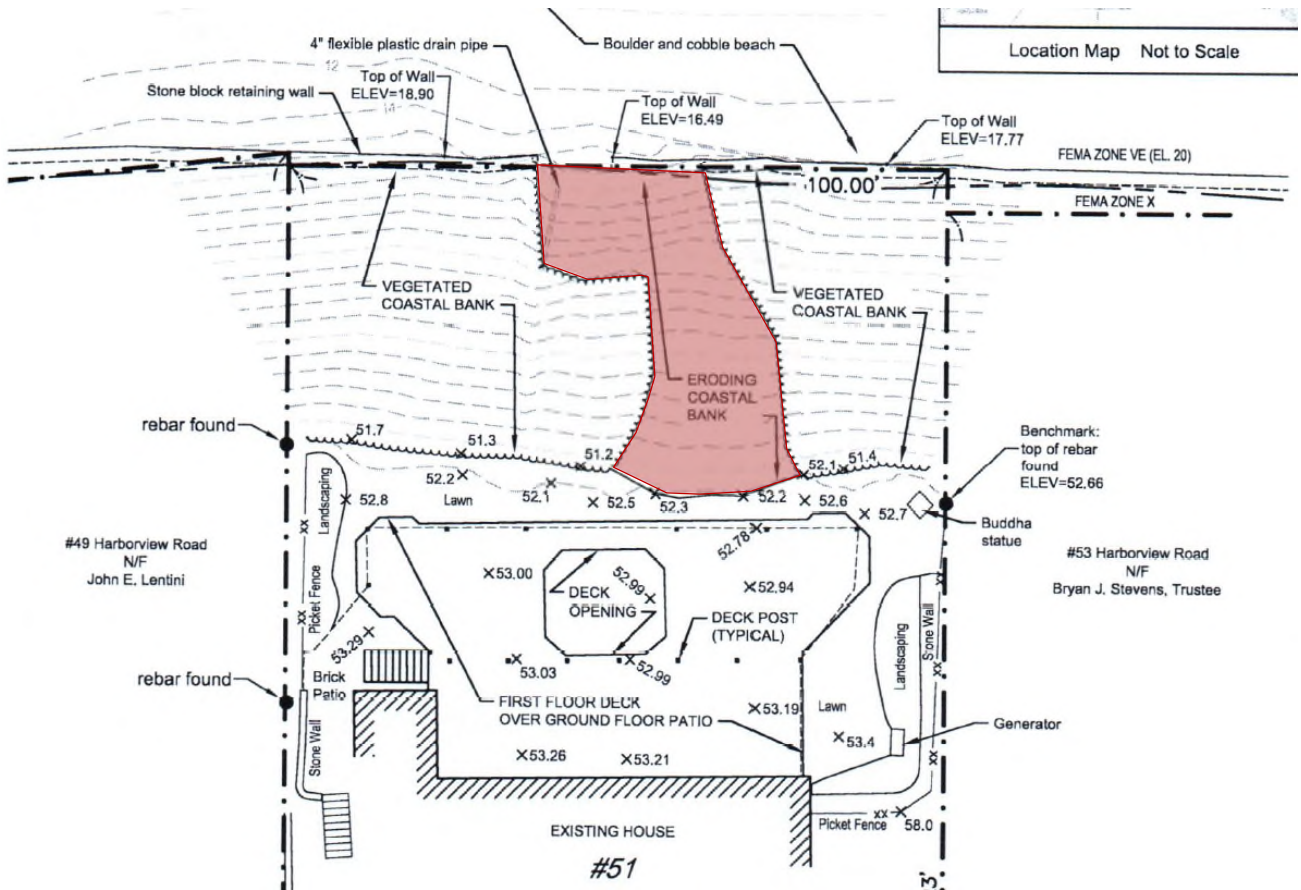
Figure 3: Photographs and Surveyed Site Conditions after July 2019 Slope Failure

The timeline assembled by the Town indicates that there were two slope failure incidents, one in July 2019 and the other in September 2021. The initial failure in July 2019 occurred, with visible slope erosion on the coastal bank as shown in **Figure 3**. The coastal bank experienced significant slope failure starting at the crest of the slope, immediately abutting the stone patio at 51 Harborview. Approximately 1/4 to 1/3 of the width of the slope within the subject property was affected. Based on the photographs and site plan prepared by others, the slope failure did not extend significantly beyond the existing stone block wall at toe of the slope. After this failure incident, several engineers and coastal geologists were involved and provided repair/restoration solutions. The Town ConCom issued in December 2019 an OOC (Ref. 1), which approved “coastal bank stabilization consisting of installation of coastal bank retention system and native coastal bank plantings” according to the plans/sketches prepared by Antonopoulos and WHG (Refs. 12, 13, 14, and 16). The OOC included “Special Conditions” such as “[p]atio is to be partially removed so that it resides no closer than 12 ft” from the Top of Bank (TOB). There was a segment of toe failure before July 2019, as shown by the aerial photography taken in April 2019 (**Figure 4**).

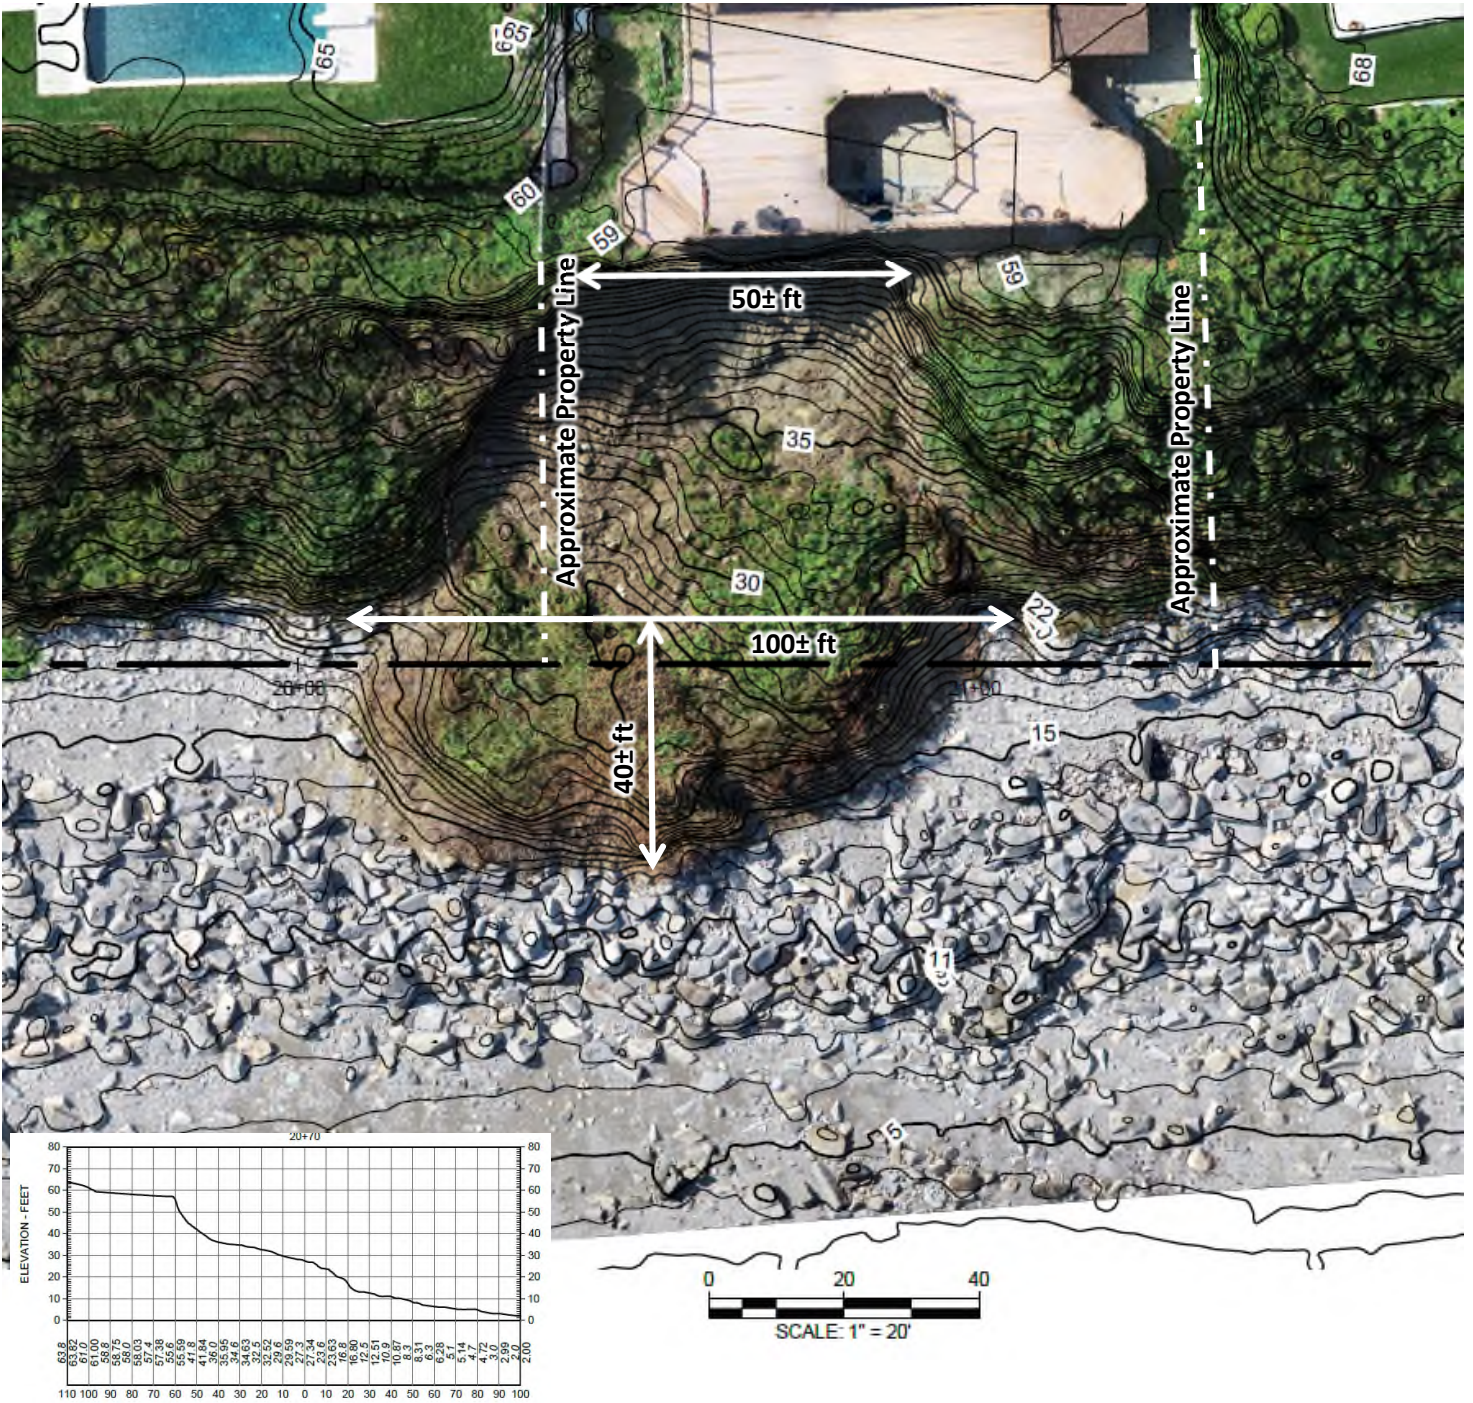
Figure 5: Surveyed Site Conditions after September 2021 Slope Failure

- The failed coastal bank segment at 51 Harborview Road did not have additional large-scale mass movement since October 2021 when the shoreline-wide topographic survey was performed by the Town. However, the rills carved out by groundwater flow have deepened and widened over time, comparing photographs taken between November 2022 and June 2023). This indicates that materials are being constantly washed out from behind the timber ERS structure and down the slope, most likely due to heavy rainfall infiltration over the patio/deck area.

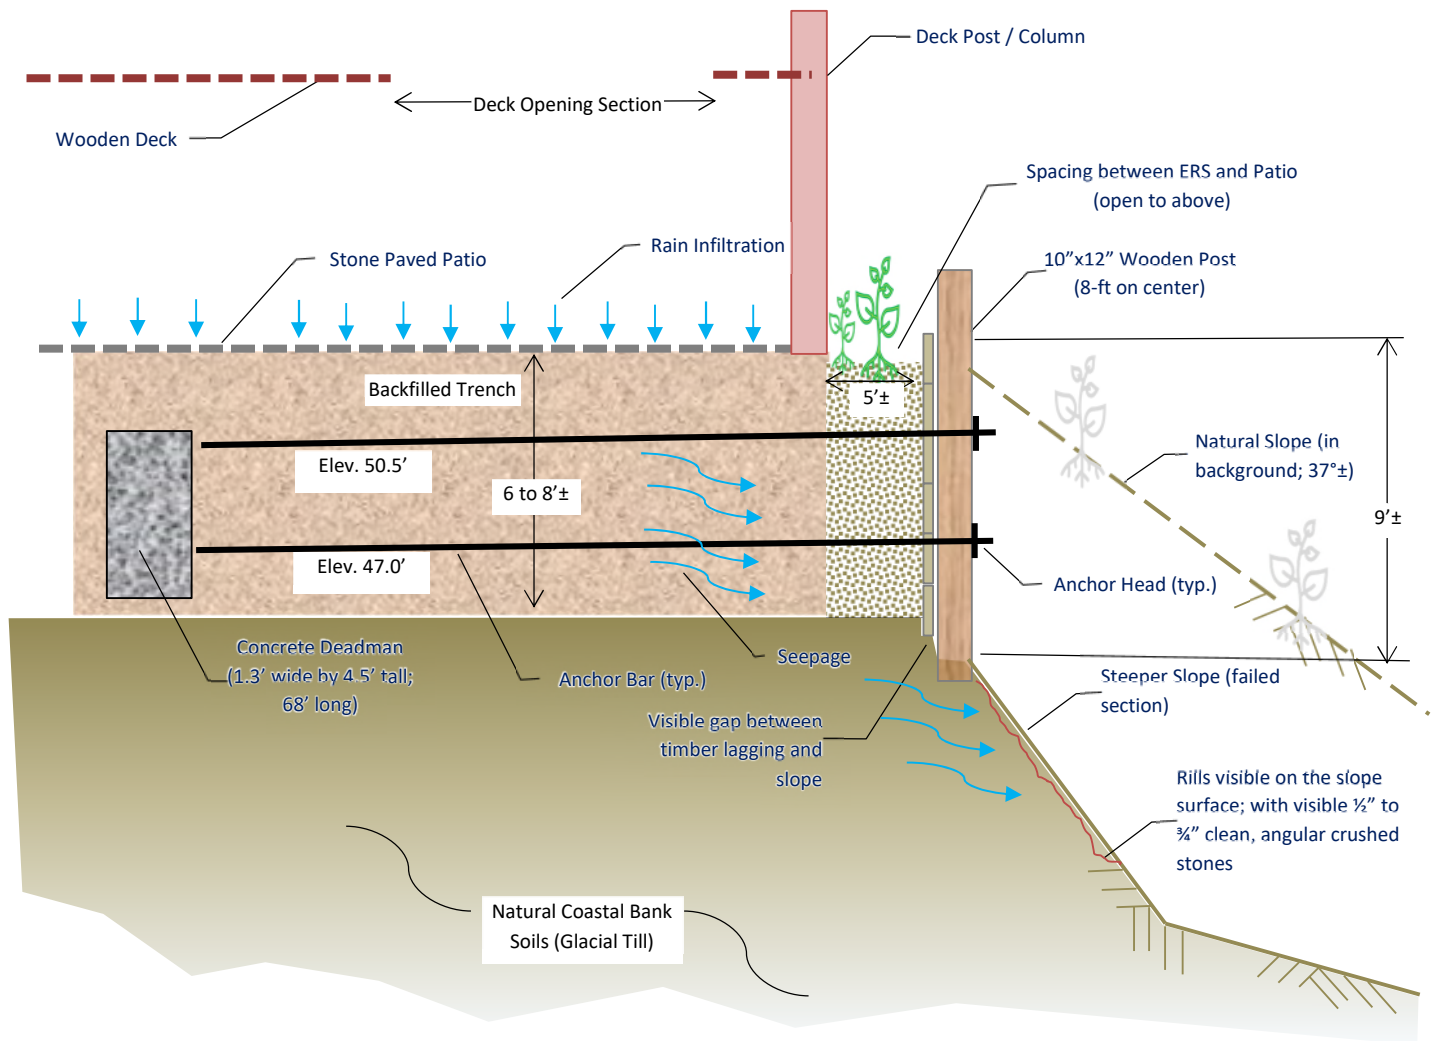
Figure 8: Schematic Profile of Existing Conditions (as of June 2023)

- The slope immediately below the existing ERS is currently at an unreasonably steep angle (approximately 60° relative to the Horizontal plane) without significant vegetation, which is resulting in high rates of erosion and reduced stability of the coastal bank. The slope angle of the failed section is greater than adjacent natural coastal bank slopes and underlain by a relatively gentle toe slope where the slumped bank soils accumulated.

- Based on GZA's understanding, the increased hydraulic conductivity of the backfill materials (clean sand/gravel mixtures; or crushed stone) increased the surface water infiltration and seepage during intense rain events. The excess water saturated the soils behind the already disturbed coastal bank. Conceivably, the saturated soils and groundwater increased the lateral pressure and contributed to the driving force for the slope to slide downhill, under gravity. Slope failure occurs when the driving force exceeds the resistance to sliding on the failure plane.

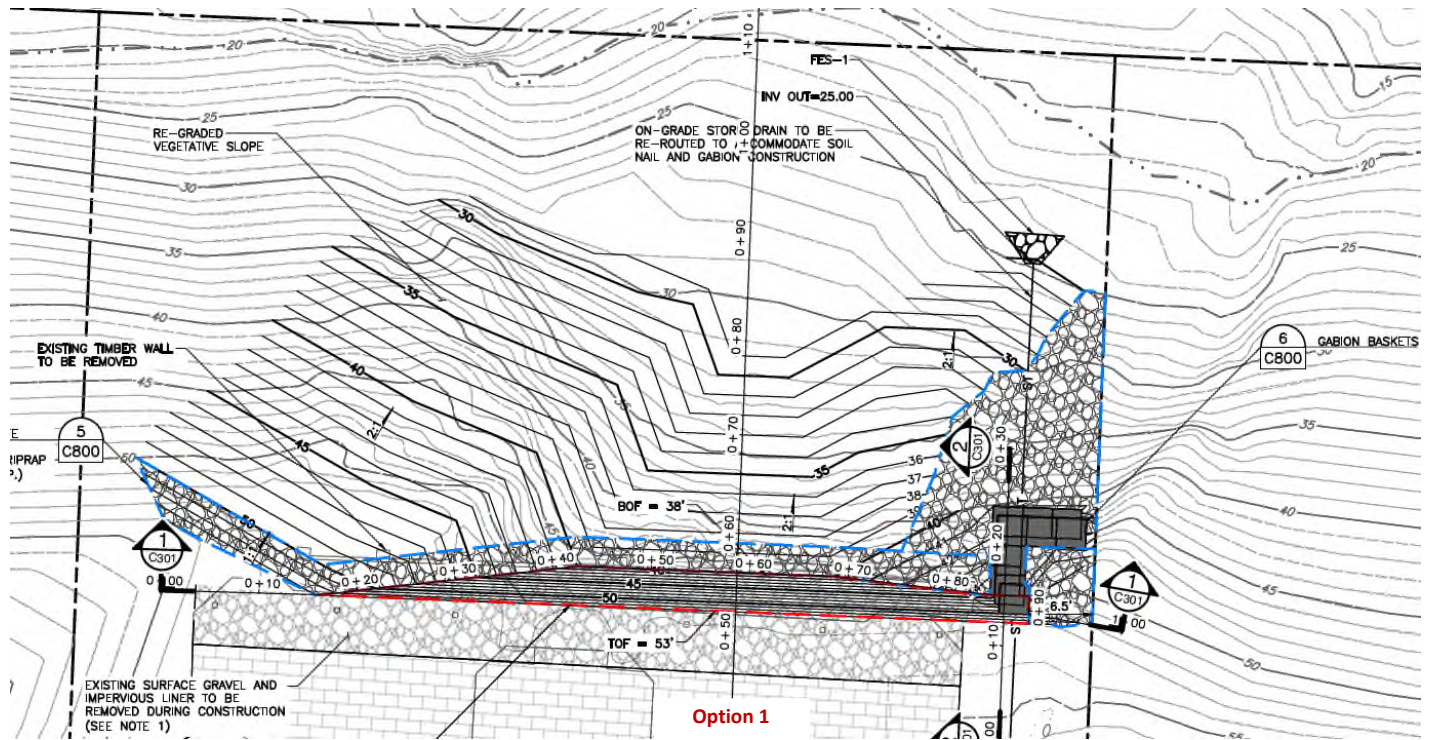
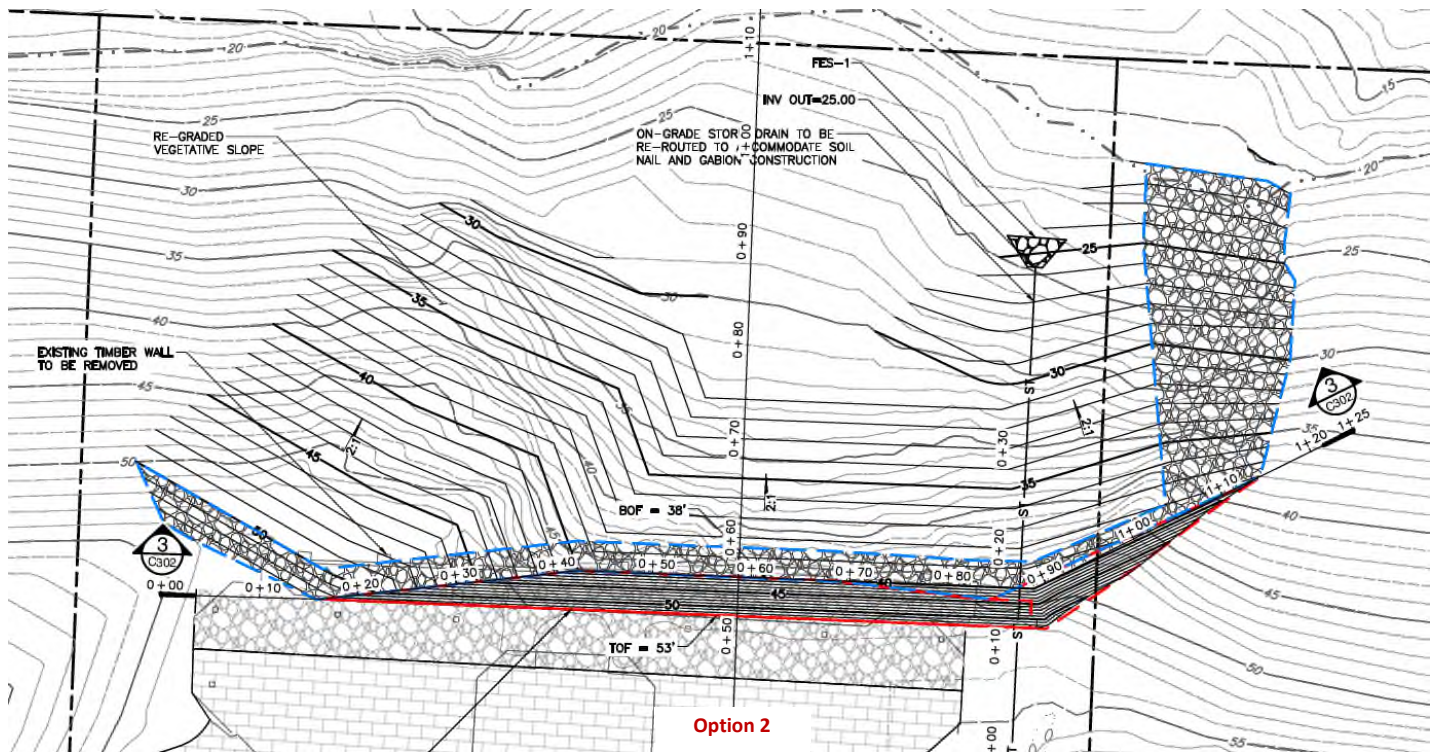
Figure 9: Plan View of Proposed Alternatives

- Two different slope repair options were presented (**Figure 9**):
 - #1: Soil nail wall with gabion baskets and riprap slope ending at the property line between 51 and 53 Harborview. Gabion baskets were proposed to provide slope stabilization at the property line, where the proposed grades do not smoothly tie into the grades on the abutter property at 53 Harborview.

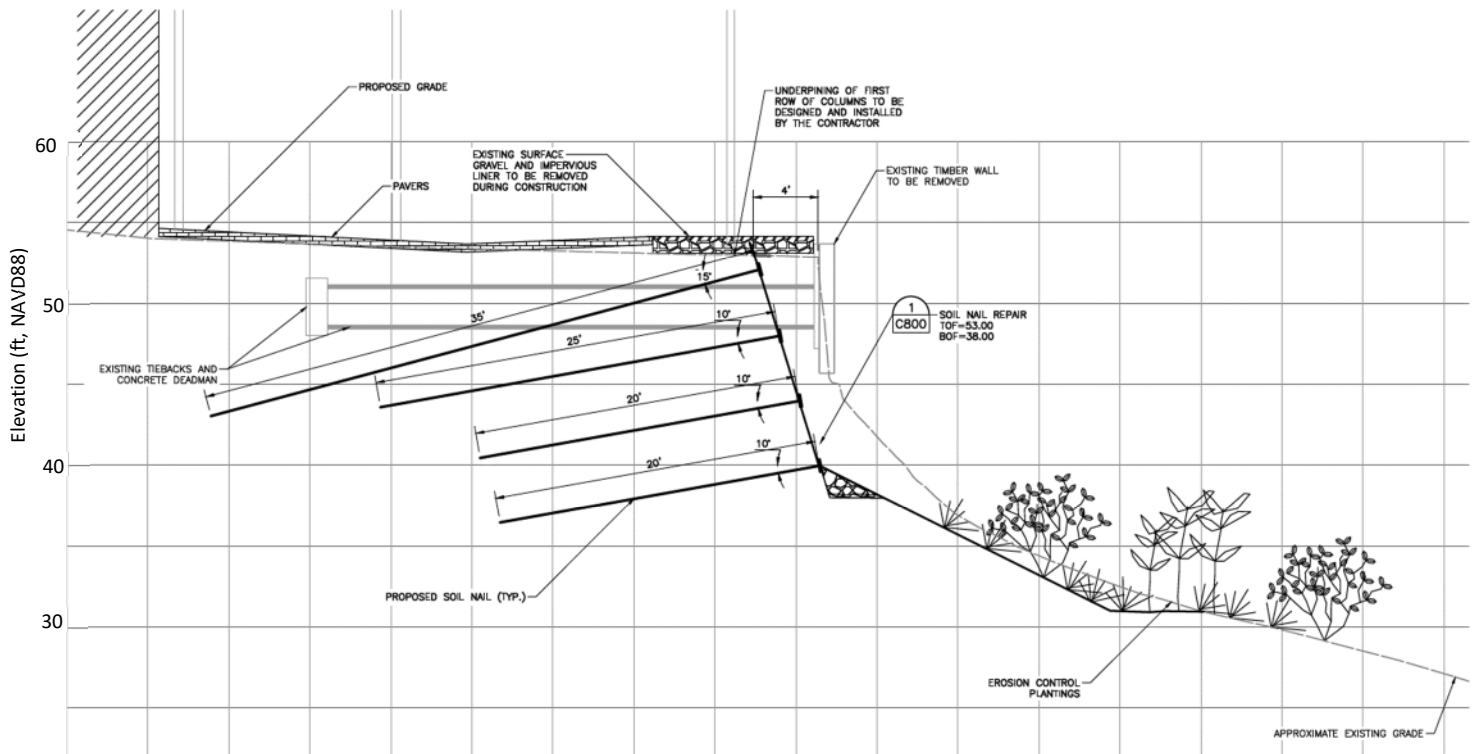
Figure 10: Typical Cross Section of Proposed Soil Nail Wall

- The proposed wall is able to achieve a factor of safety of 1.67 for a rotational type of slope failure, along the selected representative section.
- The gabion basket section did not meet the minimum factor of safety requirements (1.5) in all directions. In our opinion, the results are conservative as they were based on 2-dimensional analysis, whereas the gabion basket section is essentially a 3-dimensional structure. However, we suggest that a wider wall system be considered to

achieve the minimum factors of safety against stability failure. The design did not provide details relative to the gabion wall such as basket layout, sizes, subgrade mitigation, or backfill requirements.

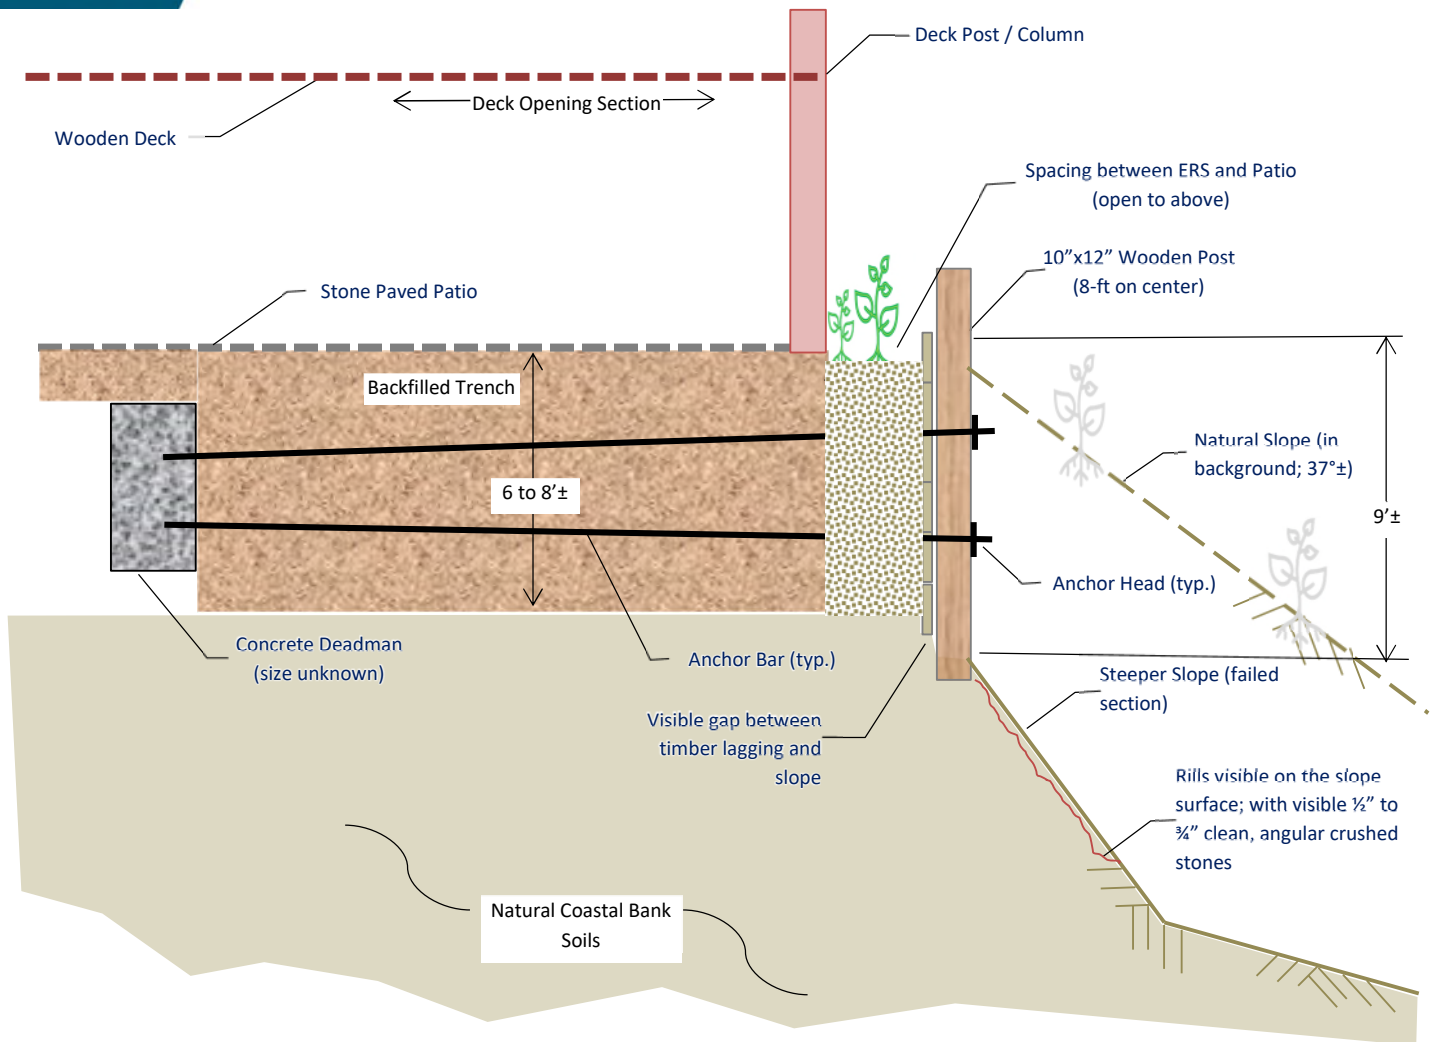
Figure 2: Schematic Profile of Existing Conditions

- Based on the information provided by the Owner, trenches (6 to 8 feet deep) were excavated during the patio/deck construction project to allow installation of the tie rods at each timber post location. The trenches were then backfilled with sand/gravel/crushed stone. **Figure 2** presents a cross section through the failed slope and timber-lagging wall, based on GZA's understanding. We included most of our field observations on the sketch. Note that backfilled crushed stone-type of materials normally do not consist of fines. As a result, the hydraulic conductivity (permeability to groundwater seepage) associated with backfill soils is usually higher than the in-situ Glacial Till.

- Based on GZA's preliminary understanding, the increased permeability of the backfill materials (clean sand/gravel mixtures; or crushed stone) increased the surface water infiltration and seepage during rain events. The excess water saturated the soils on the slope/coastal bank. The saturated soils and groundwater became the driving force for the slope to slide downhill, under gravity.

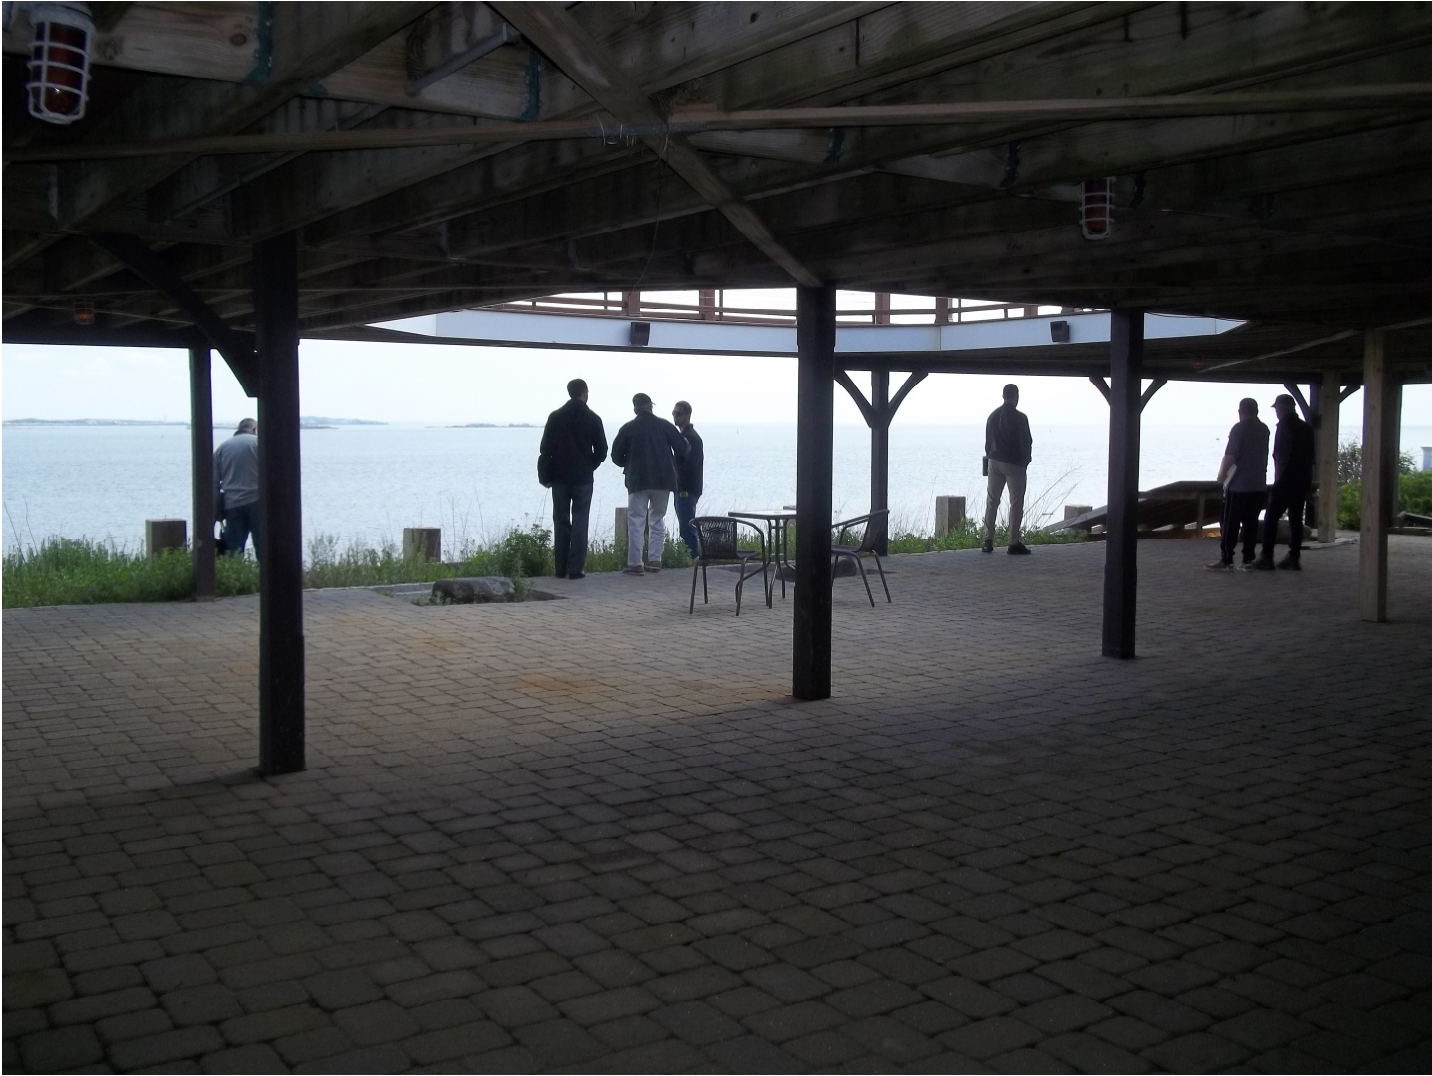
- The slope failure is immediately adjacent to the Earth Retaining System (ERS), which consists of timber soldier piles and lagging wall system constructed in 2019 (Photos 1 through 3). A section of the ERS, approximately 50 feet long, is exposed from top to toe (Photo 13) and approximately 9 to 10 feet in exposed height.
- There is significant existing and likely ongoing erosion/scour at the toe of the ERS, where large openings are visible. Orange colored (insulation) foam was used likely as an attempt to

51 Harborview NOI Peer Review		Site Visit: 6/7/2023	Project Number 01.P000069.24
Photo 2 ERS	Patio and Existing	Five-foot spacing between ERS and Patio; looking east

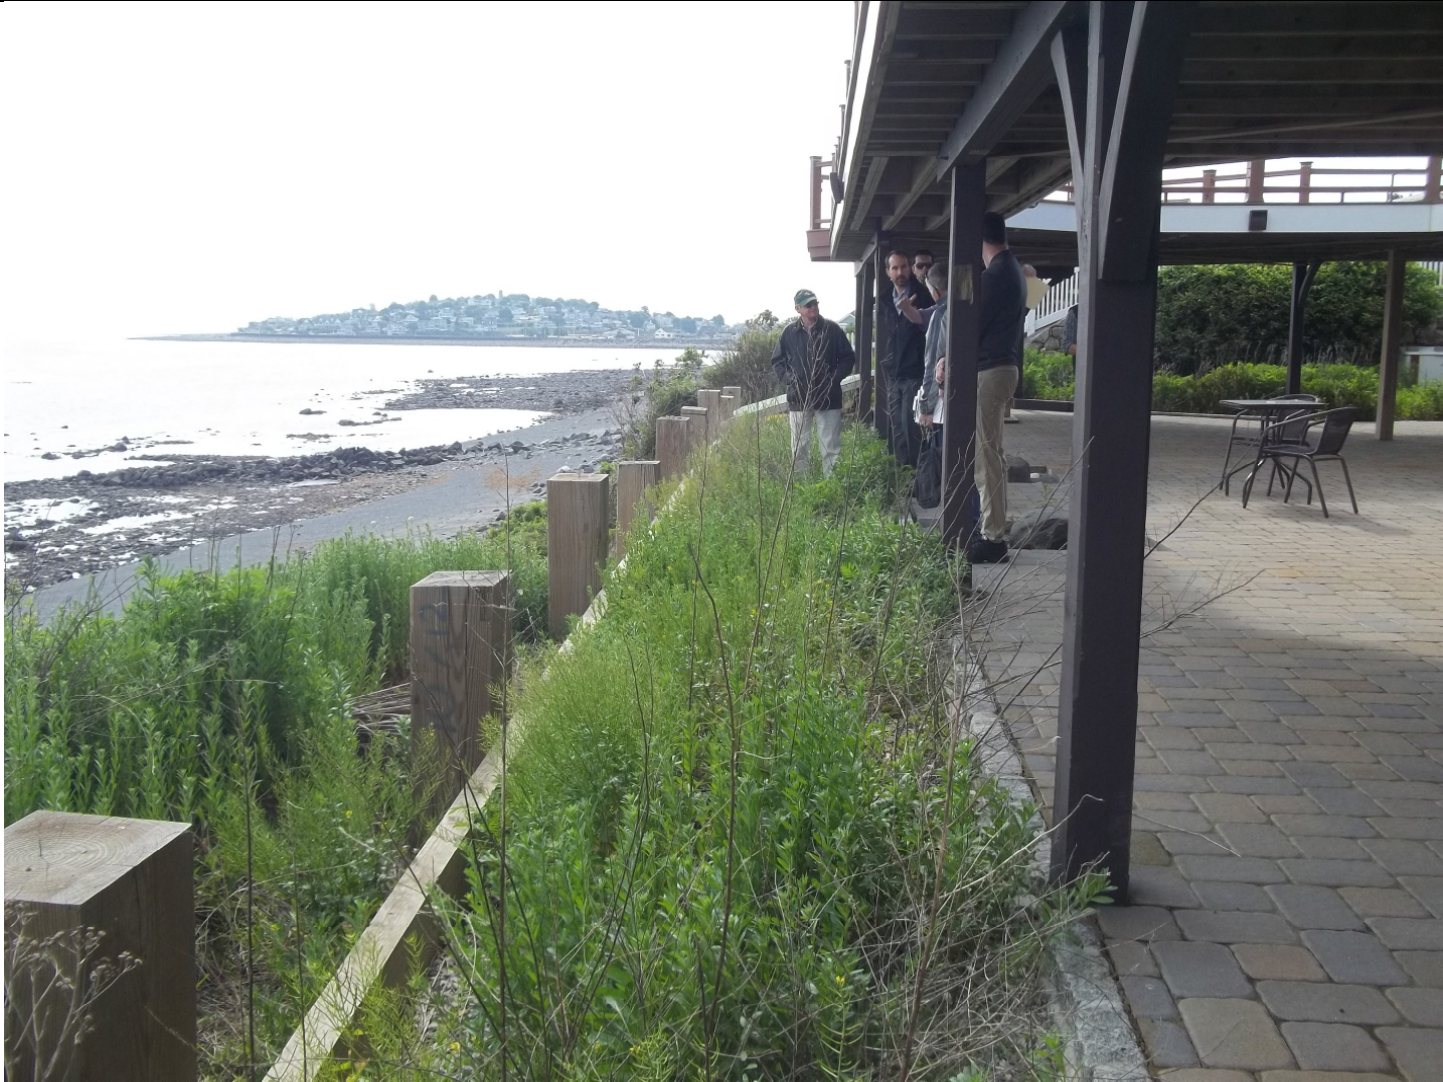
- Rills caused by water flow are visible at the surface (see Photos 8 and 10). Rills are up to 12 inches (") deep and 12" wide, based on visual estimates.

- Crushed stone (approximately ¾" typical size) was observed on the slope surface (e.g., Photo 10), which are apparently non-native, and was part of the backfill materials brought in for the construction of the patio and/or ERS and/or the drainage sumps on both sides (western and eastern ends) of the Patio area. The natural Glacial Till material was observed to be compact and consist predominantly of sand and gravel with up to 35% fines (Photo 11).

51 Harborview NOI Peer Review		Site Visit: 6/7/2023	Project Number 01.P000069.24
Photo 3	Failed Slope	Visible rills; clean crushed stone washed out behind the timber lagging wall/timber post; undermined toe of the ERS

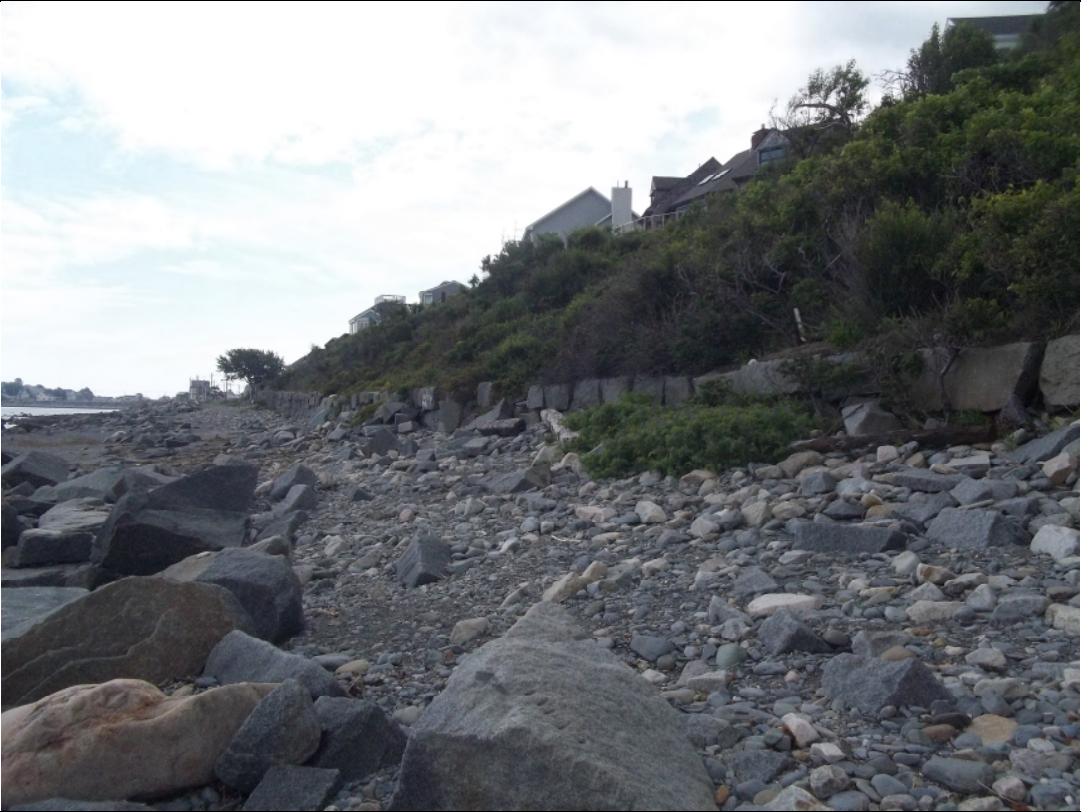
51 Harborview NOI Peer Review		Site Visit: 6/7/2023	Project Number 01.P000069.24
Photo 14	Toe Wall	Vertical stone wall (remnants; along previous railbed; looking east)

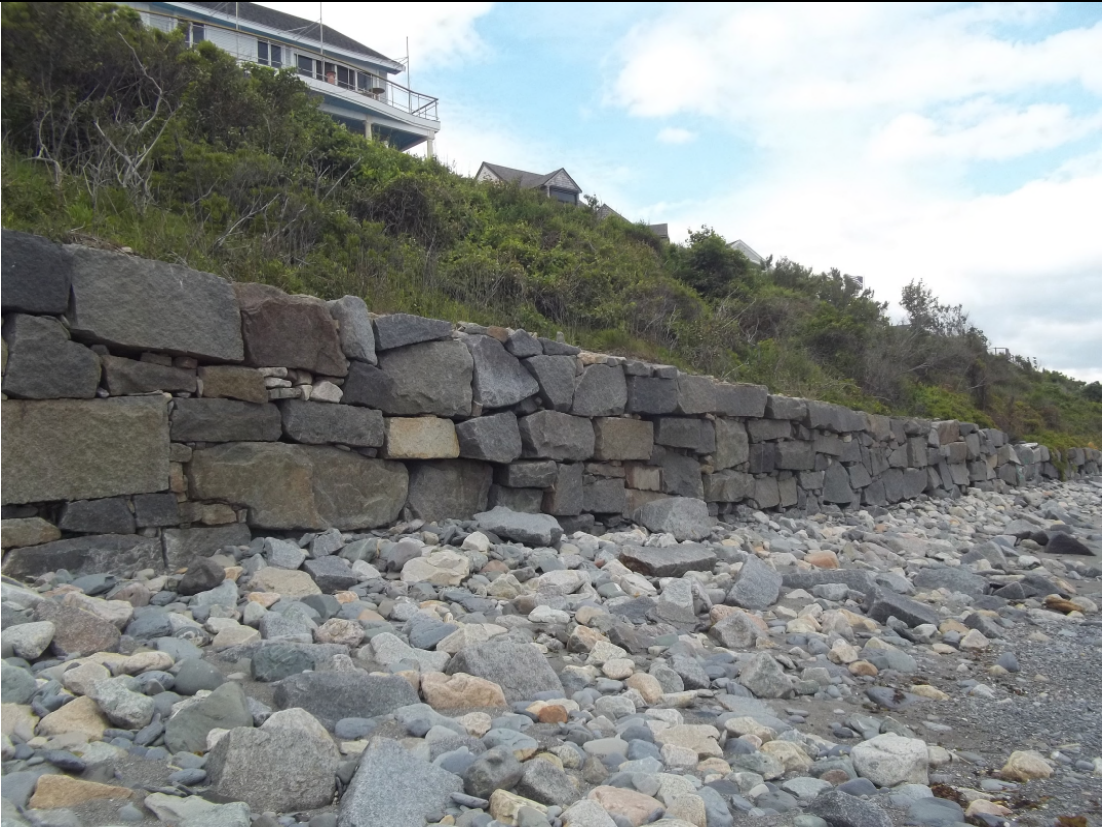
Photo 15	Toe Wall	Vertical stone wall (remnants; along previous railbed; looking west)

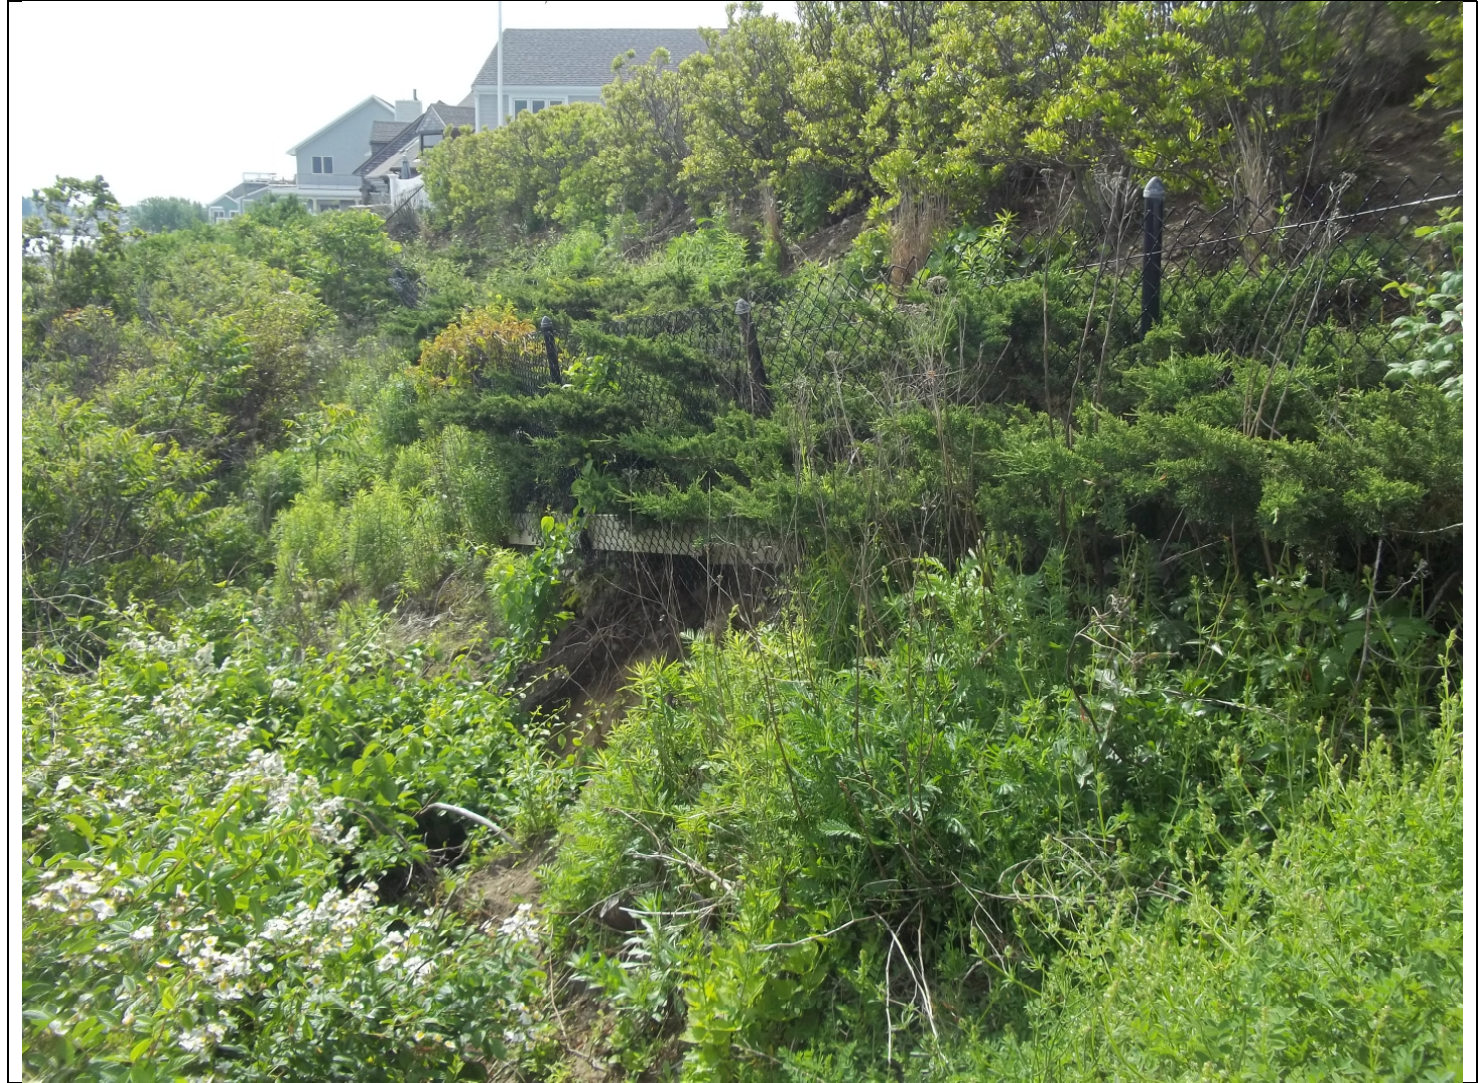
51 Harborview NOI Peer Review	Site Visit: 6/7/2023	Project Number 01.P000069.24
Photo 16 53 Harborview	Looking east; undermined slope section below chain-link fence
