Date: December 15, 2022 Job No.: 6126
To: Chris Gardner
From: Melissa Recos & Chris Brainard
Subject: Hampton Circle Playground – BMP Retrofit Site Investigation

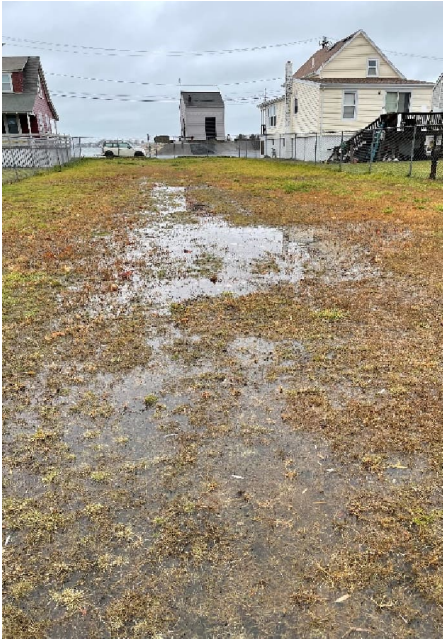
1. Chris Gardner, DPW Director for the Town of Hull, attended the site walk with Melissa Recos, Chris Brainard, and David McKinley of BETA and explained that flooding of two or more feet in depth occurs throughout this low-lying property due to storm surges during high tide periods. In the 17 years that Gardner has been employed by the Town, this type of event has occurred about half a dozen times, roughly once every 3 years. In addition to field and playground flooding, these events include tidal inundation that causes the streets to be submerged and impassible. The Town is discussing climate change resiliency planning in and around the Hampton Circle area including potential seawalls and pumps to address the storm surge events. During more typical storm events and daily high tide conditions such as that observed on December 7th, the drainage system in the park was submerged at or above the existing catch basin rims due to the elevation and tide gate on the drainage system’s outfall pipe. Under these conditions the field is saturated with puddling throughout. The site was most likely filled marsh and NRCS mapping classifies the soils on-site as limited for infiltration based on wet substratum and loamy fill material with a depth to water table of 20-inches. See Attachment 1 below from December 7, 2022 wet weather and high tide site visit.

Photo A – Standing at center of the park looking west toward Marginal Road, field saturated with puddling

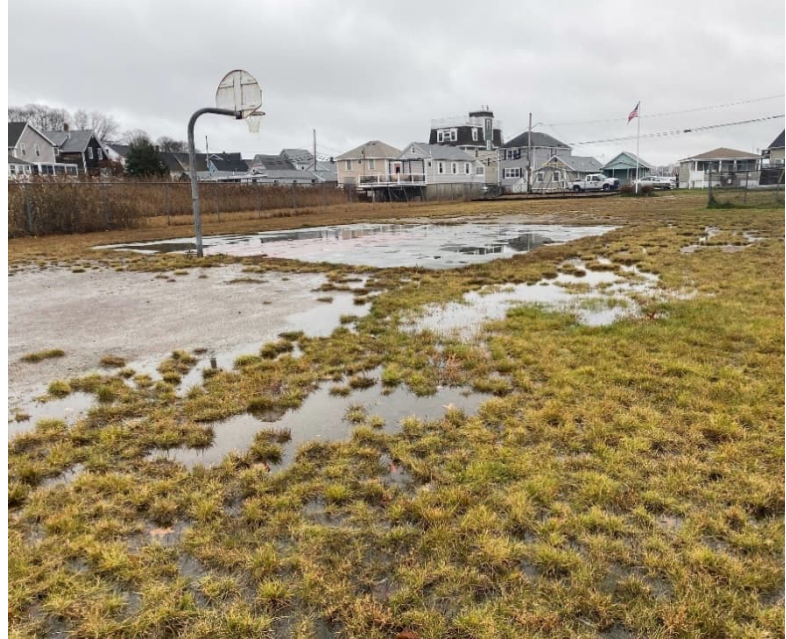
were observed with standing water at or above the rim. Based on previous investigation work all catch basins in the park have significant sediment and rusted grates that can't be opened. The ground was depressed along the outlet pipe of this catch basin running towards the outfall, the pipe is shallow with approximately 2' of cover and assumed to be in poor condition. Just inside the fence line on the North side of the playground is a natural swale depression keeping ponded water on-site.

Photo B – Standing at center of the park looking northeast toward playground area, submerged catch basin in foreground

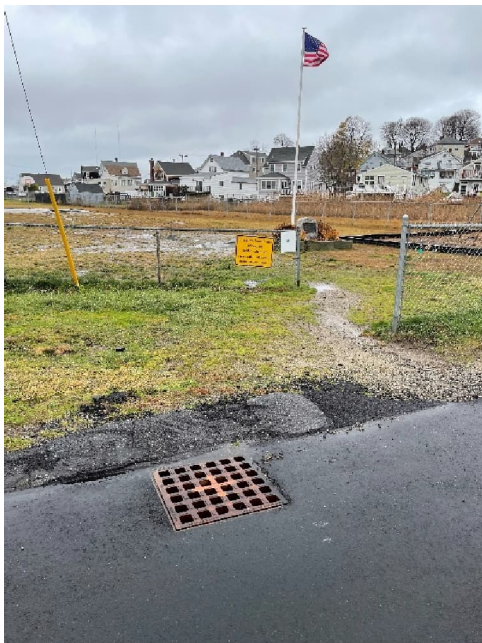
3. BETA confirmed the catchment area for the drainage infrastructure while on-site and observed ponding of water along the roadside in front of the existing swing-set and a location adjacent to the existing roadway catch basin CB-1750 where channelized runoff enters the park from the street, see Attachment 1 with photos from site walk. All of the catch basins within the property

Photo C – Wash out observed to right of CB-1750 where road runoff enters the site

- In the playground project design, revise grading to allow street ponding areas to reach the natural infiltration area and add stone infiltration trenches along graded swales and depressions to encourage as much infiltration as possible.
- In the playground project design, extend the stone diaphragm along all the downstream sides of the new parking space area to provide treatment for runoff.
- Implement dog waste education signage and enforcement at this park and consider year-round trash cans or pet stations for proper disposal of pet waste.

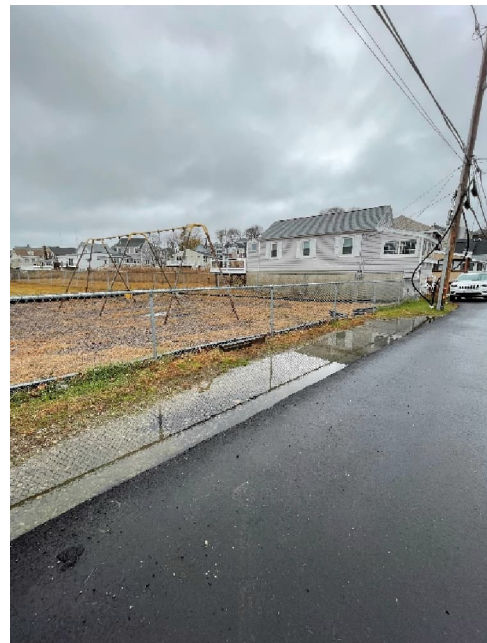
Photo D – Ponded water in front of Hampton Circle Playground swing-set
