51 Harborview NOI Review Summary

Conservation Commission Meeting

1/30/2024

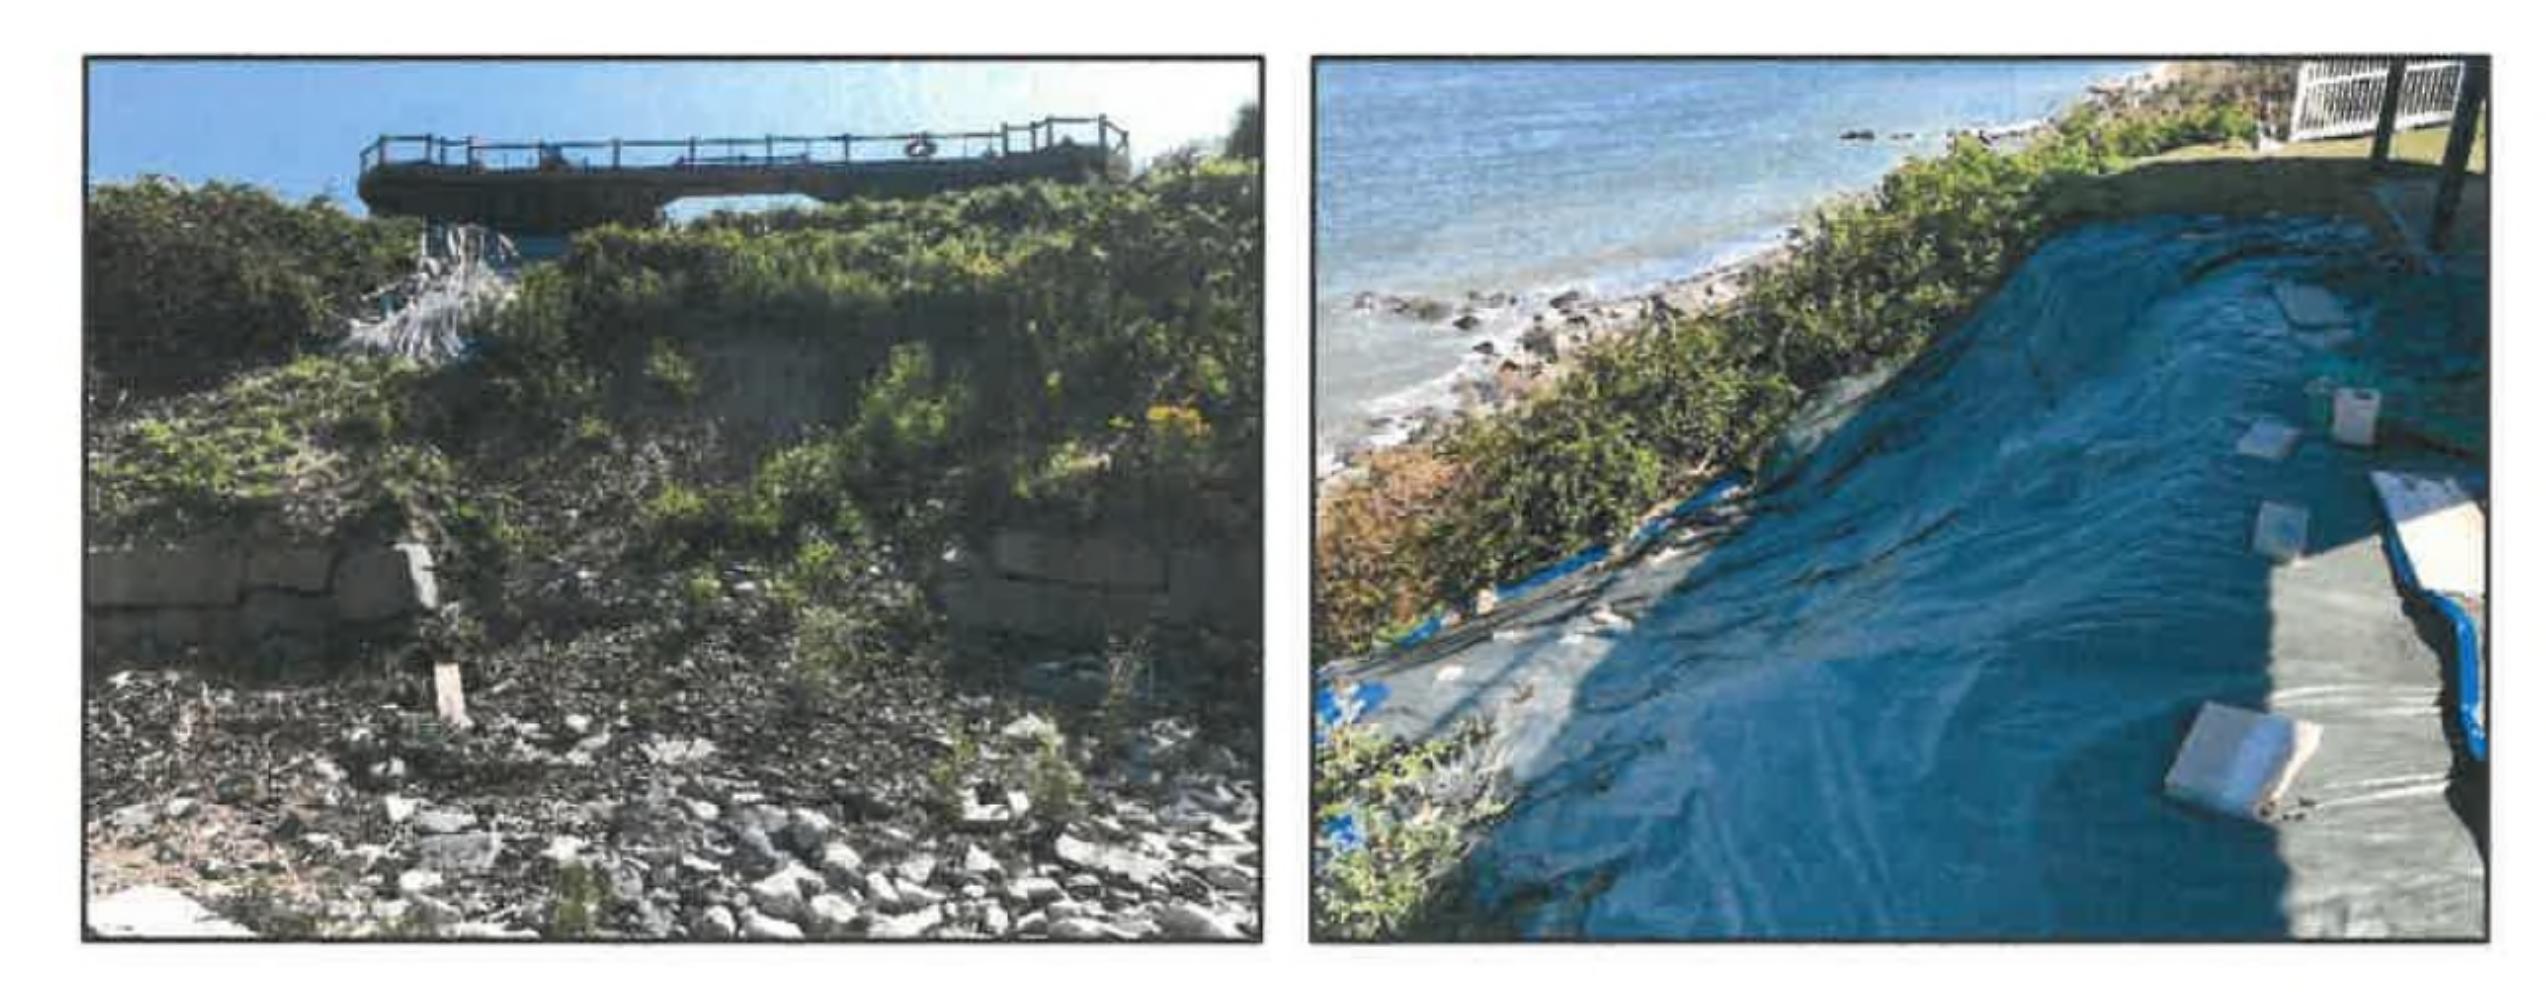
Figures 1 & 2 – Extensive erosion of the coastal bank located seaward of the existing dwelling (left) has put adjacent residential infrastructure at risk (right). Woods Hole Group, November 2019

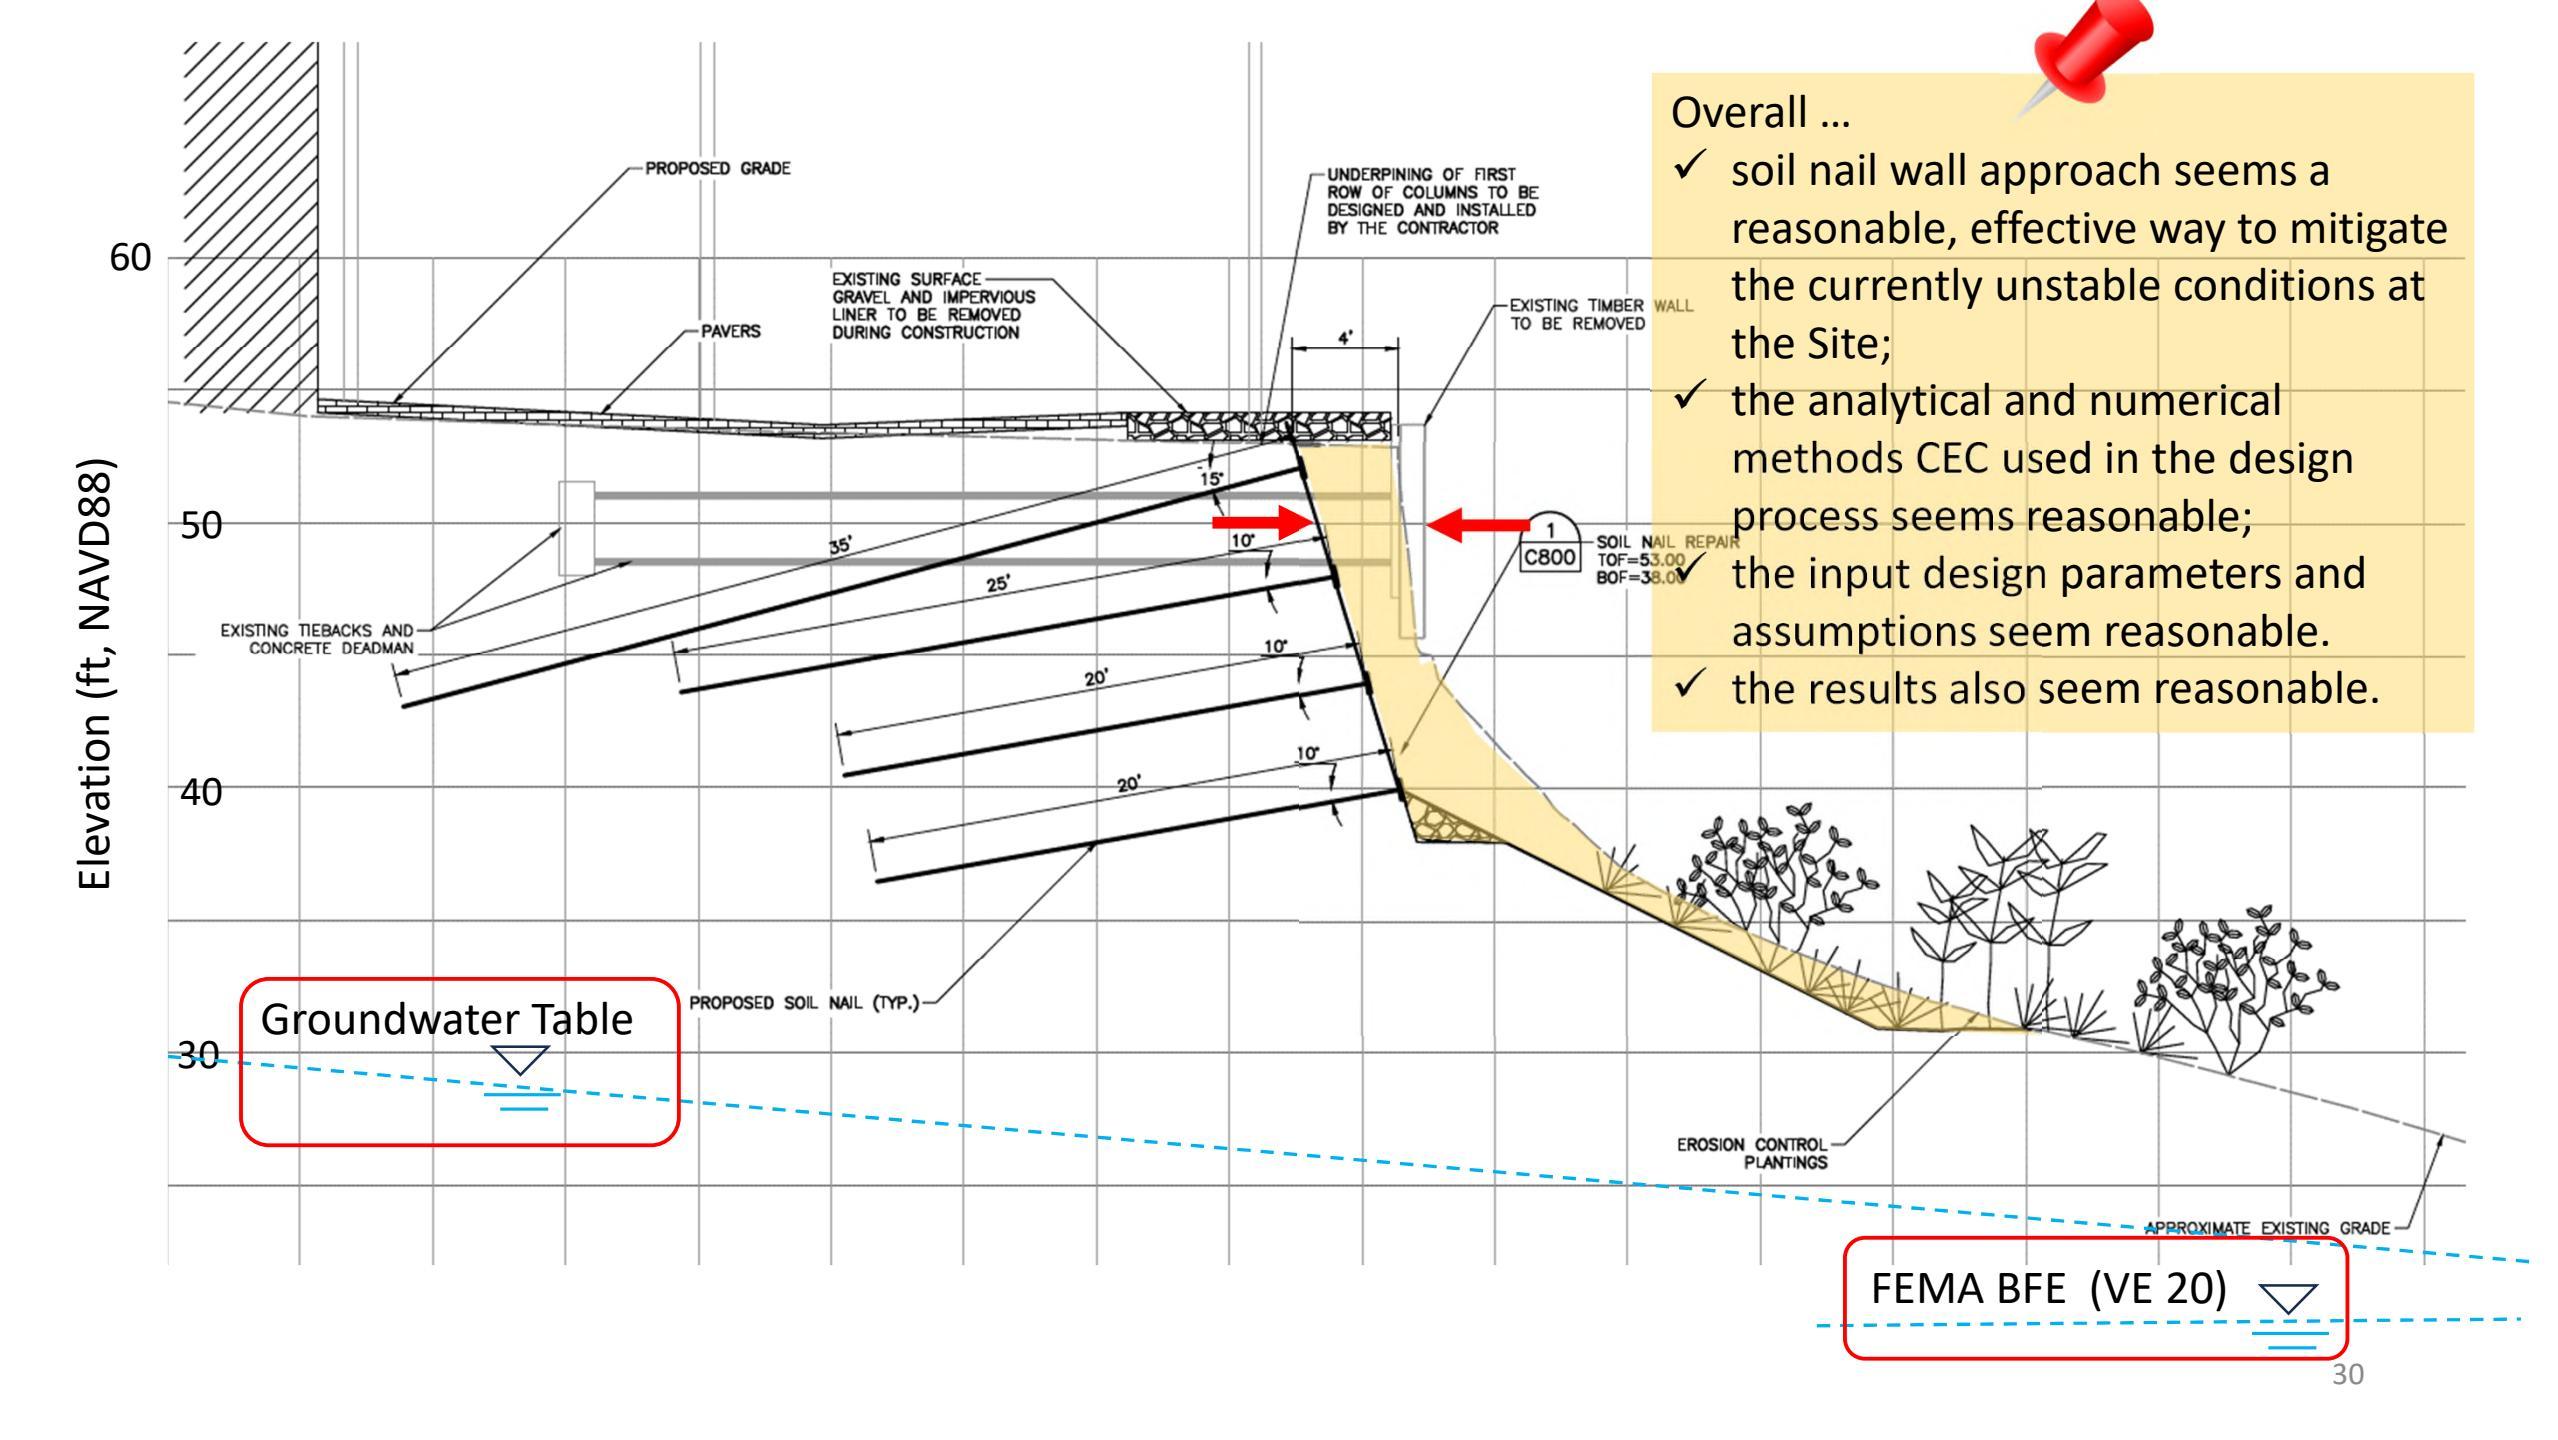
Selected bullet items per GZA's review (for further discussion / evaluation) (red – concern):

- Groundwater effects were evaluated per CEC's sensitivity analysis. The assumed groundwater table intersected with the slope failure plane in the back analysis. The groundwater table did not intersect with the failure block in the soil nail wall design analysis;

- Back analysis of the adjacent slope to the west (49 Harborview) indicates that the natural slopes are marginally stable with a factor of safety of 1.17 (i.e., calculated factor of safety values greater than 1.0 but not significantly higher);

- The proposed wall is able to achieve a factor of safety of 1.67 for a rotational type of slope failure, along the selected representative section;
- The gabion basket section did not meet the minimum factor of safety requirements (1.5) in all directions. The design did not provide details;

- The proposed project does not restore the site to the pre-2019 conditions including the granite block wall at the toe;
- The proposed design should incorporate a method to limit seepage migrating to the proposed wall within the previously installed anchor trenches below the patio and capture runoff from the patio area and divert away from the new wall;

- Perched groundwater table (i.e., wetting front) due to heavy rain infiltration below the patio area as a sensitivity check; and
- Specify service life of the soil nail wall in the design package.
