Crescent Beach Hull, MA

April 13, 2015

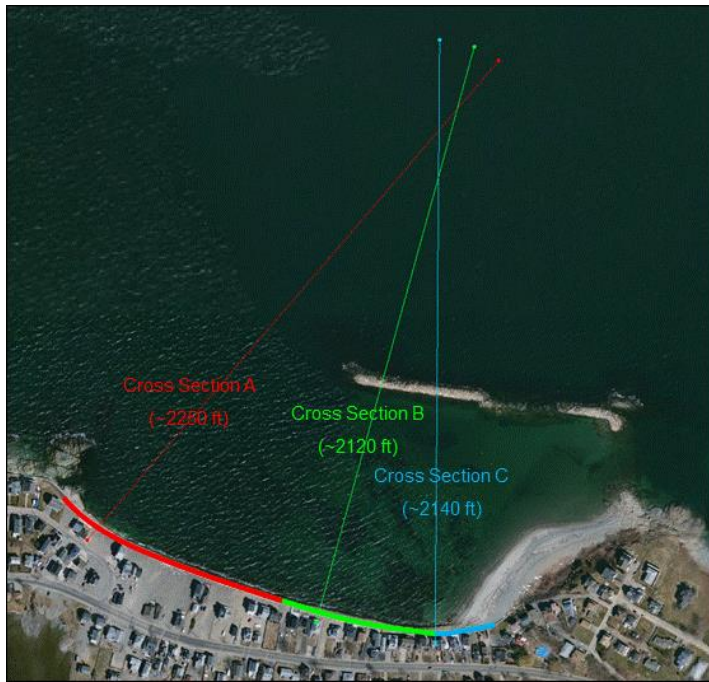
Existing Conditions

- Breakwater is under-resolved with 164 ft grid spacing (Cross Section B and C)

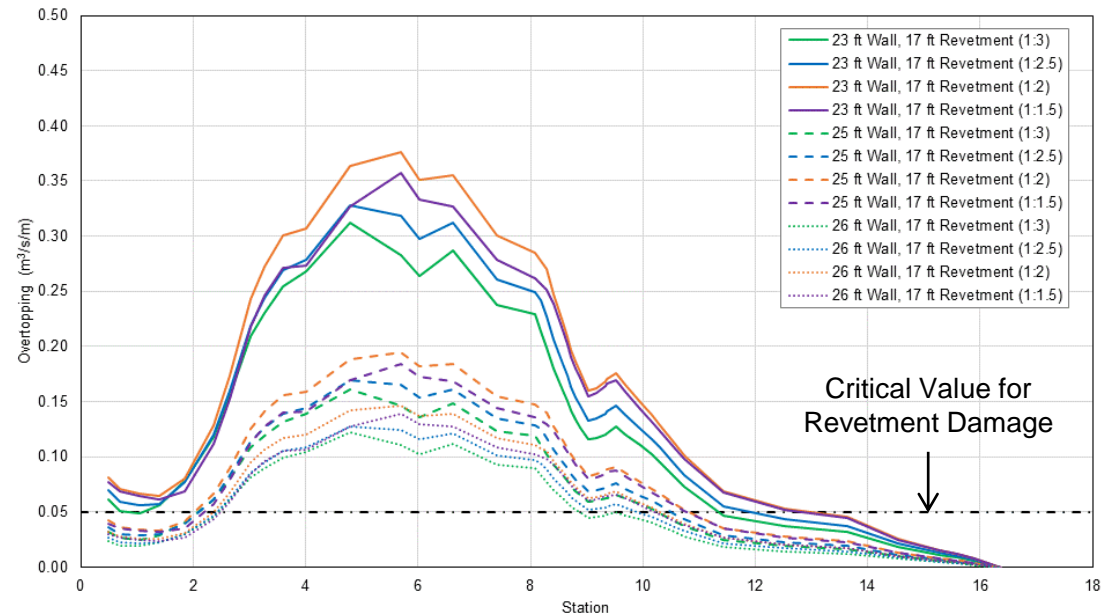
Option 1, 2 & 3

17 ft MLW Revetment

- Overtopping estimated by Pedersen (1996)

1. Increase the elevation of the seawall to 23 ft MLW and revetment crest to 17 ft MLW
2. Increase the elevation of the seawall to 25 ft MLW and revetment crest to 17 ft MLW
3. Increase the elevation of the seawall to 26 ft MLW and revetment crest to 17 ft MLW
4. Increase the elevation of the seawall and revetment crest to 23 ft MLW
5. Increase the elevation of the seawall to 25 ft MLW and revetment crest to 23 ft MLW
6. Increase the elevation of the seawall to 26 ft MLW and revetment crest to 23 ft MLW
7. Increase the elevation of the seawall and revetment crest to 25 ft MLW

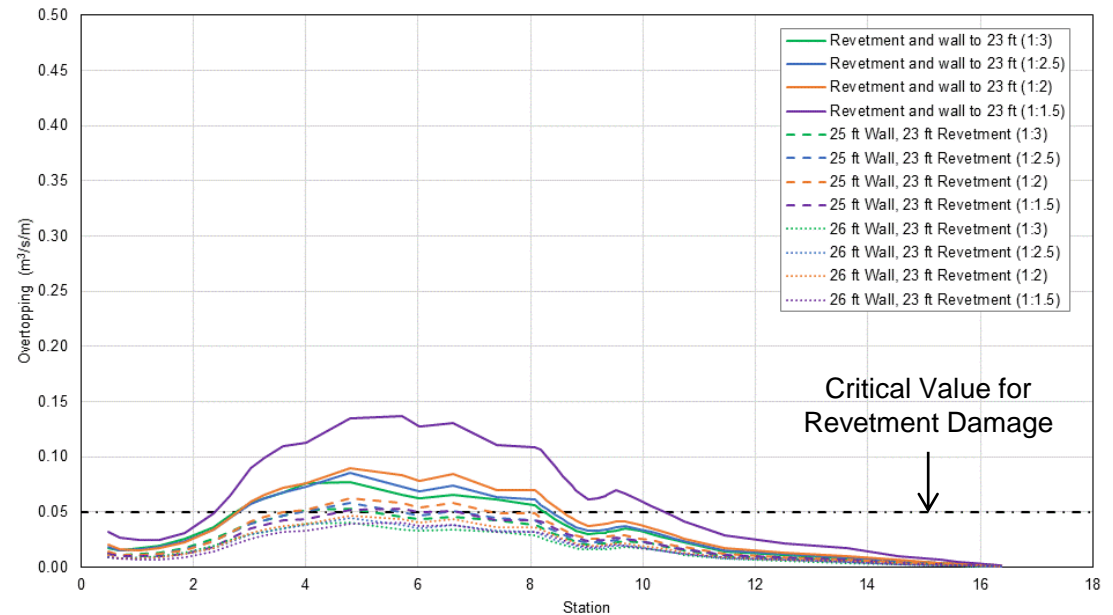
Option 4, 5 & 6

23 ft MLW Revetment

- Overtopping estimated by Pedersen (1996)

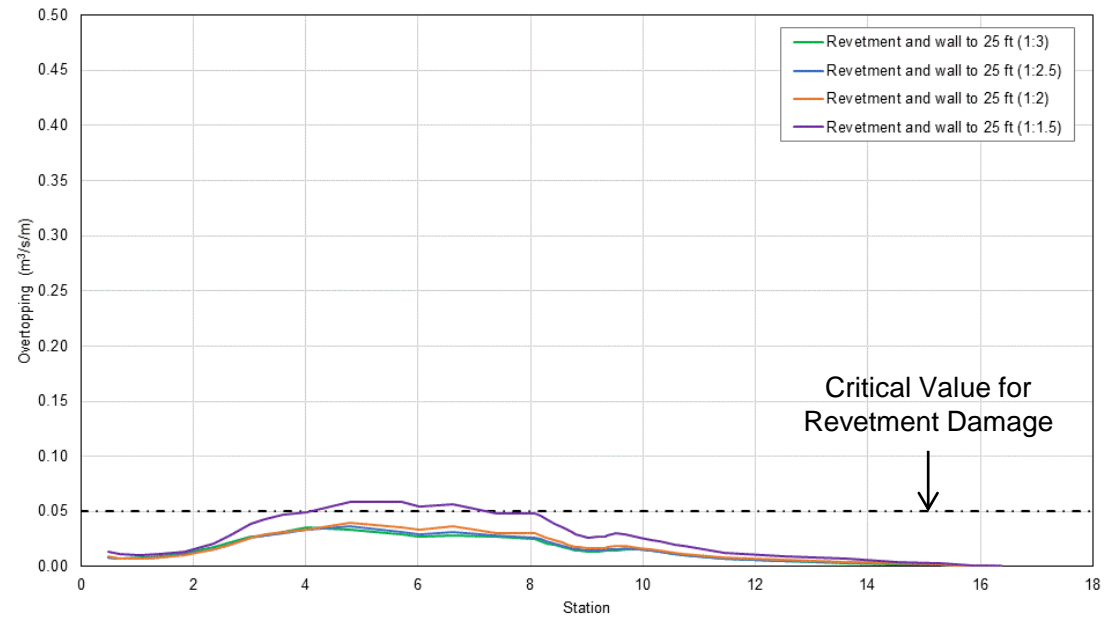
Option 7

25 ft MLW Revetment

- Overtopping estimated by Pedersen (1996)

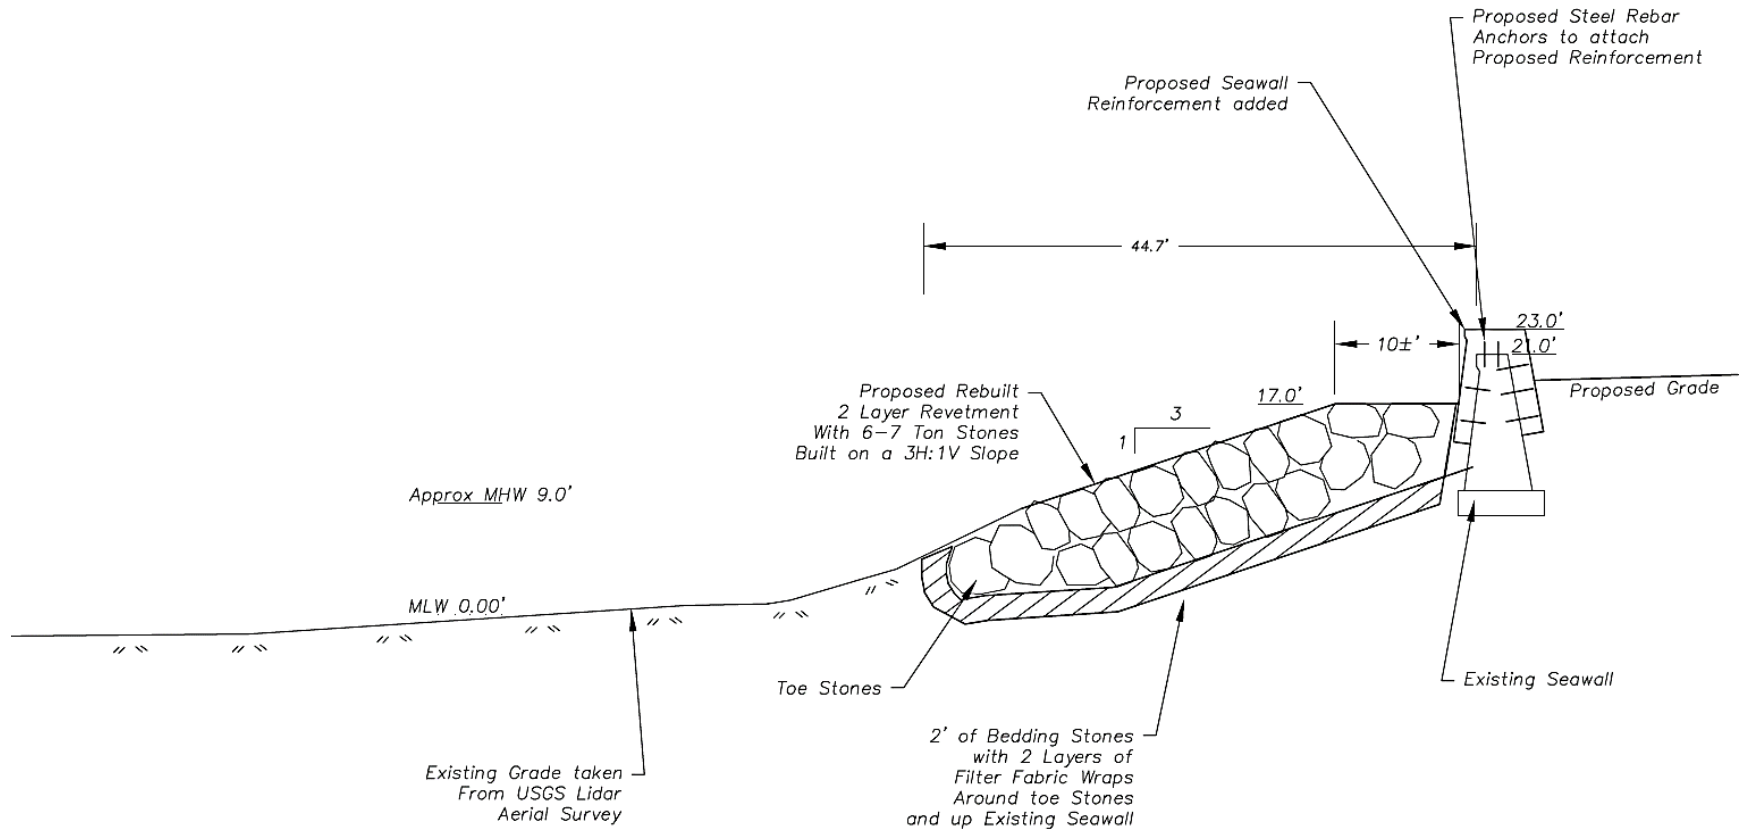
Proposed Design for Station 10+25 to 16+50

- Raise the existing seawall elevation
- Replace with existing grouted revetment sections with larger armor stones (6 to 7 tons) to increase wave energy dissipation
- The revetment slope may range from 1:1.5 to 1:3
