NATURE-BASED SOLUTIONS FOR COMMUNITY RESILIENCE ON **North Nantasket Beach**

Public Meeting

April 24, 2019

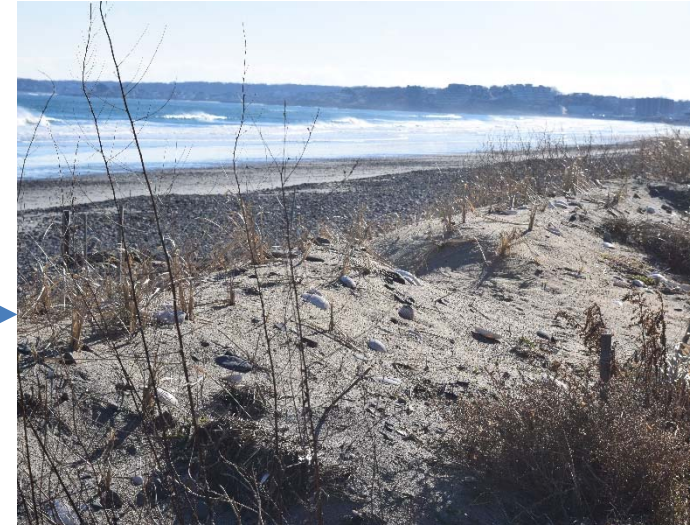
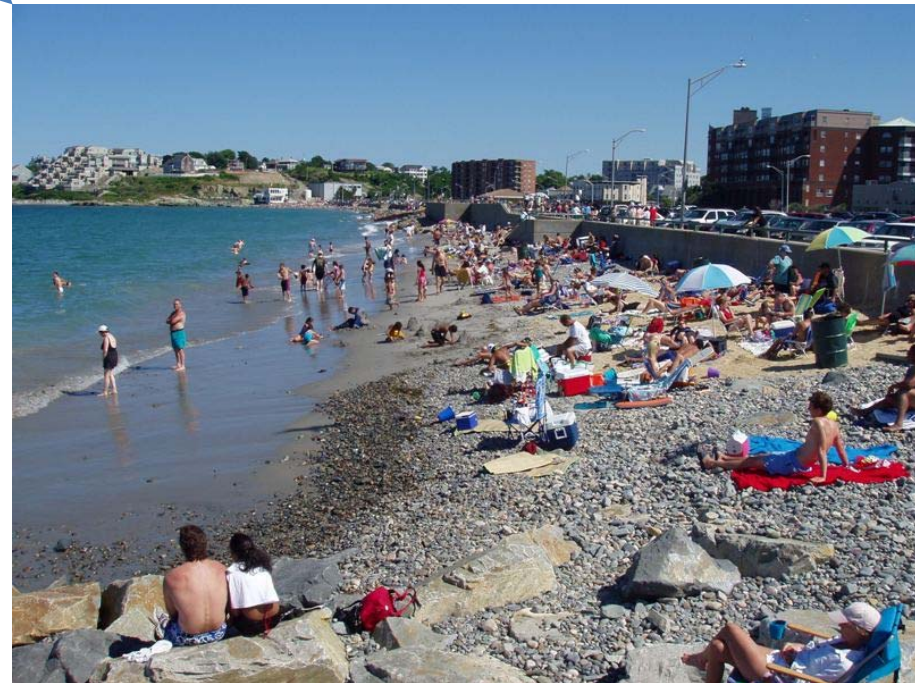
Narrowing of both dune and beach due to lack of sediment supply

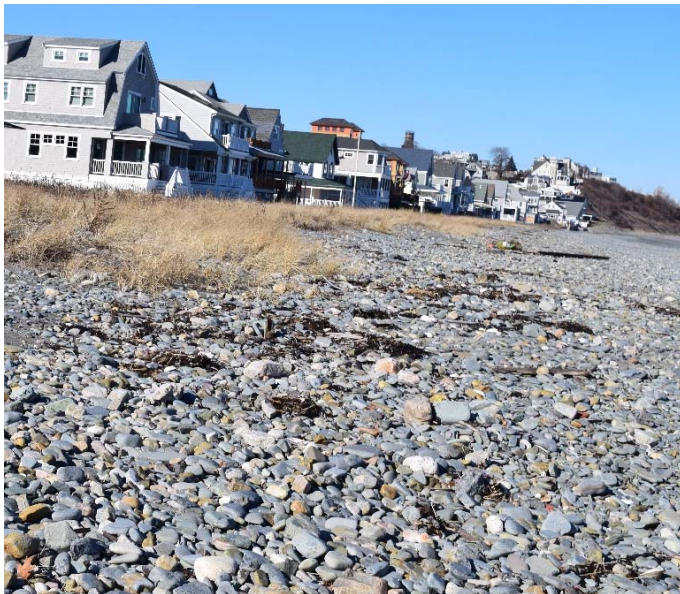
Cobble dune
(typically flat, semi-vegetated)

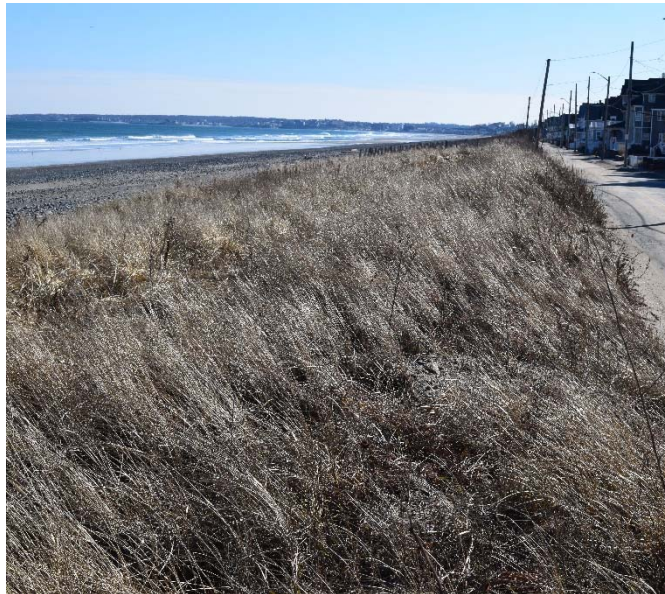
Wide, vegetated dune
(typically with a flattened crest)

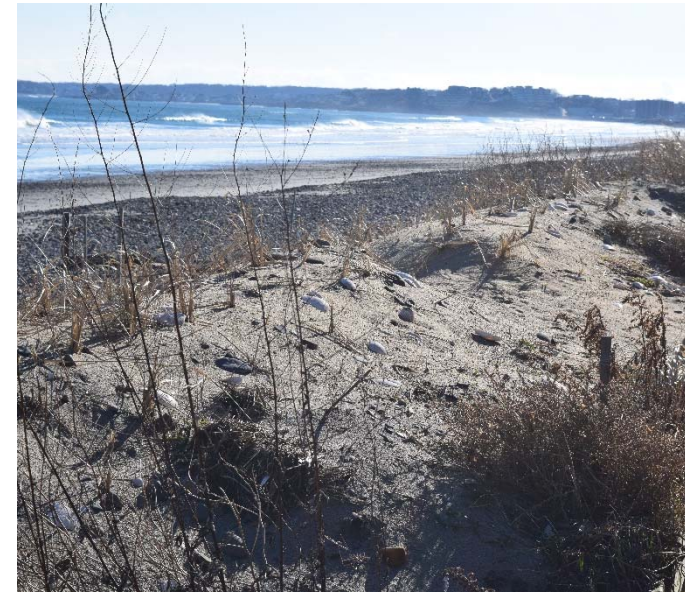
Narrow, vegetated dune
(typically with a steeper crest)

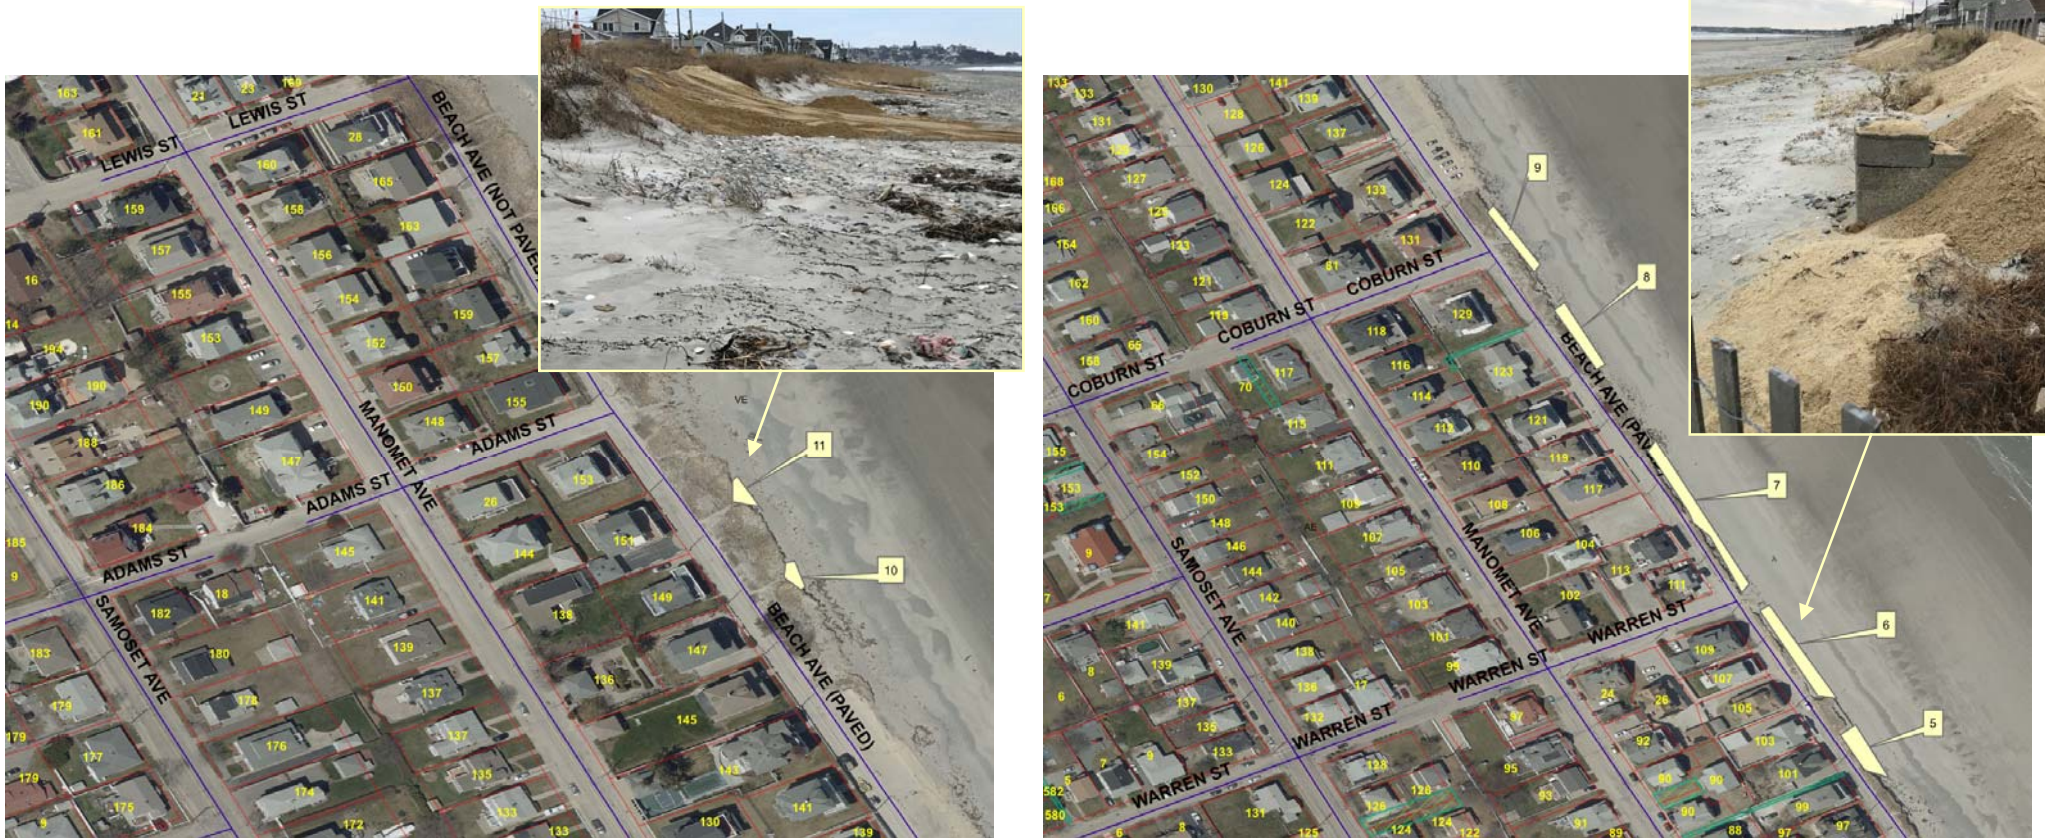
Following the January and March 2018 floods, DPW repaired eroded dunes

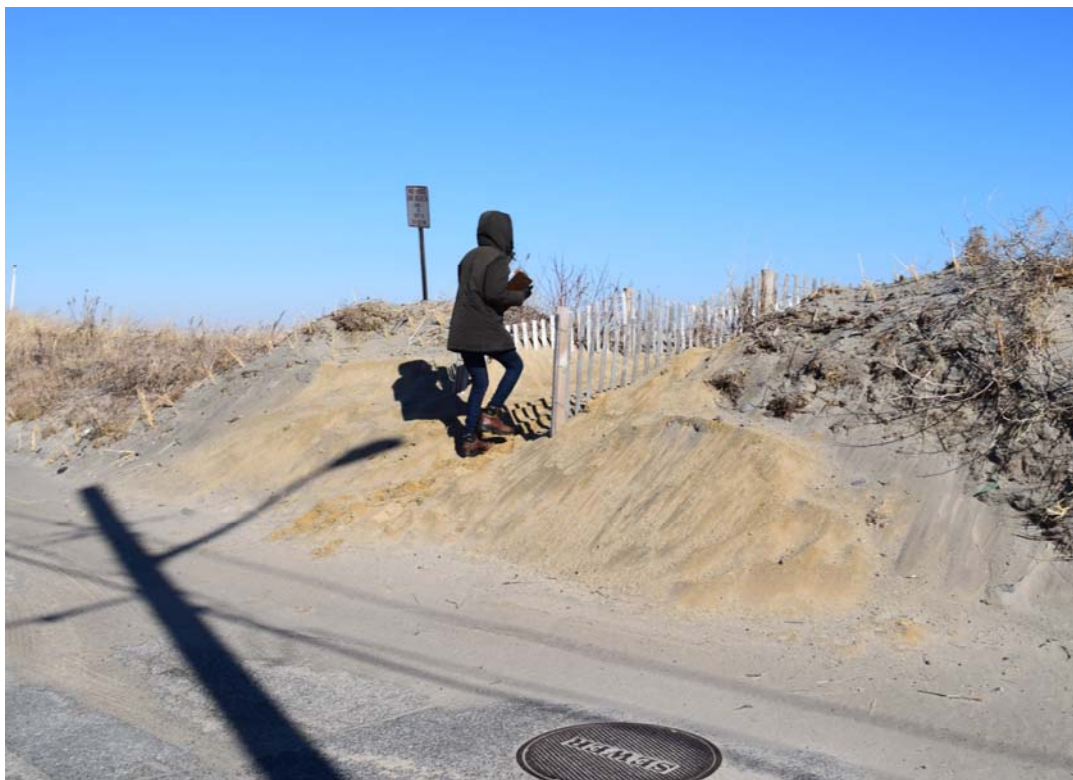
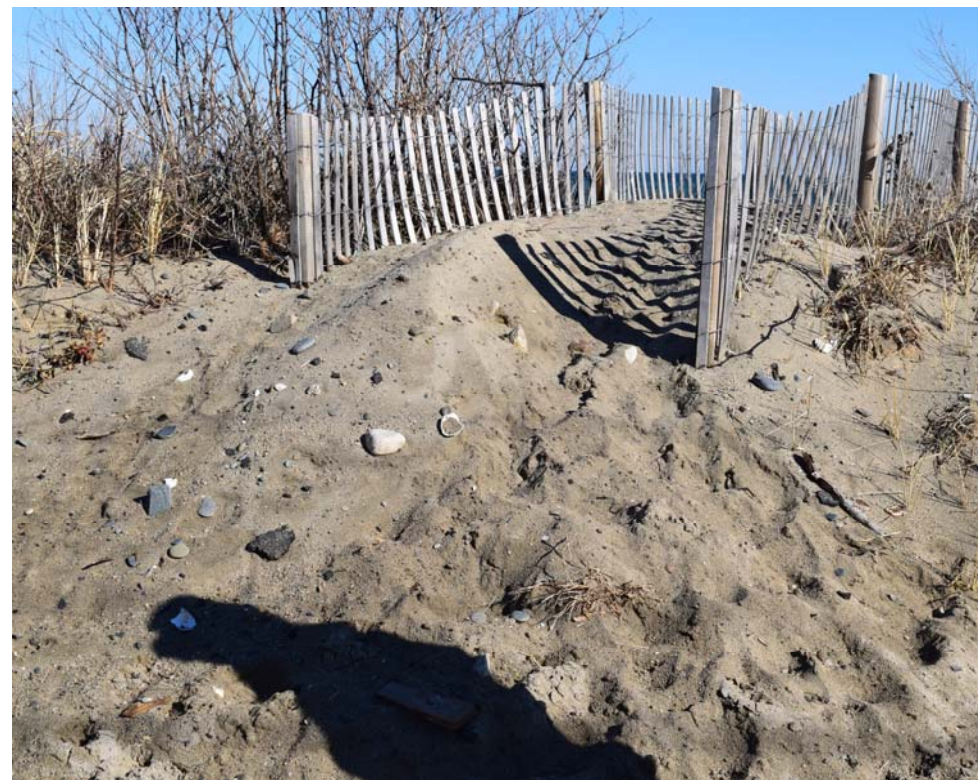
Every winter, before nor'easter season, DPW places sand in crossings to minimize potential flood breach through openings

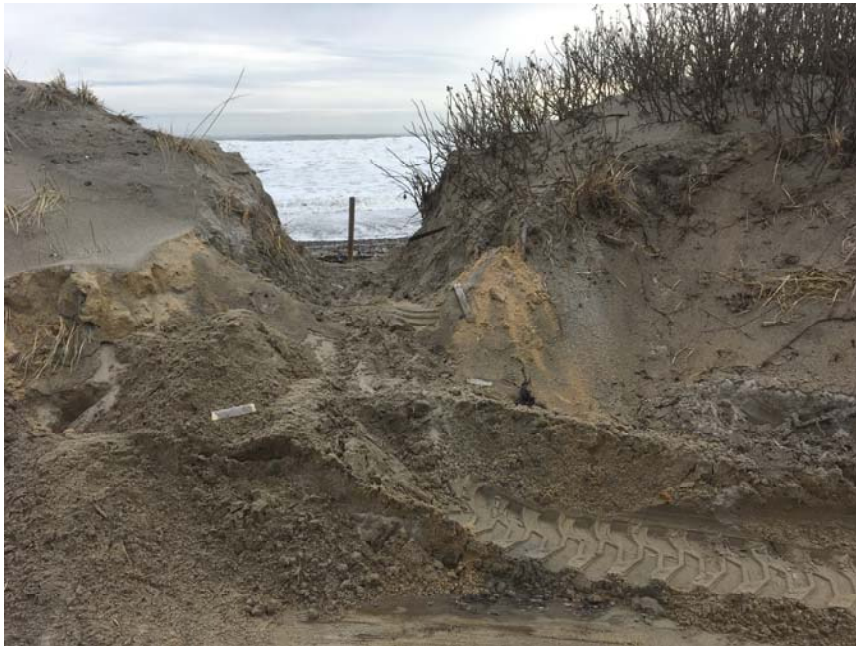
Non-Permitted

Non-permitted dune crossings are much more vulnerable to erosion and flood breach during coastal storms than permitted crossings due to design practices and maintenance.

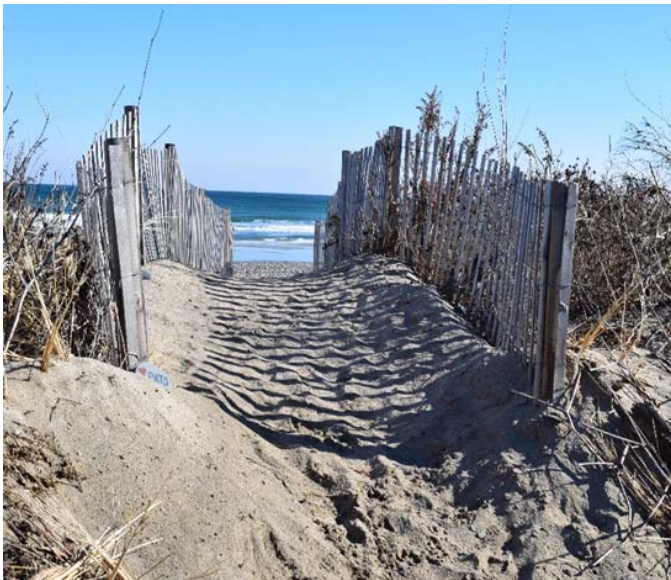
Permitted Town-maintained crossing

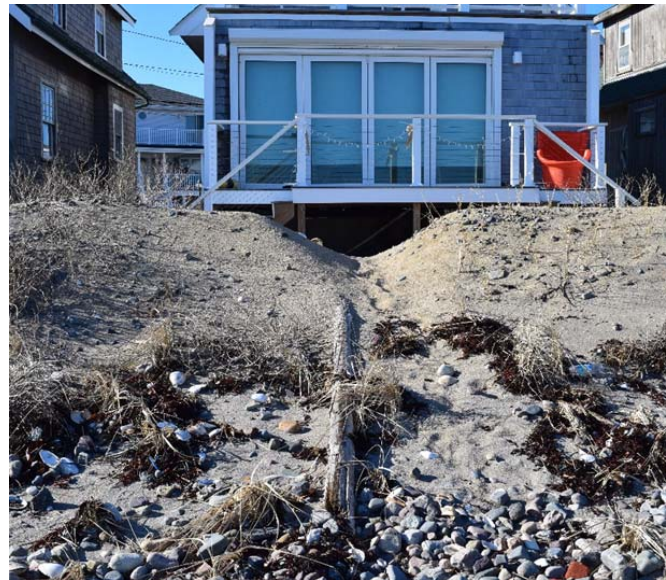
Non-permitted crossing

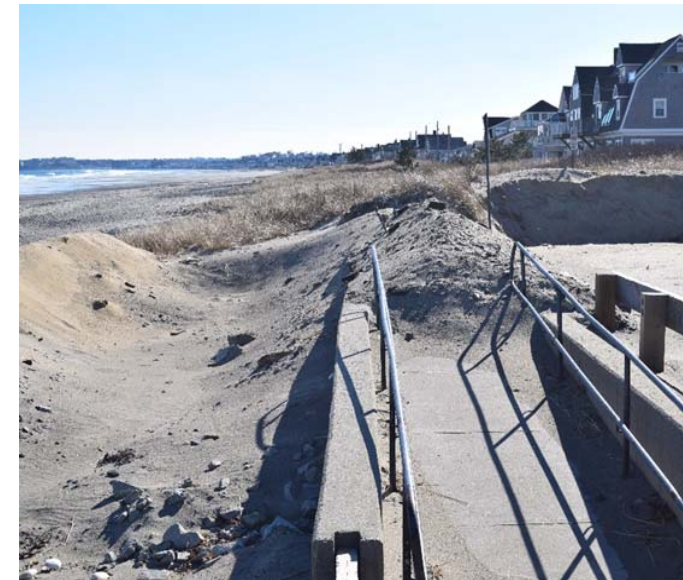
Handicap (ADA) access ramp

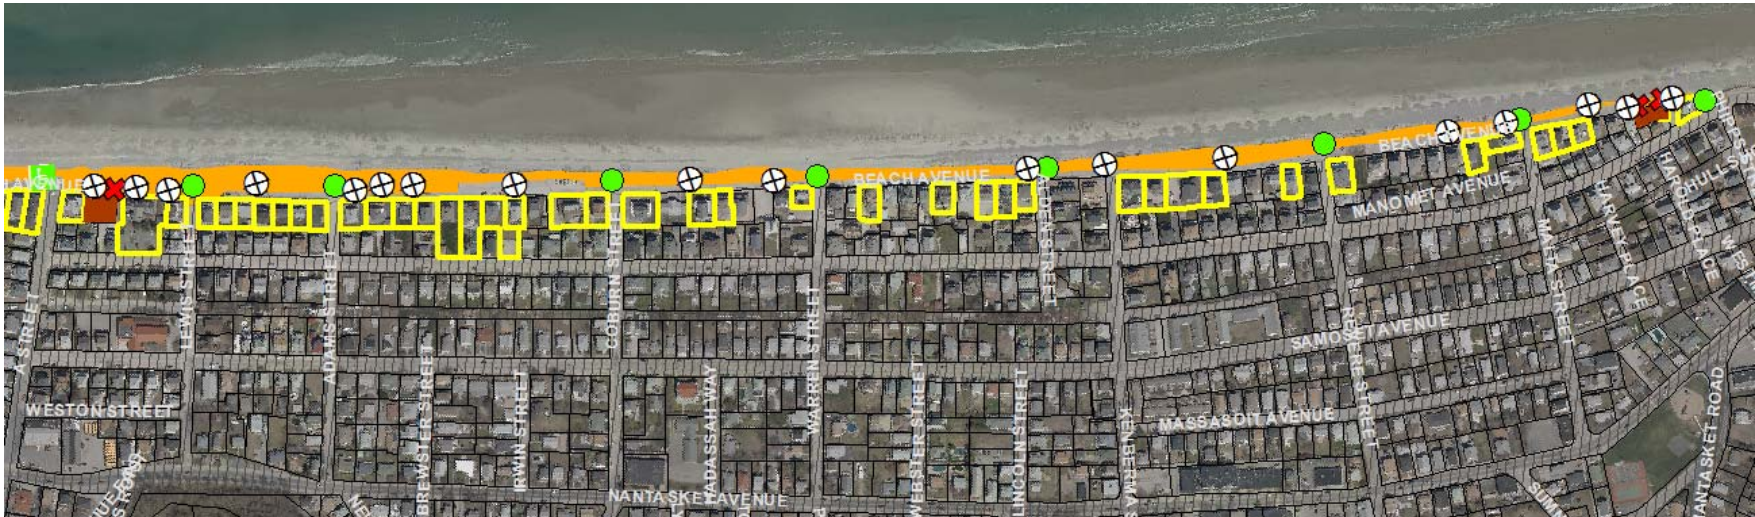
Phipps Street to A Street

Close 1 of 9 Town-maintained crossings (Beach Ave @ Kenberma St)

Close 17 of 20 non-permitted crossings

Allow 4 landlocked parcel owners opportunity for permitted crossings

Longest walking distance from Beach Ave residences with private beach rights to remaining 9 permitted crossing post-implementation would be ~420 ft. (2 minutes), average would be ~250 ft. (1 minute)

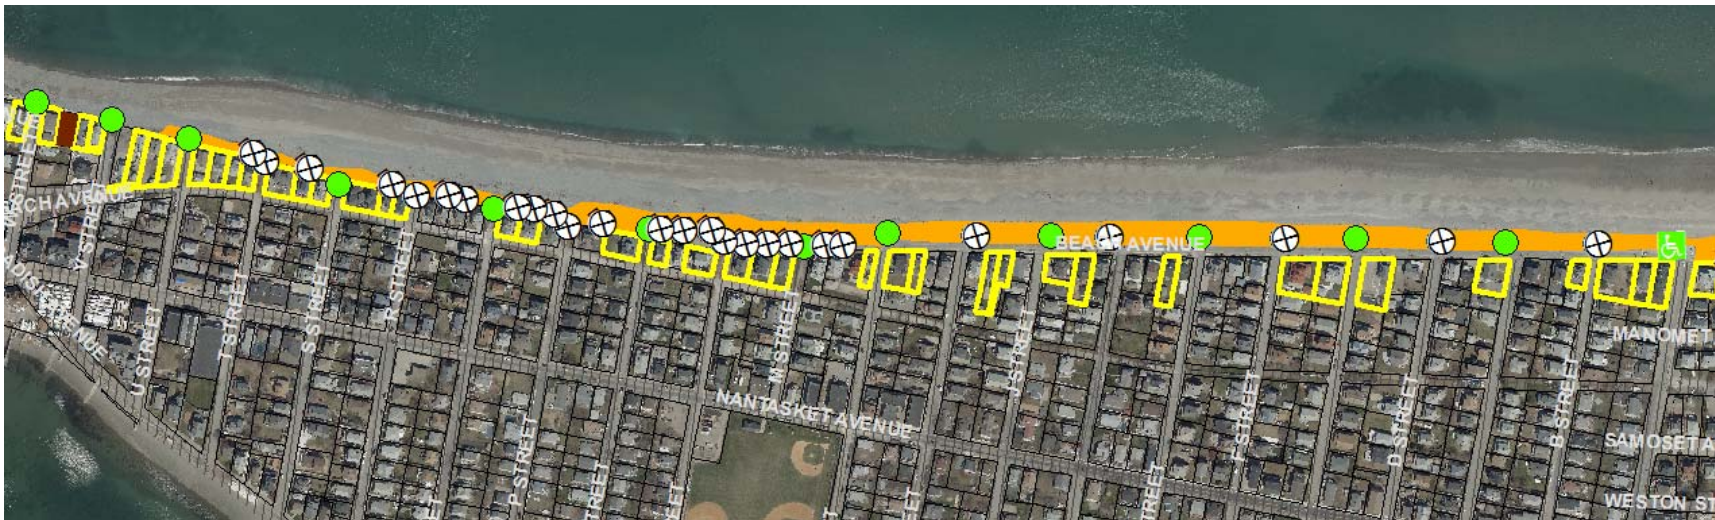
- Implement recommendations from Alternative 1A
- ⊗ Close 9 of 21 Town-maintained crossings from A Street to V Street (every other crossing)
- Longest walking distance from Beach Ave residences with private beach rights to remaining 12 permitted crossing post-implementation would be ~250 ft. (1 minute), average would be ~140 ft. (<1 minute)

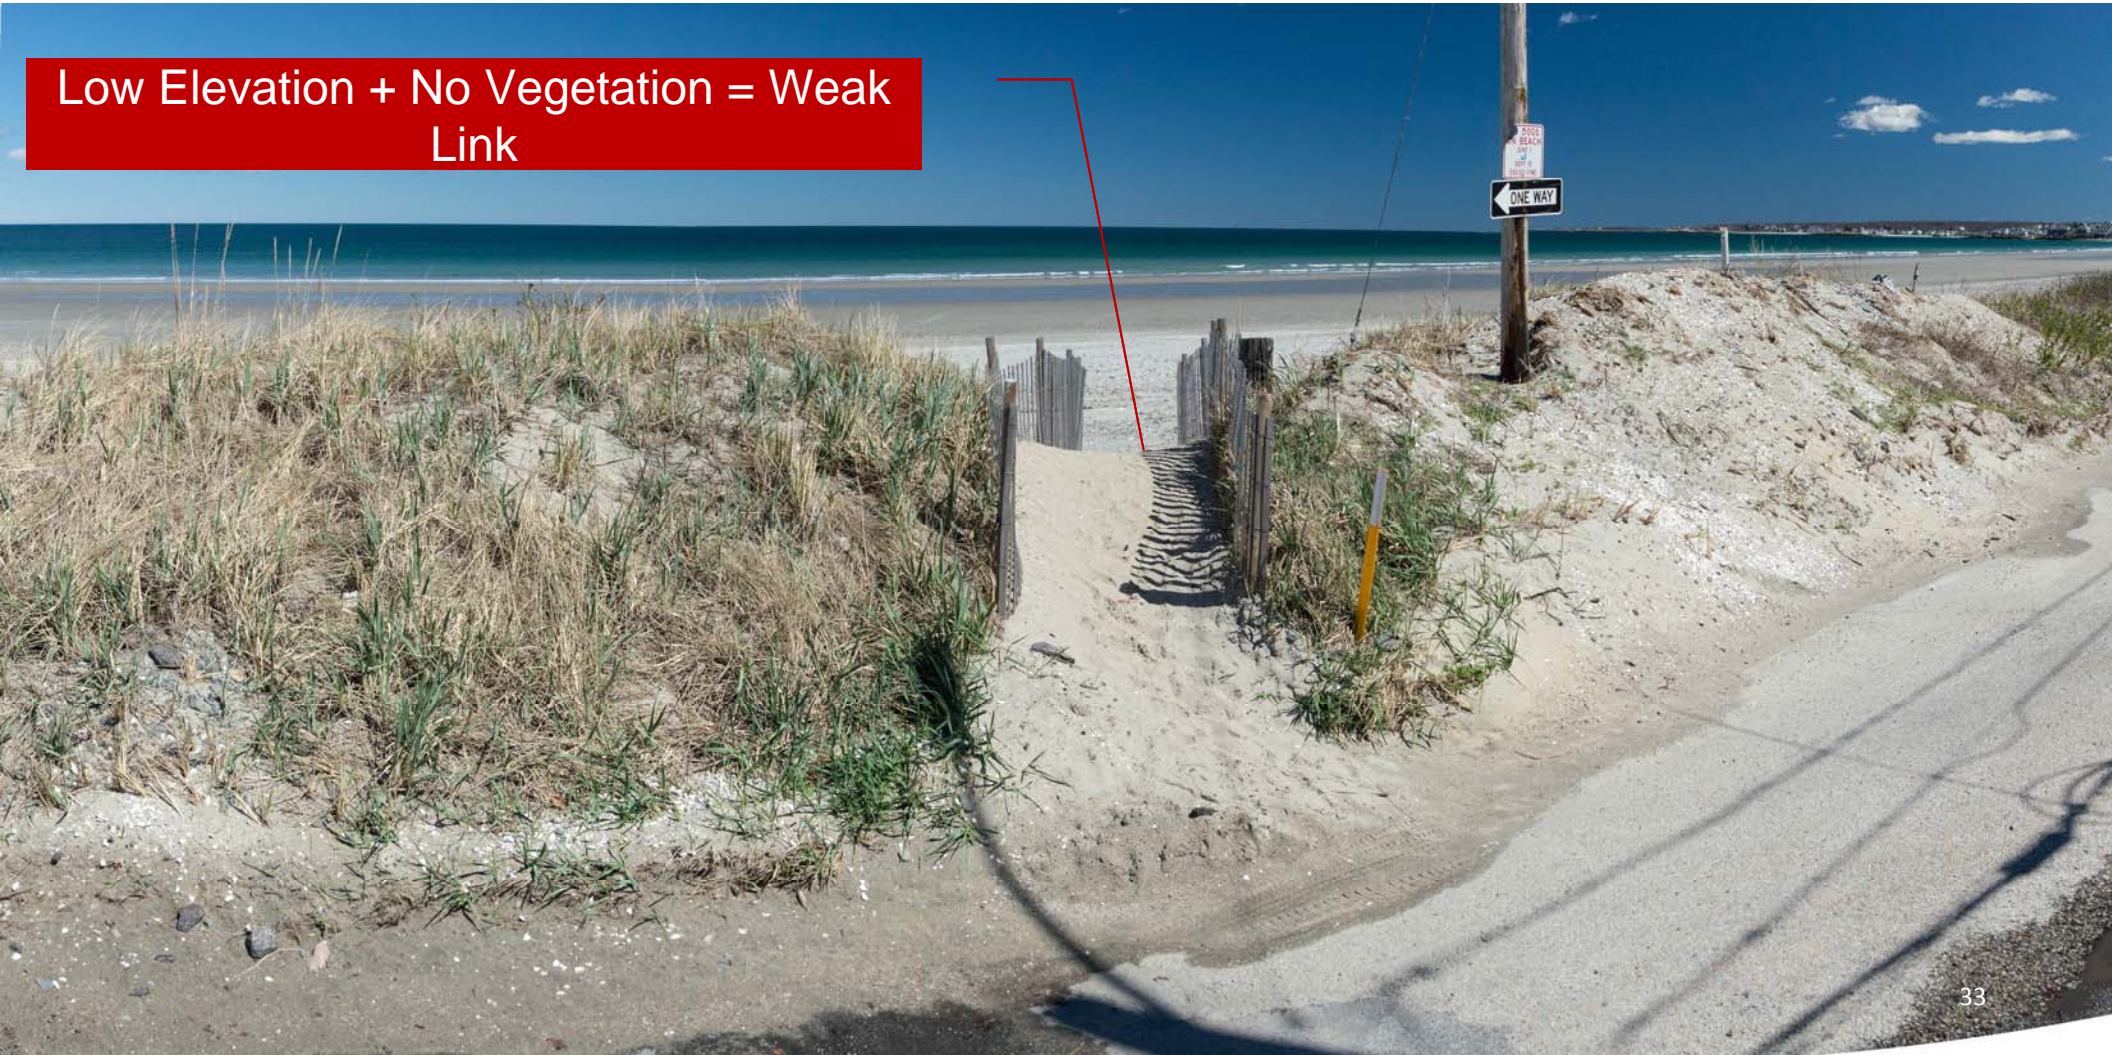
Typical Permitted Crossing – Existing Conditions

Low Elevation + No Vegetation = Weak Link
