HULL WATER POLLUTION CONTROL FACILITY

September
2022

MONTHLY OPERATING REPORT

NPDES NO. MA0101231

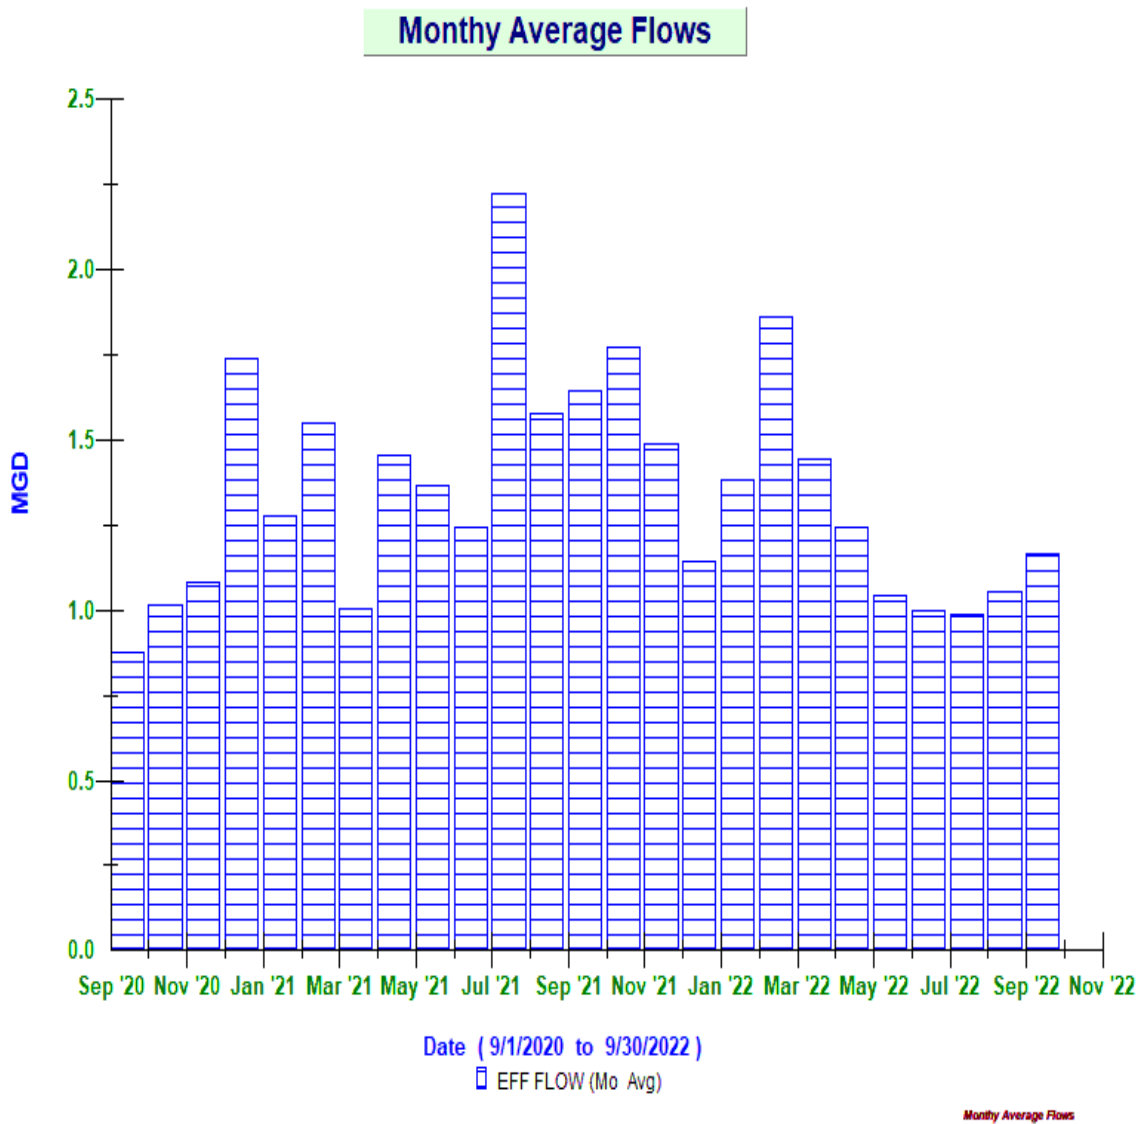
A. AVERAGE EFFLUENT MONTHLY FLOWS – 2+ YEAR COMPARISON

The monthly average flow for September was 1.17 MGD, slightly higher than 1.05 MGD in August. Total precipitation for September was 2.99 inches, more than August's 2.39 inches, but still no impact on plant flow, due to the very dry conditions. The graph shows the 2-plus year summary of the monthly average flows.

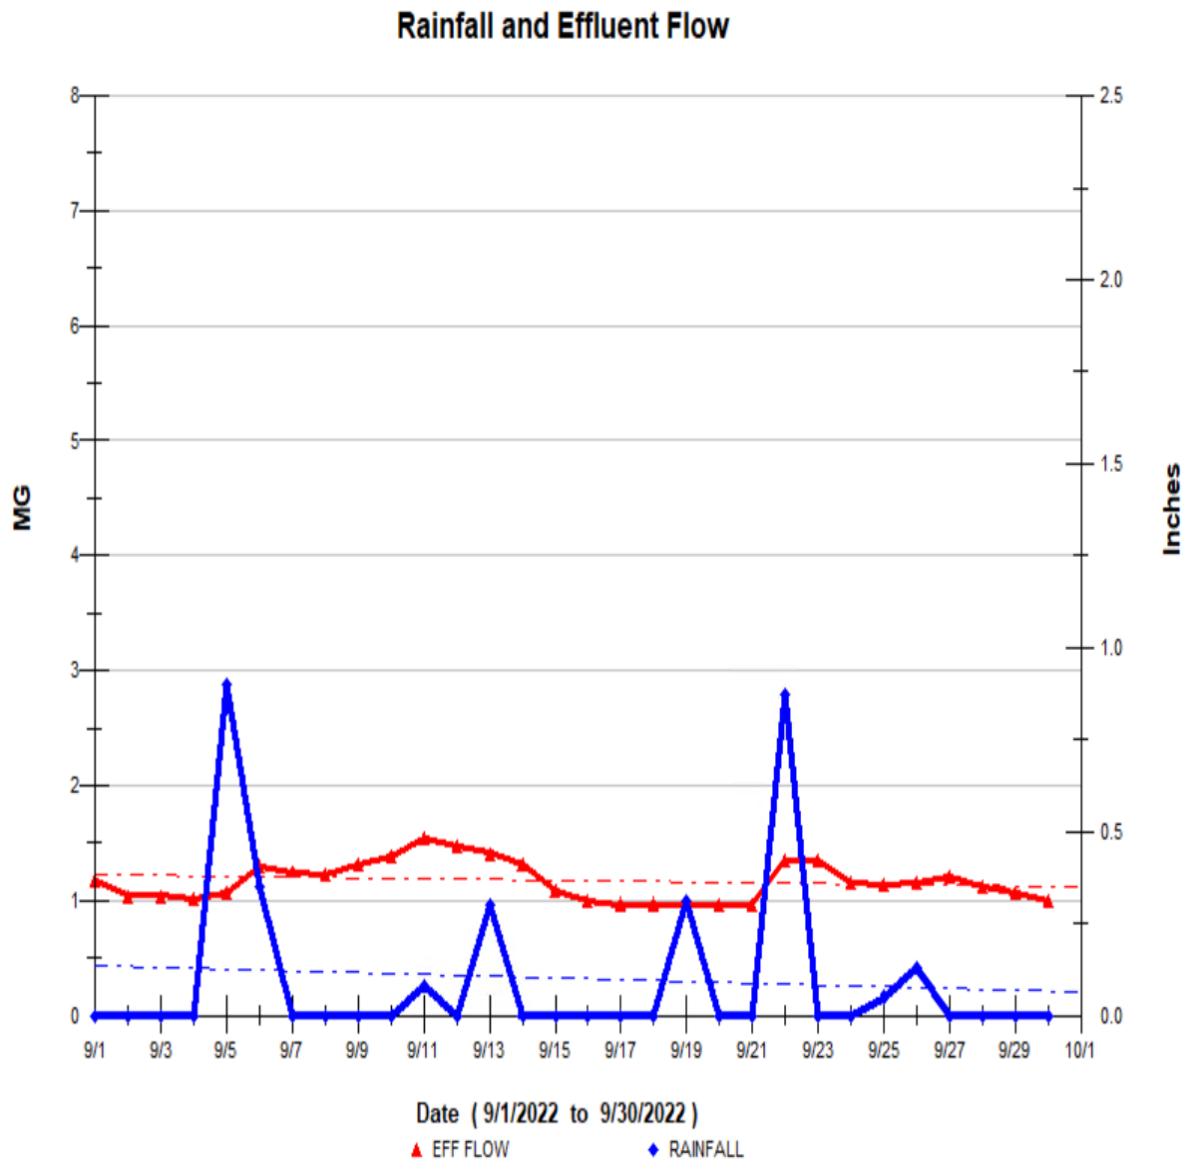
B. TWO MONTH SUMMARY OF RAINFALL AND THE INFLUENCE ON EFFLUENT FLOWS

This graph shows the days where precipitation occurred [rainfall] [Blue Peaks].

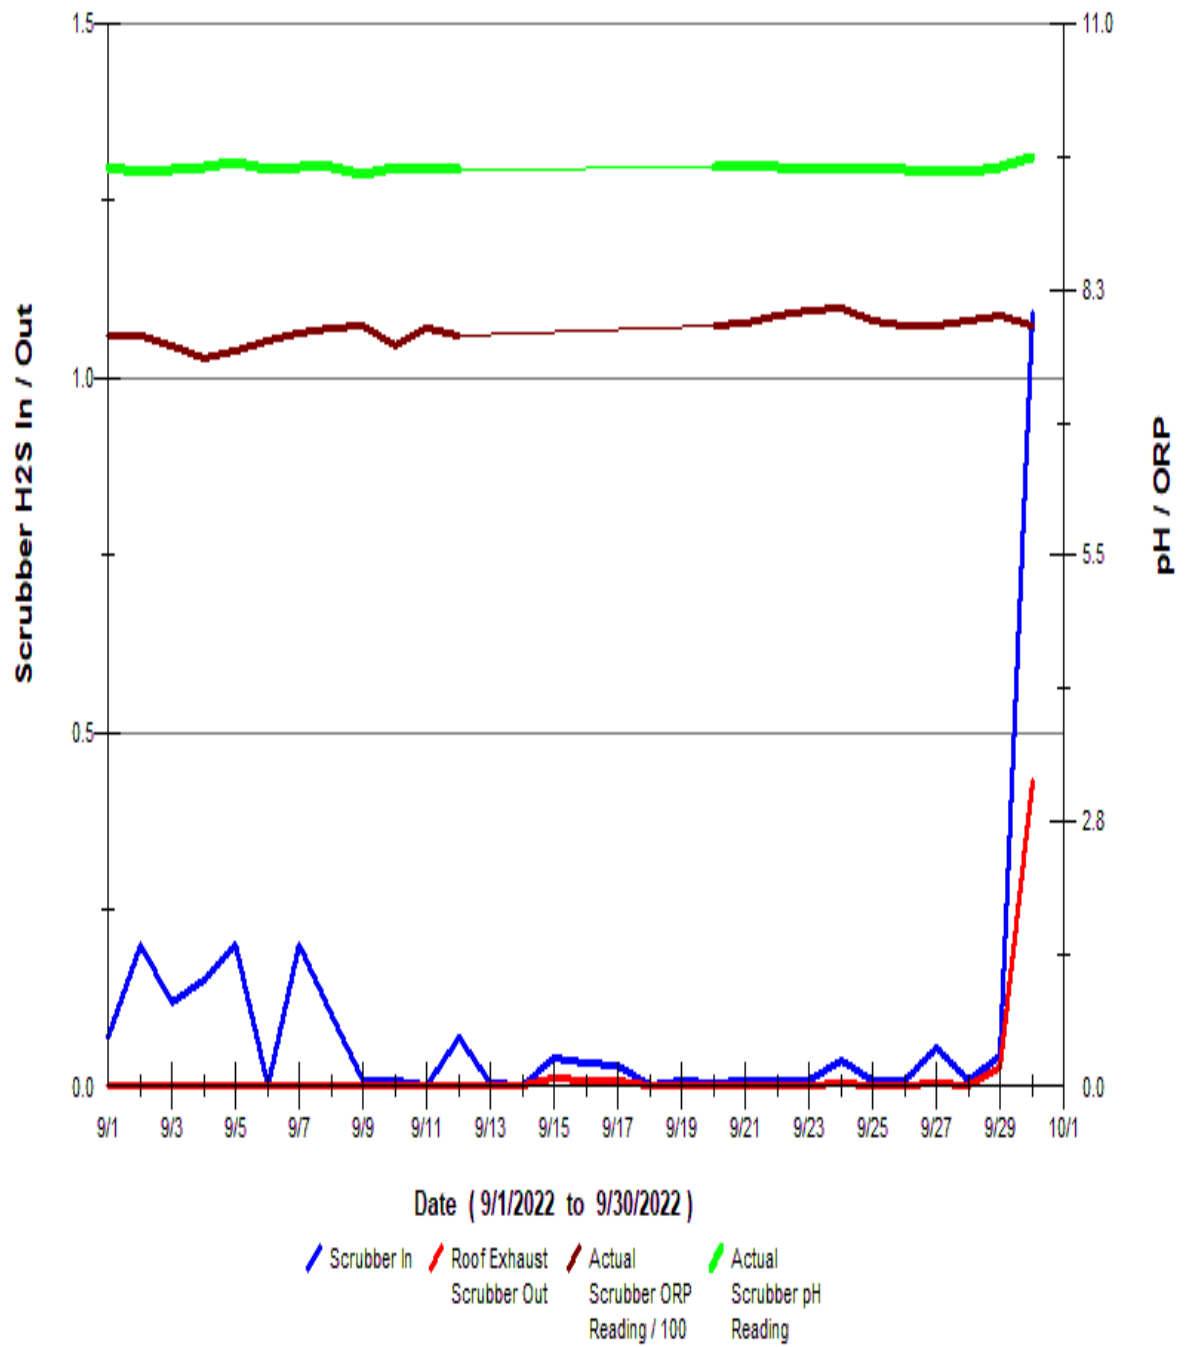
Scrubber H2S, pH and ORP

- The "In-Pipe" bacteria containers in collection system were changed out on September 6th & 24th
- Slight changes - Hydrogen sulfide (H₂S) monitoring units were recording and trending on the odor scrubber. [inlet and outlet]. Increased scrubber fan speed slightly. See graph below

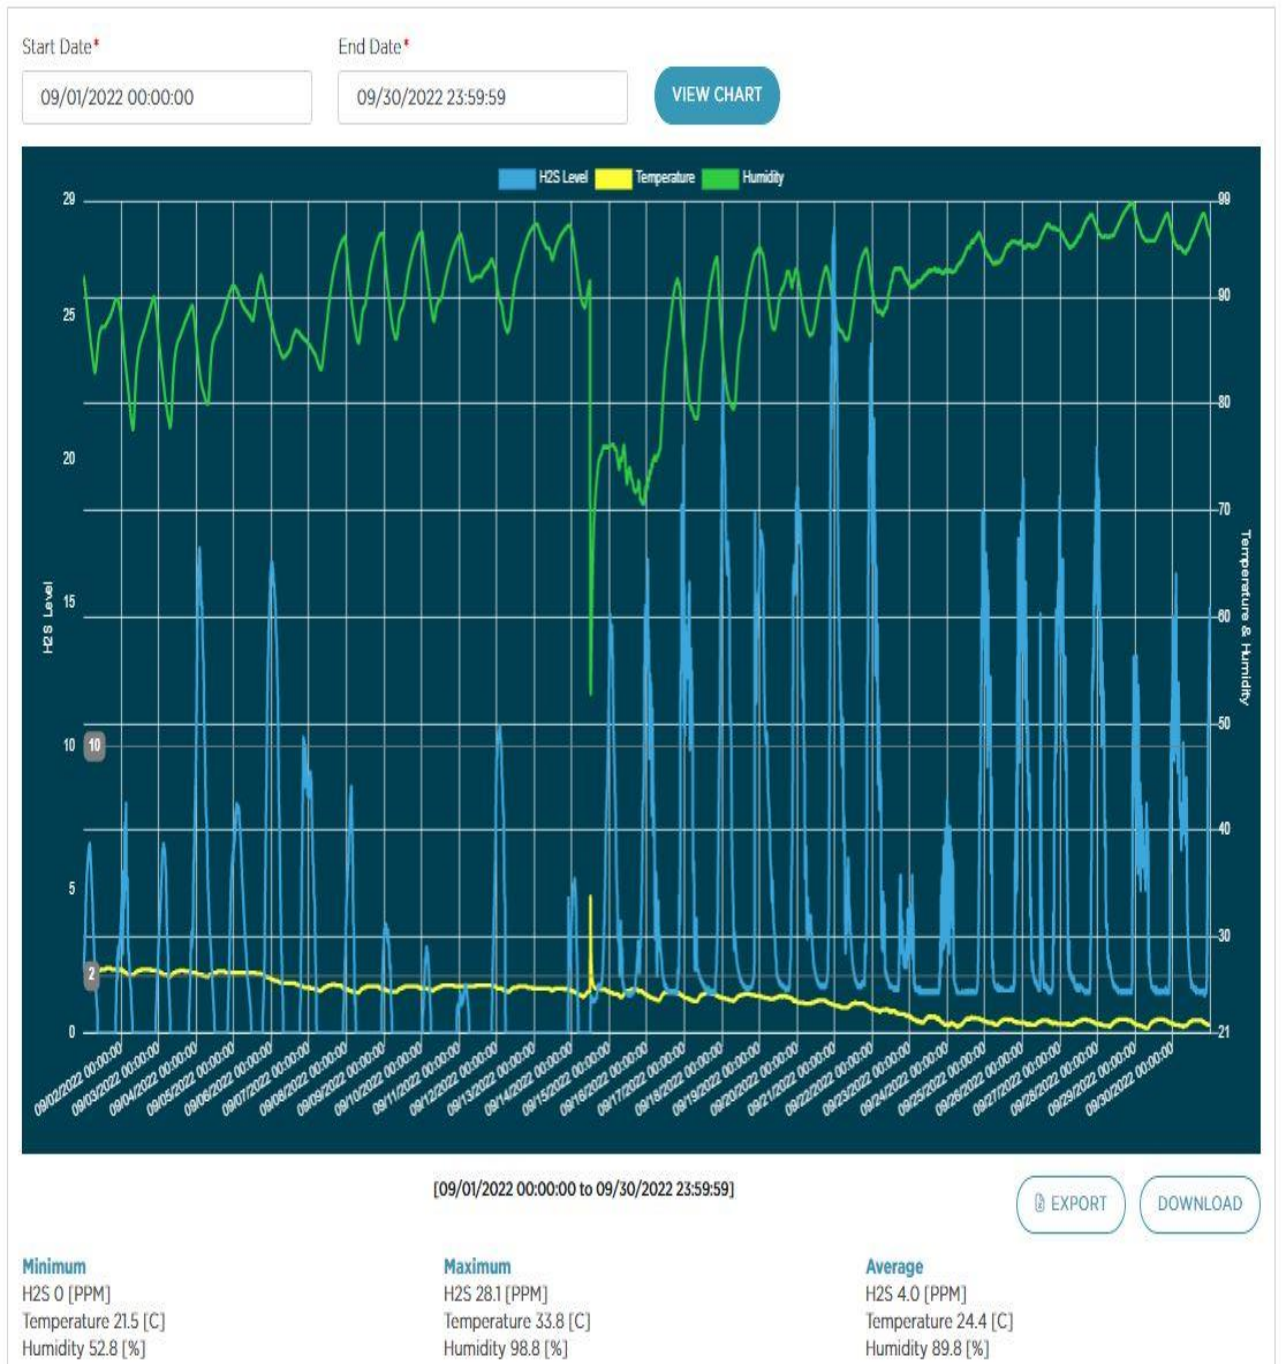
XYZ – Nantasket Ave [closest to plant]

The odor data logging unit at XYZ monitoring the overall H2S levels close to the plant. From the graph, the daily pattern of H2S levels see a rise in the mid afternoon until late evening/early AM.
