Sewer Works

Newsletter of the Hull Sewer Department Winter 2024

Sewer Break on George Washington Boulevard (GWB)

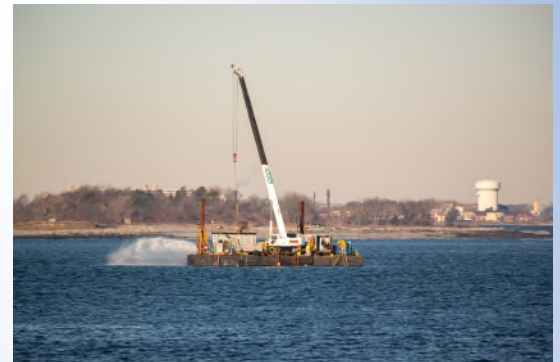
Photo by Joe Berkeley

Our Ocean Outfall Rehabilitation Project, funded by an ARPA grant, began in December 2023. You may have seen the barge out in the harbor beyond the Nantasket Avenue Seawall. Semper Diving, the awarded contractor, has been working quickly to complete this project; however, weather and sea conditions have not been favorable for good production. The work involves extending diffusers above the ocean bottom and removing accumulated sand, gravel, and sea growth from the outfall pipeline. This priority project will ensure reliability, public health, environmental integrity, and restoration of outlet capacity. We anticipate project completion Spring 2024.

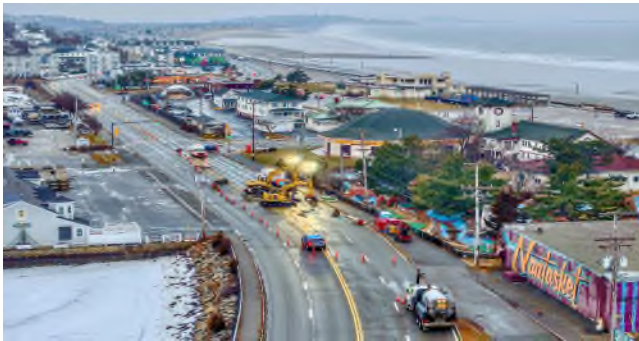
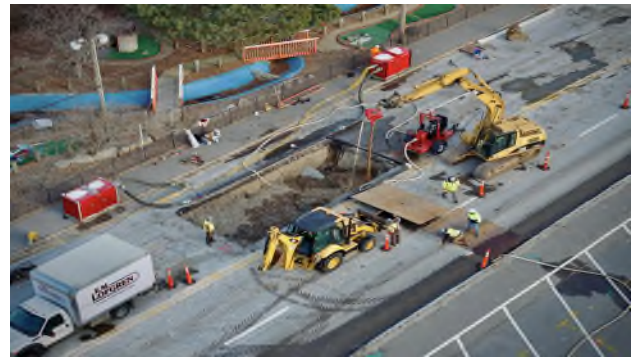
Photos courtesy of Richard Green

During routine monitoring of the sewer system, higher flows were observed in the sewer on George Washington Boulevard (GWB). A collapse in the sewer pipe on the corner of Wharf Avenue and George Washington Boulevard was found. Work to replace the collapsed 12-inch diameter asbestos cement sewer pipe began on January 22nd. This work was complicated by being 14-feet deep, high groundwater conditions, and an adjacent 14-inch diameter pressure force main only feet away. Once the section of pipeline was replaced and the service lateral reconnected, an inner liner the entire length of the pipe between the manholes was placed to provide long-term stability of the pipe. This collapse was similar to the one that occurred in June 2023 at the corner of Nantasket Avenue and Edgewater Road and further demonstrates the vulnerability of the sewer system. See also the Operations Message on Page One of this Newsletter.

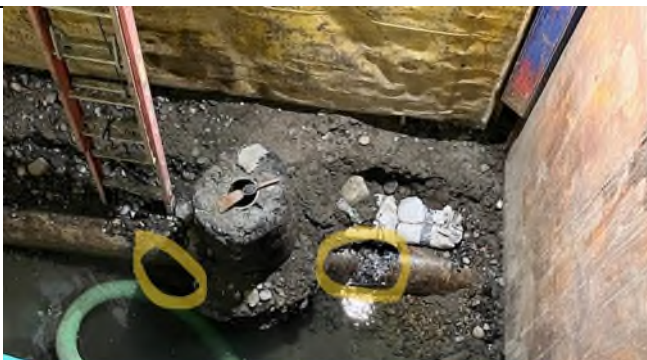
*The pictures above were provided by Richard Green. The photos below, taken by John Struzziery and Tom Molinari, depict the collapsed sewer pipe in the left photo, with the breaks circled in yellow, and the new pipe that replaced it in the photo on the right.
