Subject: 51 Harborview Road
Hull, Massachusetts 02045
Response to Comments
CEC Project 334-762

On behalf of the Applicant for the above referenced property, Civil & Environmental Consultants, Inc. (“CEC”) has prepared this memorandum and attached Contractor’s Qualifications, Soil Nail and Slope Stability Design Narrative (the “Design Narrative”) and Aerial Overlay Exhibits in response to comments provided in a memorandum by Mr. Chris Krahforst, dated February 1, 2024.

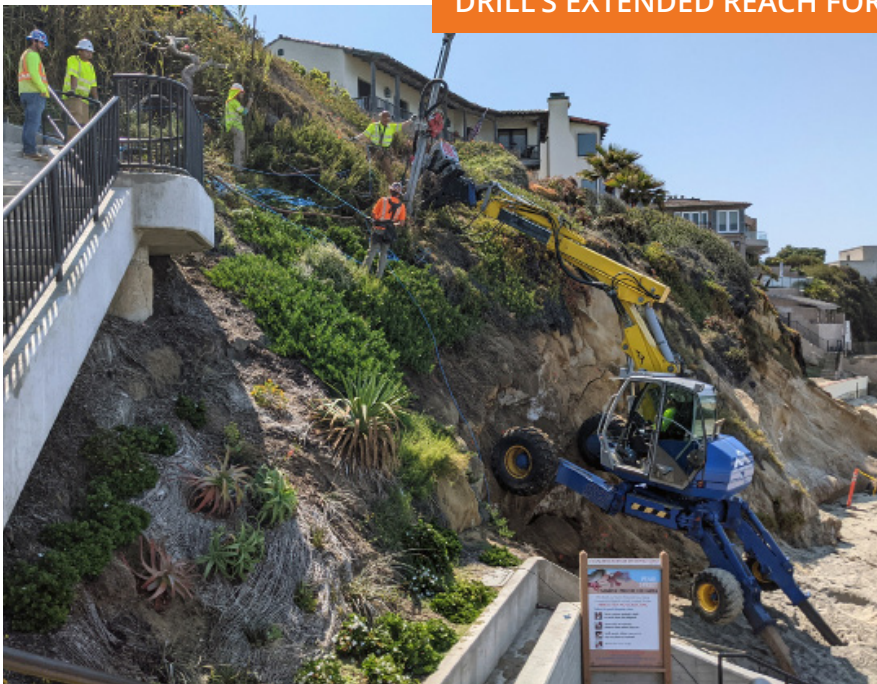
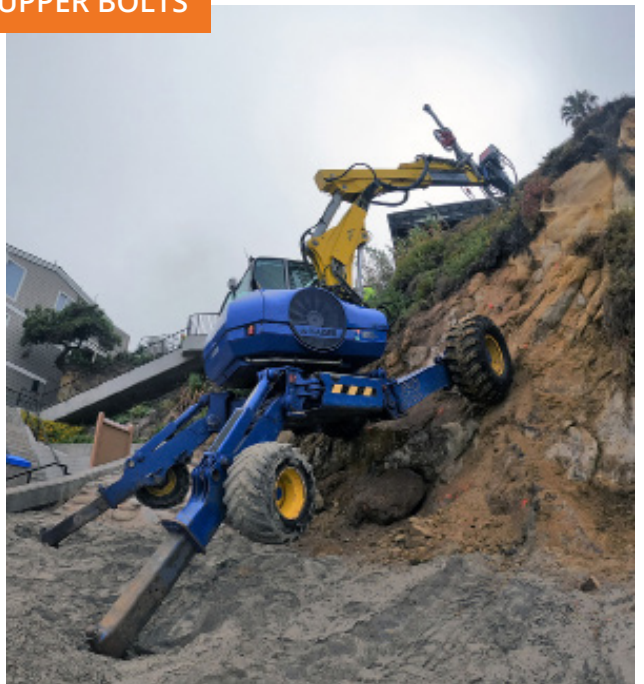
DRILL'S EXTENDED REACH FOR UPPER BOLTS

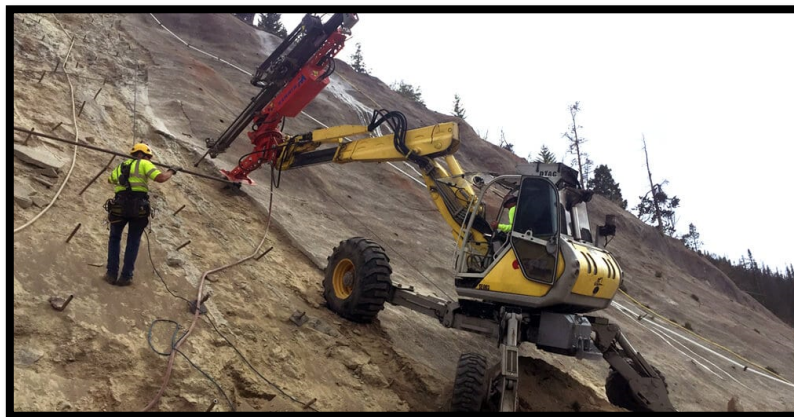
Photo 1 – Spider excavator installing soil nails

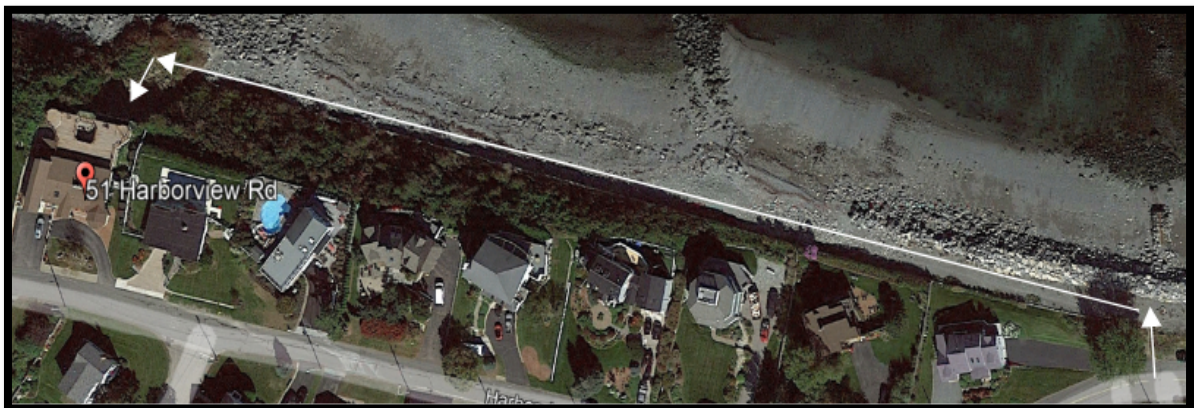
Photo 2 - Anticipated access route for spider excavator
