STRAITS POND TIDAL FLUSHING STUDY

**HULL, COHASSET AND HINGHAM,
MASSACHUSETTS**

July 2004

**US Army Corps
of Engineers
New England District**

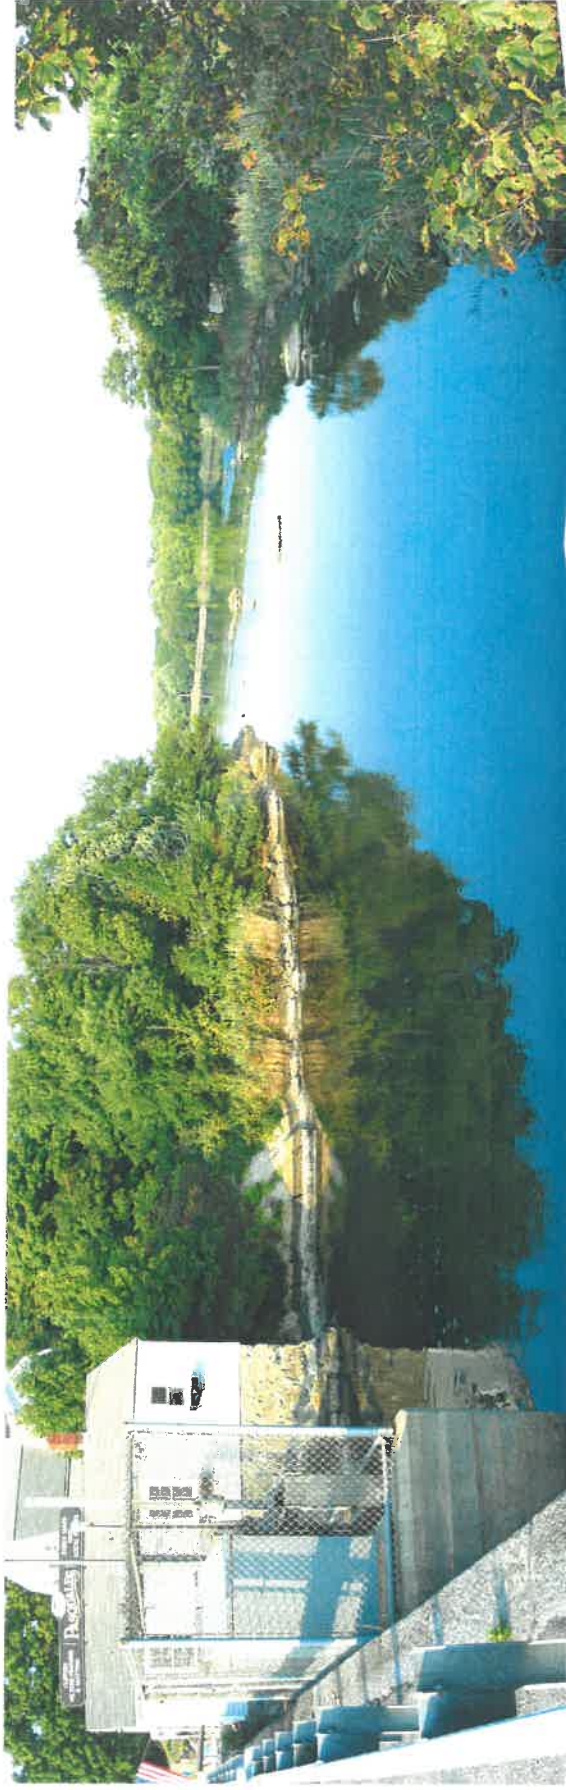
Photo 1. Straits Pond, October 2003. Route 228 bridge is on the left with the gate enclosure on the right side of the bridge. The pond elevation about 2 feet, NGVD.

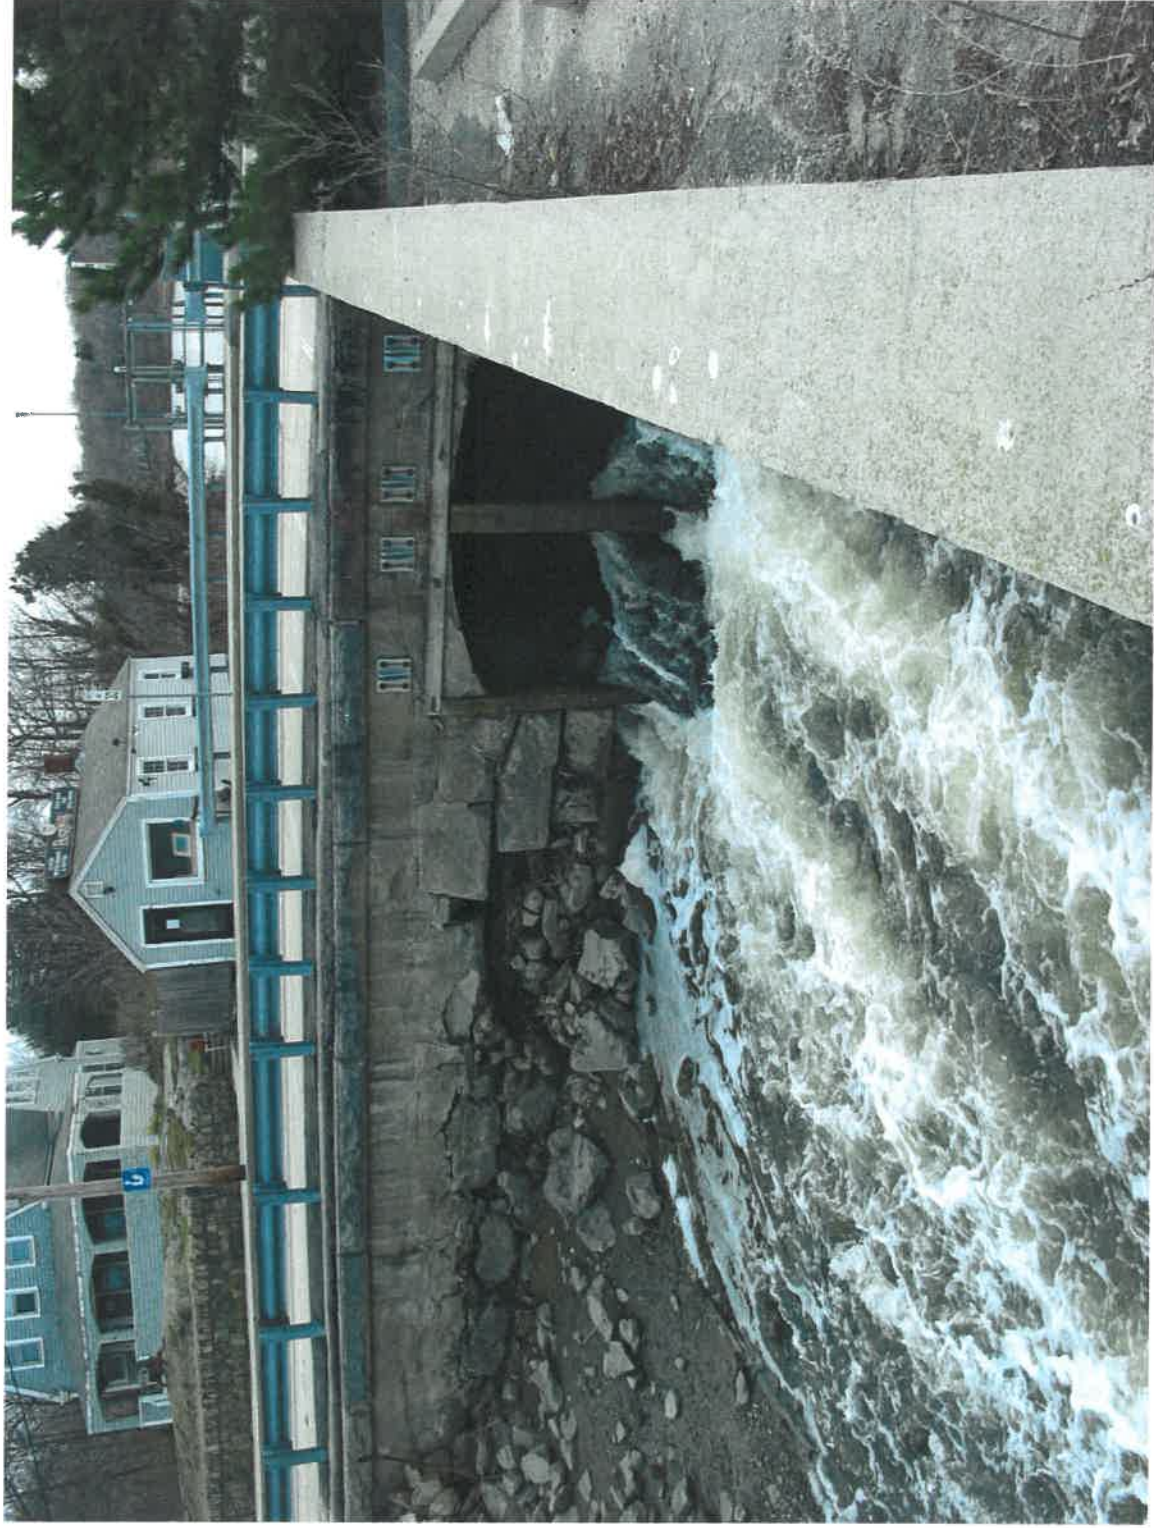
Photo 2. Route 228 bridge from the estuary side during the midpoint of a falling tide, April 2003.

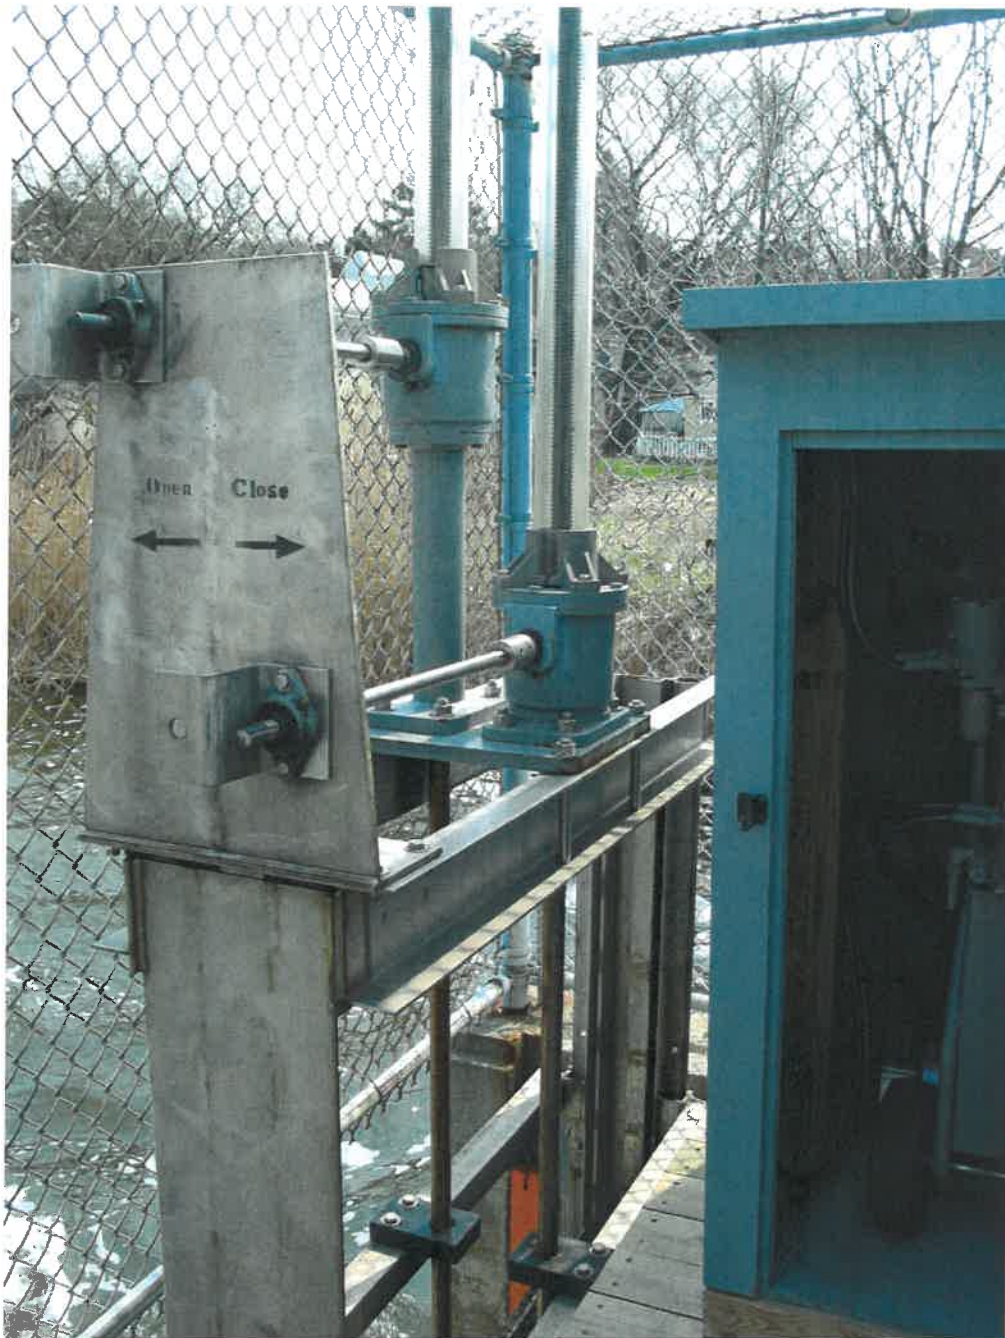
Photo 3. Gate control mechanism.

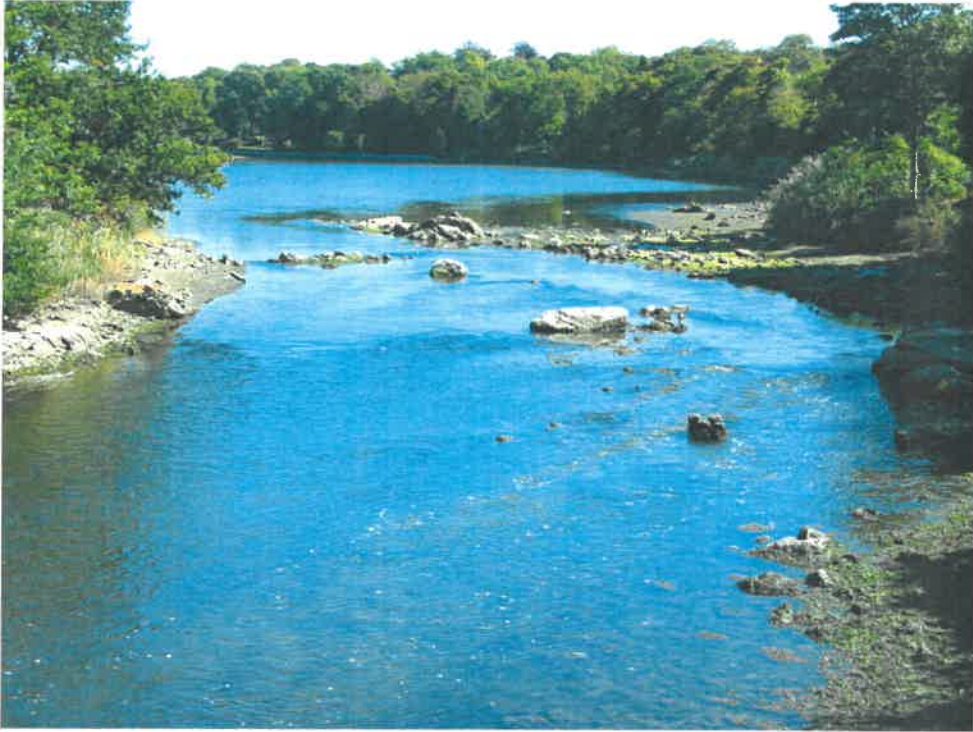
Photo 5. Straits Pond, October 2003, showing the high point in the channel with the pond around elevation 1 ft, NGVD.

Three channel restrictions were examined in table 2. “Initial” refers to the restriction based on the Corps survey cross section. However, photographs taken by Jason Burtner when the pond was lowered over successive days to elevation 1 foot, NGVD (photos 5 – 7) appear to

show a more restrictive section than the Corps survey indicates. Consequently, a second more restrictive channel section was estimated from the Corps survey and these photographs; this is the “Photo-Modified” channel restriction in table 2. The third case assumed the channel restriction (the high point) was completely removed; this is the “None” channel restriction in table 2.

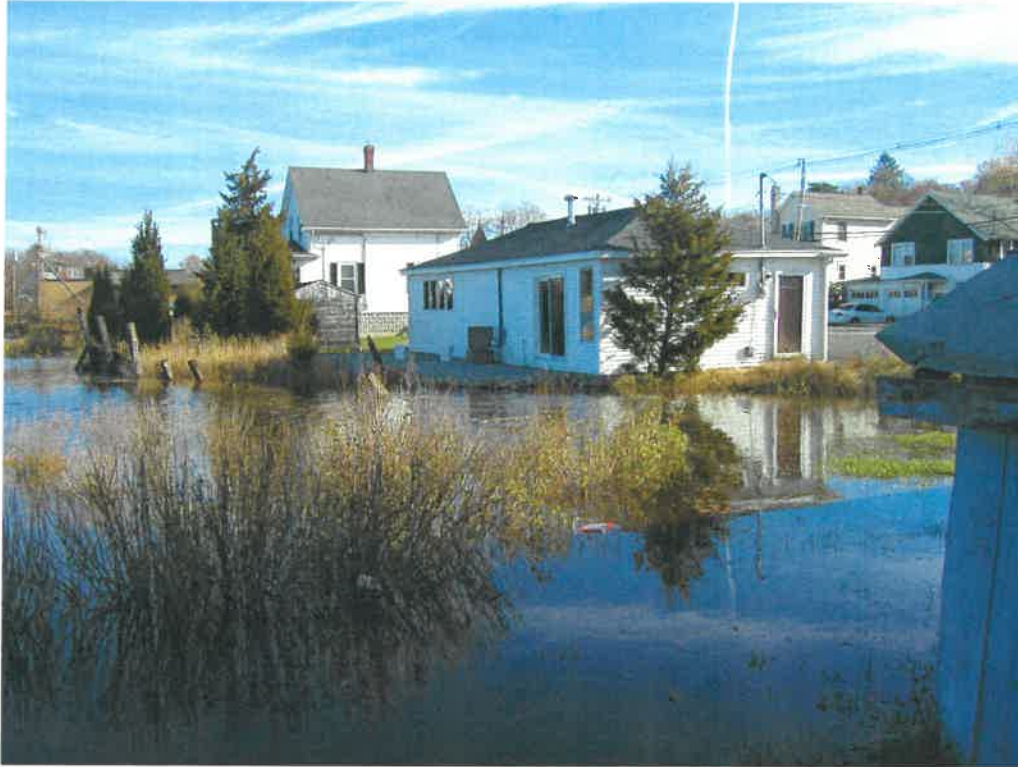
Photo 8. Estuary flooding, November 2003.

As reported by Jason Burtner, and shown in photos 8 – 10, properties on the estuary side of the Route 228 bridge experience flooding in association with astronomical or storm tides that exceed 12 feet, MLW (7.5 ft, NGVD). The property owners perceive this problem as increasing with time. This prompted Mr. Burtner to ask that if the tide gates were operated in a manner that allowed a more normal ebb and flow of the tide (i.e. the tide gates more or less constantly open), would that reduce the current high tide elevation? In other words, would allowing the incoming tide to enter Straits Pond, thereby acting as a hydraulic reservoir, reduce the peak high tide elevation and reduce potential flooding to the adjacent properties, rather than having the incoming tide being halted against a closed tide gate? Mr. Burtner noted that such an effect appears to be occurring at Musquashcut Pond in Scituate.

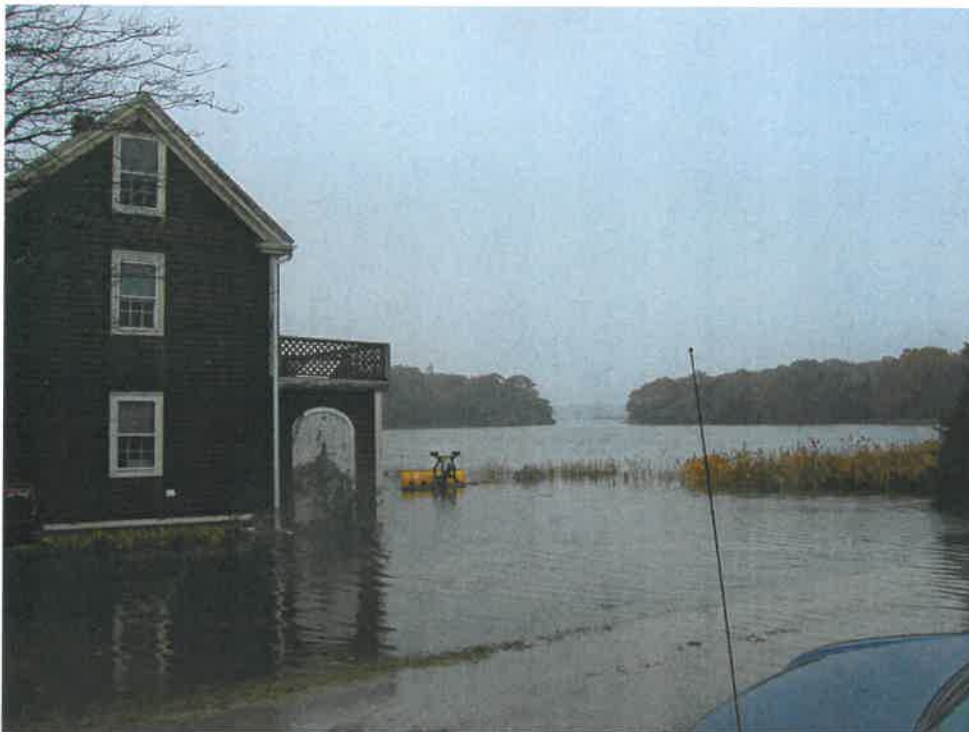
Photo 9. Estuary flooding, November 2002.

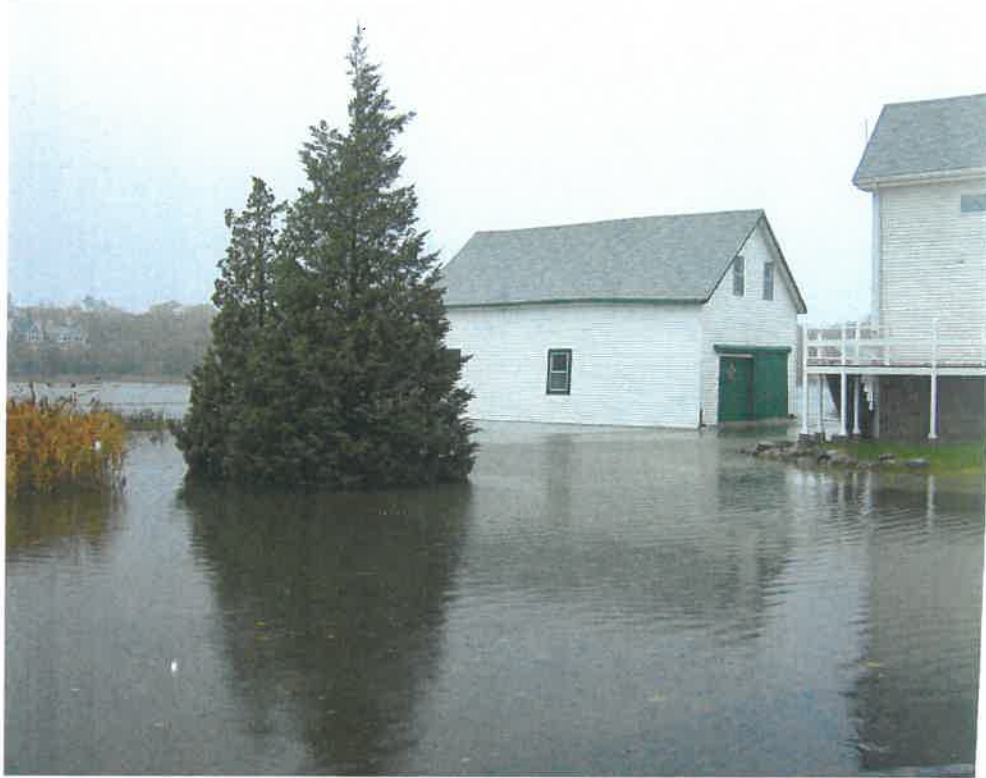
Photo 10. Estuary flooding, November 2002.

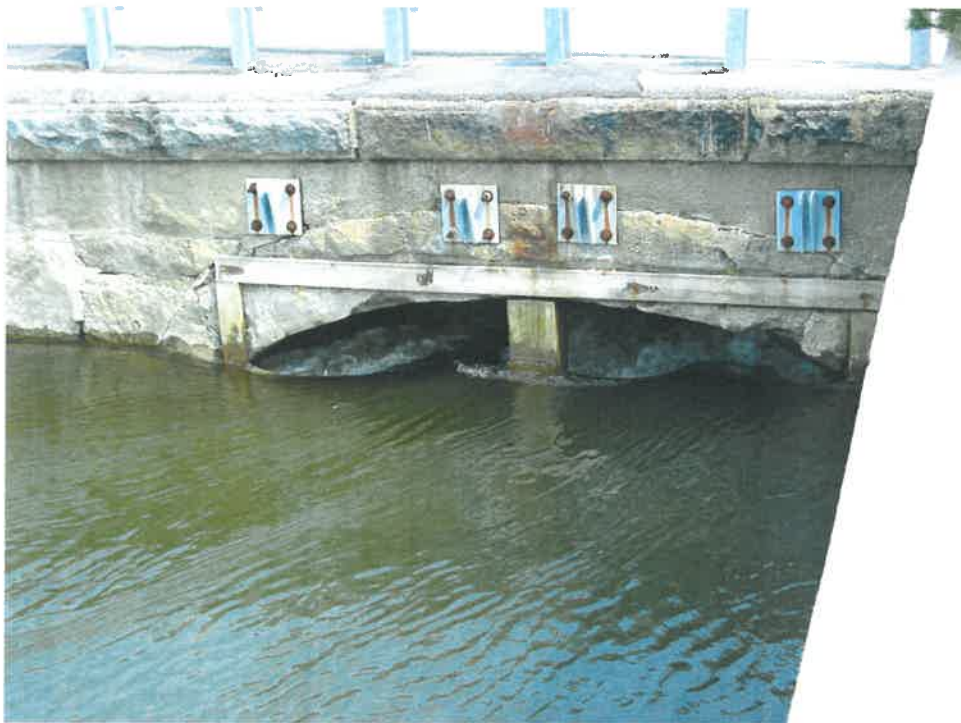
Photo 11. Timber supporting beam on estuary side of bridge.

Technical modeling details are as follows. Version 3.1.1 of HEC-RAS from May 2003 was used in the unsteady mode. Dimensions for the Route 228 were taken from a report by Vanasse Hangen Brustlin, Inc. (VHB) that described it as having a 12-foot span, 8.5-foot rise, and 57 foot length. The VHB report and field observations show water, sewer, and gas lines under the bridge, which were accounted for in the model with Manning’s “n” values and gate coefficients. The channel invert under the bridge was –2, and the crown of the bridge opening was elevation 7.13 feet, NGVD. The vertical timber in the center of the estuary side of the bridge

(photo 11) was represented as a pier. Manning’s “n” values generally ranged from 0.012 for the new concrete wall on the estuary side of the bridge to 0.03 for rough channel below this wall; however, in some places these values had to be raised to prevent the program from erroneously calculating highly supercritical flow conditions.
