Update on Straits Pond

Presented to the Board of Selectmen

July 27, 2017

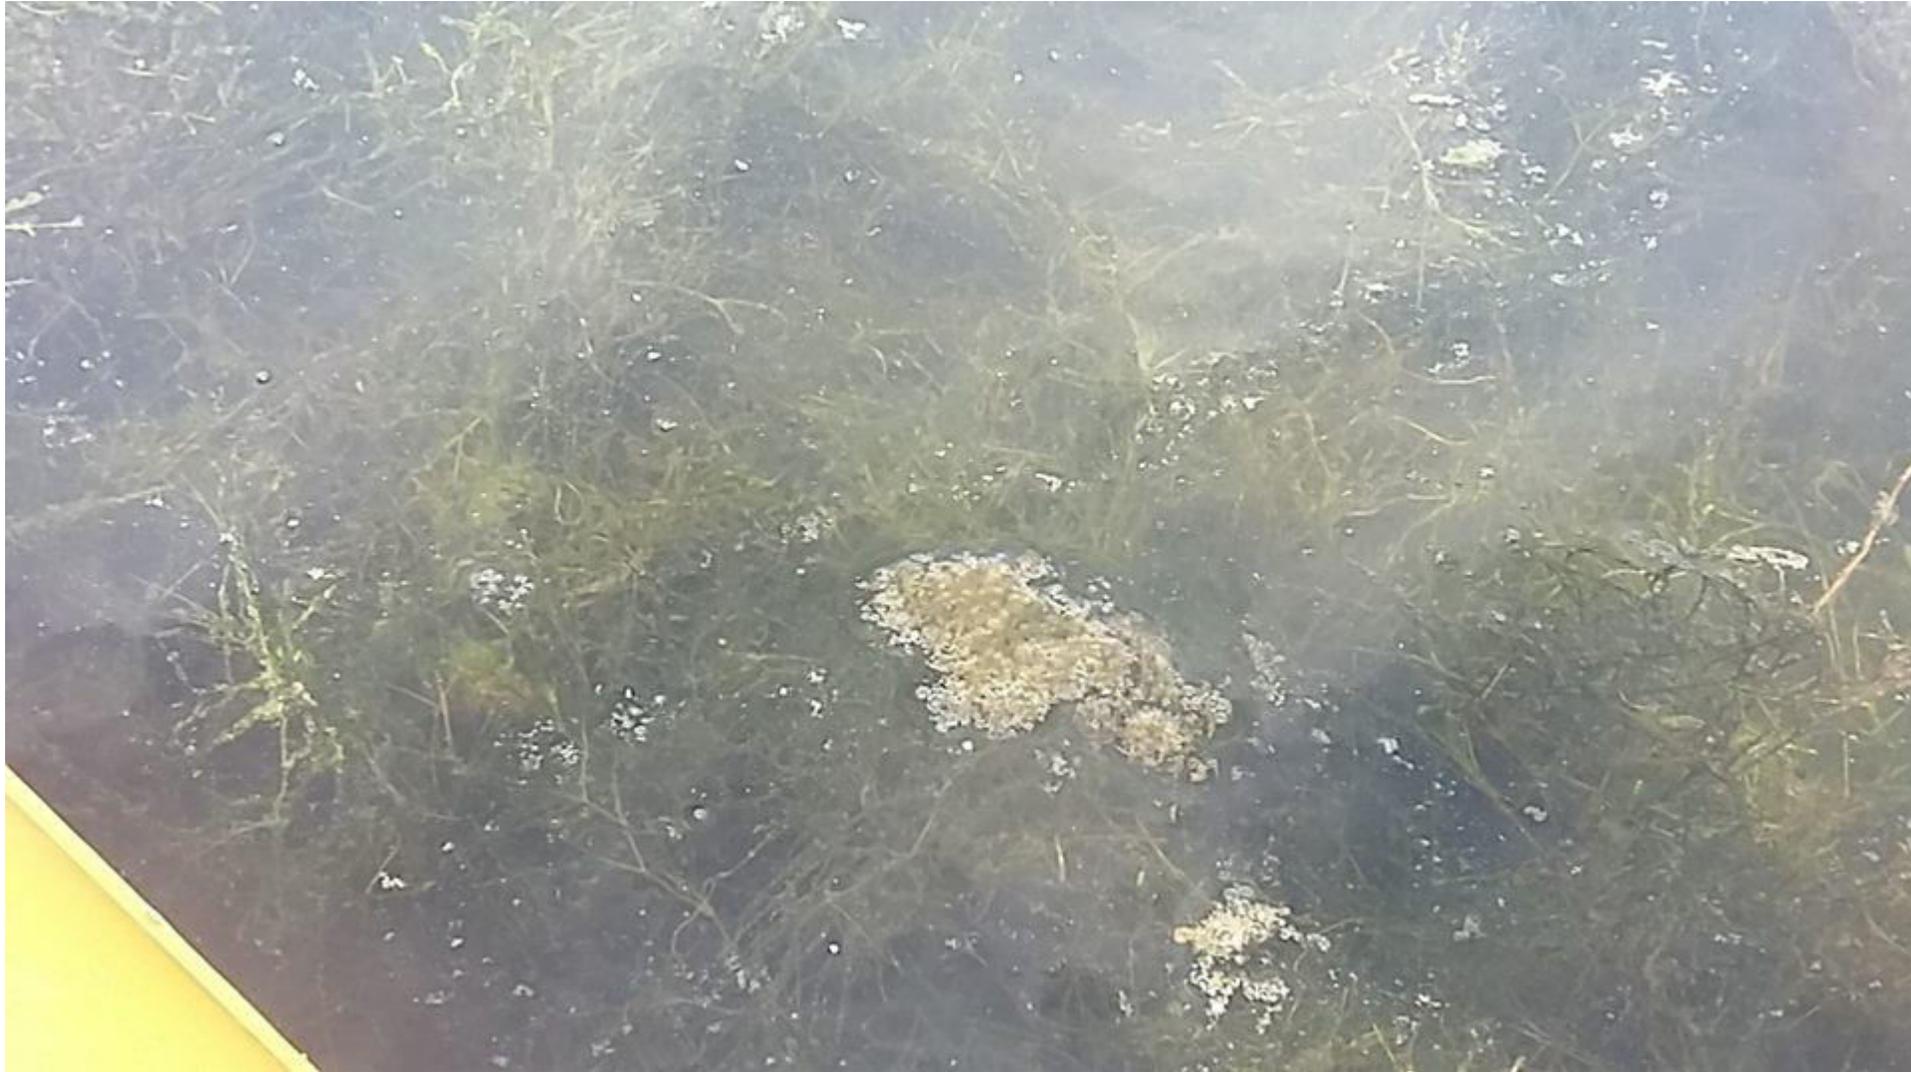
Ruppia is important not only for its oxygen production, but it serves as an excellent nursery habitat for many of the desirable aquatic organisms found today in SP. Figure 5 shows *Ruppia* growing below the surface in SP.

Ruppia sp. in Straits Pond, July 2017

Ruppia grows vertically and at times exceeds in length the height of the water column and thus lays itself over along the top of the water, especially during low tide stages. At times this can confound the flushing of other co-occurring nuisance algae, like Cladophora (aka “hair” algae) which can form dense floating mats, or Ulva (aka Sea Lettuce) which floats in the water column. These algae, when they die off, consume oxygen through their decay and can contribute to the unpleasant odors currently being reported.

Ruppia did show signs of stress, indicated by the presence of epiphytes (small plants that grow on the surface of larger aquatic plants) which was observed on many of the stands of Ruppia in SP. The epiphytes were not analyzed, but looked to be of small single-celled brown algae, possibly the result of an intensive brown algae bloom observed over the last few months in the waters of Boston Harbor and along the coast of Massachusetts Bay.

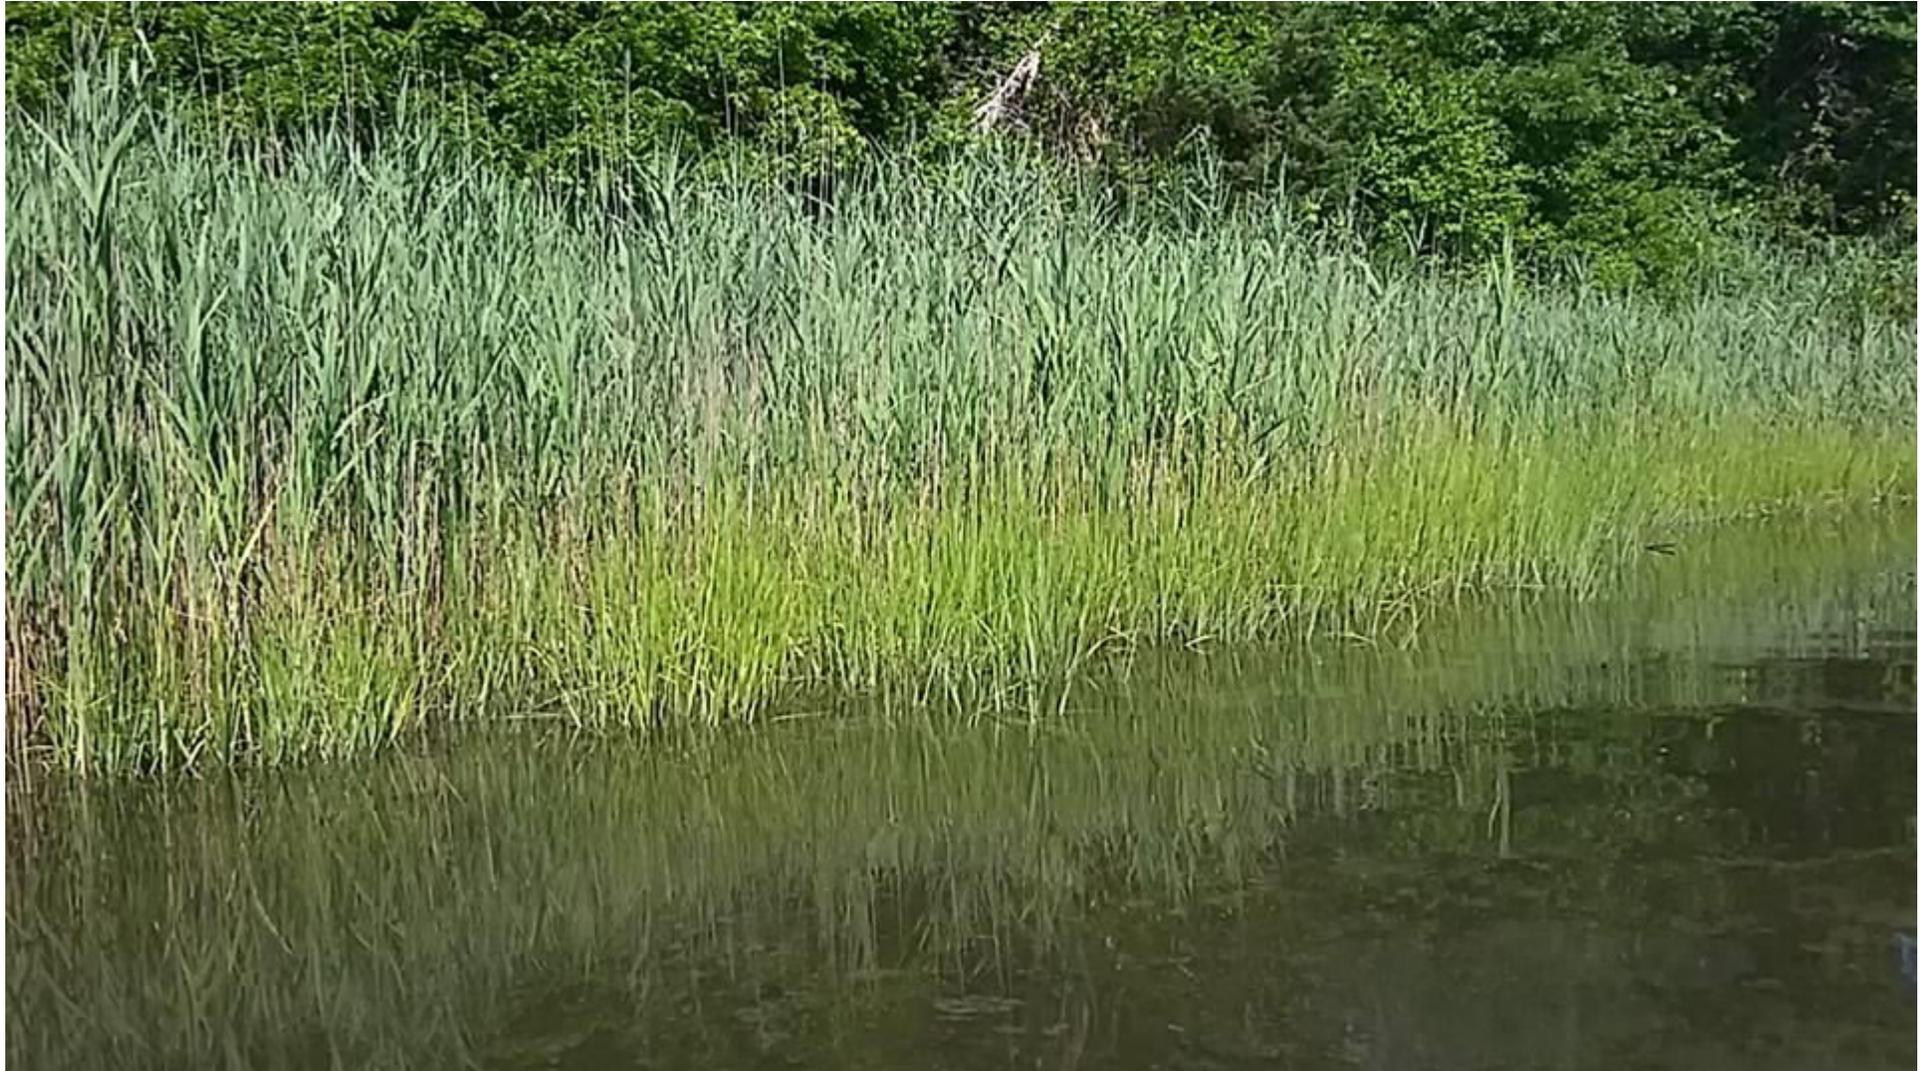
Because of the measures taken to improve the exchange of water between SP and Boston Harbor, the marsh grass *Spartina alterniflora* is returning along the fringes of the SP shores, and displacing or replacing the strands of the invasive Phragmites. Figure 6 shows the fringing *S. alterniflora* in from of a stunted or dying stand of the taller Phragmites. This is another good indicator of the return of ecosystem quality of Straits Pond.

Figure 6. Fringing *Spartina alterniflora*, Straits Pond July 2017
