# Feasibility Study

## Town Hall - Police - Fire Complex

Project Number: 1302.00

May 2013

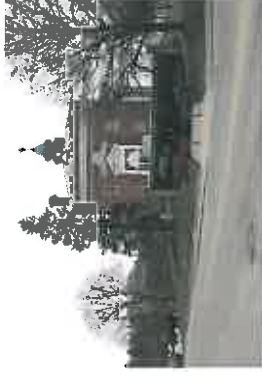
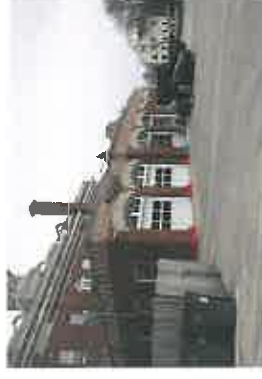
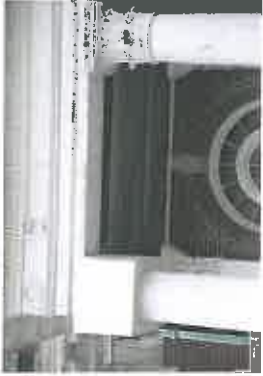
- A brick parapet is present along the west, south, and east sides of the 1920 structure's low roof. According to town personnel, this parapet once had a stucco veneer that was recently removed. The brick was deteriorated at numerous locations where this stucco veneer was removed.
- The wood fascia along the hip roof of the 1920 structure is rotted in various

locations.

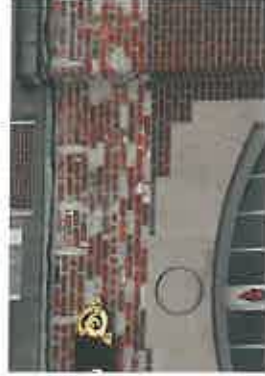
- On the Atlantic Ave façade, on the east facade of the main portico there are several bricks, which are missing, at an area that appears to usually be covered with wood trim. New brick should be installed to prevent moisture, animals or pests from entering the building wall cavity.
- Near the existing exterior fire escape where some brick has cracked, spalled or otherwise is damaged.
- The existing parapet over the single-story police and fire apparatus garage was, according to town personnel, once covered with stucco and has since been removed. The brick is severely damaged in this location and the faces of the bricks have spalled off.
- On the Atlantic Ave façade, under the main portico there are several large round holes in the brick, most likely from some ornamental decoration which

has since been removed. The voids should be properly filled to prevent premature degradation of the brick.

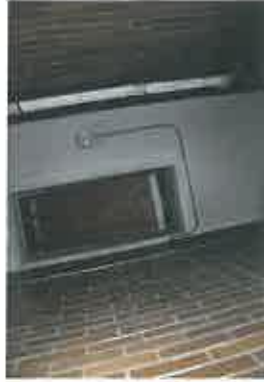
- The existing door hardware on the second floor pair of doors exiting into the stairway is not ADA compliant nor is Code compliant; it is a life safety issue and should be addressed immediately.
- There are numerous wall penetrations are not sealed to prevent passage of smoke/

fire. Generally when a pipe, conduit or other similar item penetrates a wall, the void created around that pipe should be sealed properly to stop smoke, sound or other smells from transferring to the adjacent side of the wall.

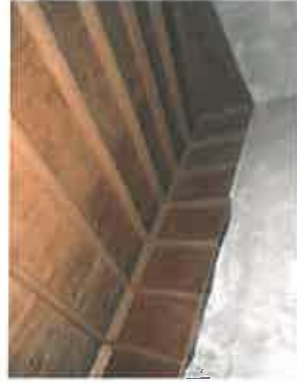
- **Basement Concrete Framing:** Based on limited observations made during the survey and digital photographs provided by town personnel, significant spalling with exposed steel reinforcement is present along some concrete beams, columns, and the underside of the slab. PARE recommends that spalled or deteriorated areas of concrete be removed to sound concrete. Exposed reinforcement shall be cleaned and/or replaced. The repair areas should be patched with a polymer-based repair mortar (small or overhead areas) or cast-in-place concrete (larger areas), as appropriate.

While the exact limits of repair are not known, an opinion of the probable construction cost for a repair of this type is \$1,500 to \$3,000 per beam or column repair and \$50 to \$100 per square foot for slab repairs.

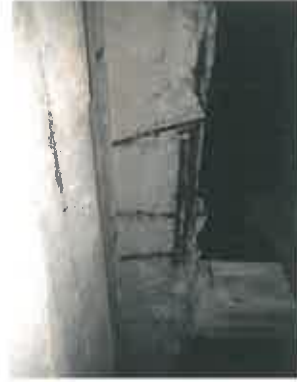
- **Fire Escape:** Various structural deficiencies (described above) were observed along a metal fire escape providing access from the second floor of the 1920 structure to the roof of the 1970 addition. The recommended repairs are as follows:
  - o Deteriorated or detached treads should be removed and replaced.
  - o The angle securing the south side of the bottom of the escape to the low roof should be removed and replaced in-kind. A similar support should be installed at the north side of the bottom of the escape.
  - o Two missing anchor bolts along the escape frame should be replaced.
  - o The guardrail should be removed and replaced where detached or

- o Deteriorated steel shim plates should be removed and replaced with non-shrink grout.
- o Brick cracks at escape support locations should be repaired with a structural adhesive, such as epoxy injection.
- o The fire escape should be cleaned of all rust/corrosion and painted.

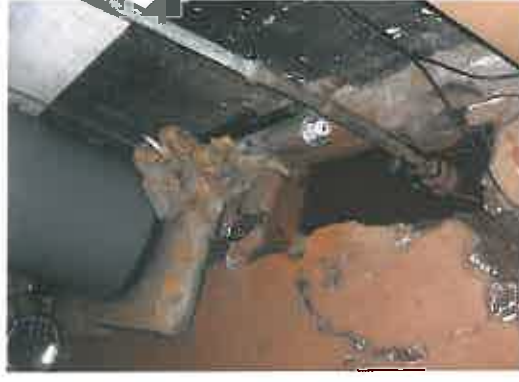
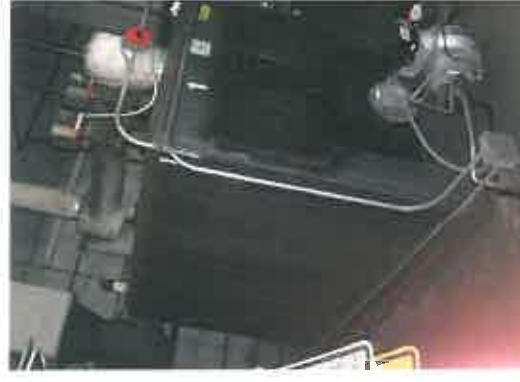
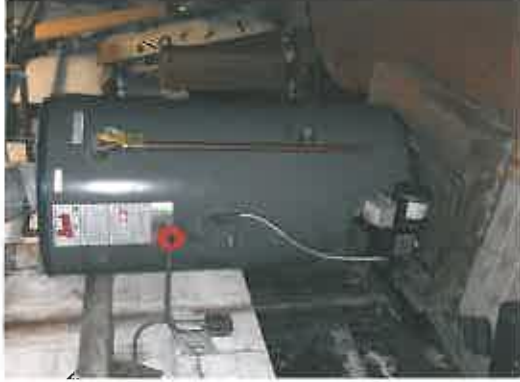
- d. Domestic hot water is generated primarily from a Bock, model 72E, ser 98123216T, oil-fired water heater installed in the boiler room. This unit has a model MSR burner rated at .5 – 2.75 GPH. This water heater tank is a replacement for the original tank. The data plate was covered by the Fire-Matic sensor. The former tank had a capacity of 70 gallons.

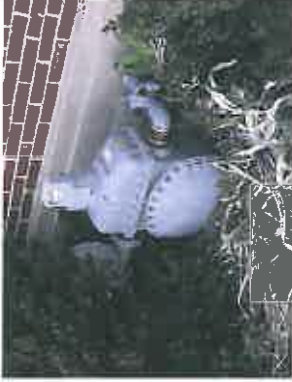
- a. Natural gas is supplied to the Town Hall from meter #05471473, size 560 installed on the Atlantic House Road side of the building. The incoming service pipe is a 1" and a 2" pipe services the building. From this meter location the gas enters the building and feeds the emergency generator in the rear garage of the Town Hall and a unit heater in the Fire Department. The Fire Department unit heater is a Modine, NG, model PA225AF, ser 15012020488, 225 MBH in, 173.3 MBH out.
- b. A second natural gas service meter, Actaris, 12/07, # 14548500, is located outside of the garage area for the Police Department. The inlet pipe is a 3/4" and a 1" serves the building. This natural gas services the Police building rooftop air-handling unit, boiler, water heater, and Break Room 4-burner stove.

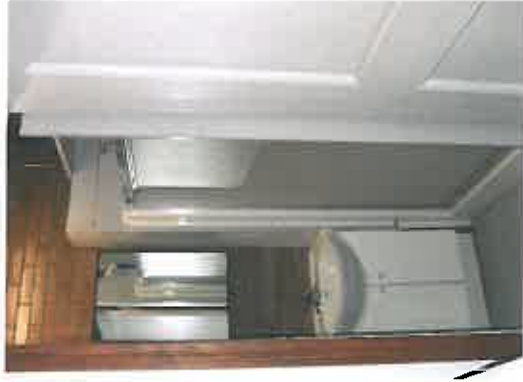
- a. The plumbing fixtures on the second level of the building are a mixture of original and replaced units. New fixtures are required to comply with the most recent Code standards for plumbing.

- b. Several of the toilet rooms on the first and second floors have had new fixtures installed approximately 20 years ago. These fixtures are more efficient than the originals but these do not comply with the current Code standards for water conservation.

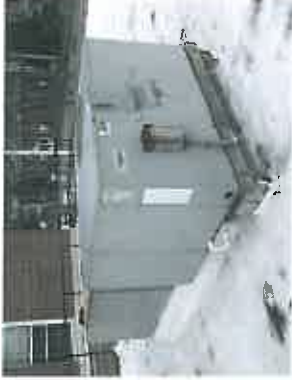
- d. The Police Department staff offices are served by a heat pump unit installed in the corridor beneath the ceiling. The unit and ductwork are exposed. The heat pump is a Lennox, C10-41-1, B10-41-1P, ser 5480J05337, R-22. The condensing unit is on the roof and the data plate is not legible. The condensing unit is rusted and in poor condition. The heat pump has no provisions for the introduction of fresh air into the space.

- c. Rework/ replace the existing rooftop air-handling unit above the Police Station. Install a new unit of adequate capacity capable of satisfying this building. The rooftop unit shall be equipped with a fresh air economizer and comparative enthalpy controls for free-cooling.

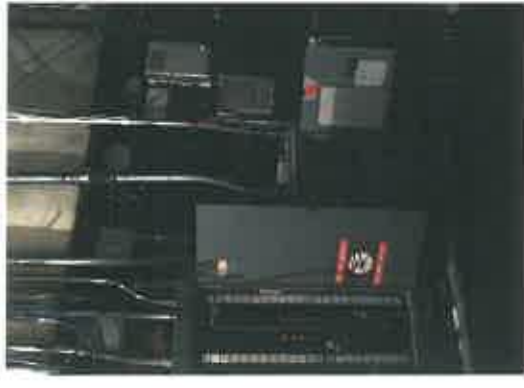
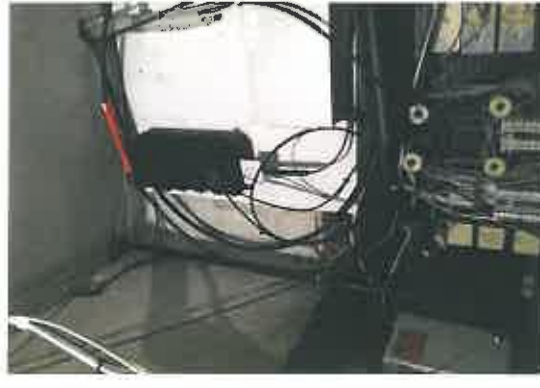
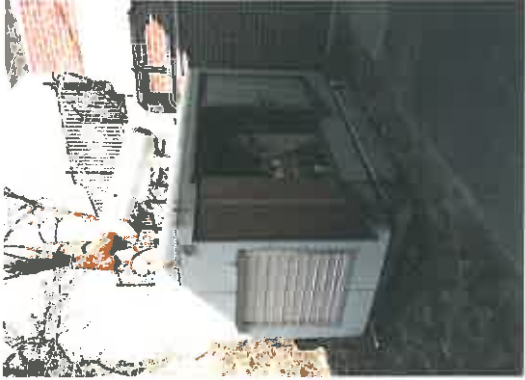
- a. The building has an 80kW, 120/240 volt, single phase, natural gas, exterior

- generator in a weatherproof enclosure, as manufactured by Kohler. It is located outside of the single stall Garage of the Fire Station.
- b. A 600 amp, 120/240 volt, single phase automatic transfer switch, as manufactured by Kohler, is located in the single stall Garage of the Fire Station. It appears that the generator and automatic transfer switch are not original to the building and serve the entire building.
- d. In general the emergency power distribution system appears to be in fair condition.

- a. The existing generator and automatic transfer switch given the condition and the fact that it is inadequately sized for a renovation should be replaced with new. The existing generator and automatic transfer switch are single phase which will not integrate with new proposed three phase service. A new exterior generator in a weatherproof enclosure should be provided, with fuel source as determined by the Owner.
- b. The Owner shall determine under the design phase if the new generator is to serve the entire building as currently constituted or a portion of the building. If the generator is to serve portions of the building, then two hour rated Electric rooms will need to be created for emergency panels, fed by two hour feeders.
- c. Optional standby power distribution can be housed in Electric rooms with normal power distribution.

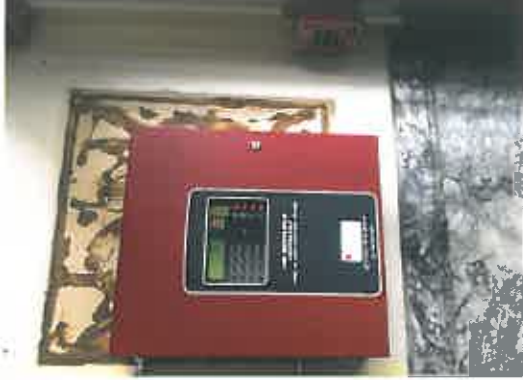
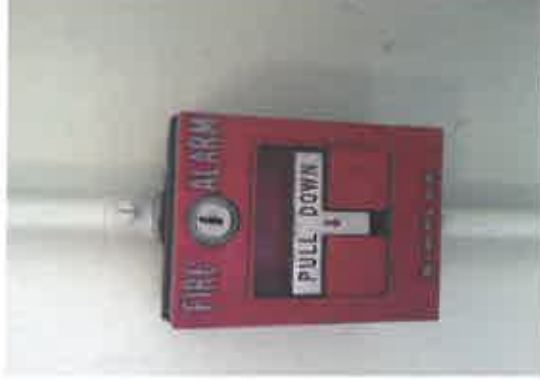
- a. The addressable fire alarm control panel as manufactured by Fire Lite serves the entire building and is located in the Main Vestibule. It appears that the original conventional fire alarm control panel was replaced with this panel, however the existing conventional devices remained so likely the panel annunciates by zone, not by device.

- h. In general the fire alarm system appears to be in poor condition.

- a. The existing fire alarm system should be replaced in its entirety with a new addressable fire alarm system, given condition and the fact that the existing fire alarm system is conventional.
