MEMORANDUM

Date: January 18, 2024

Re: 51 Harborview Road NOI Peer Review

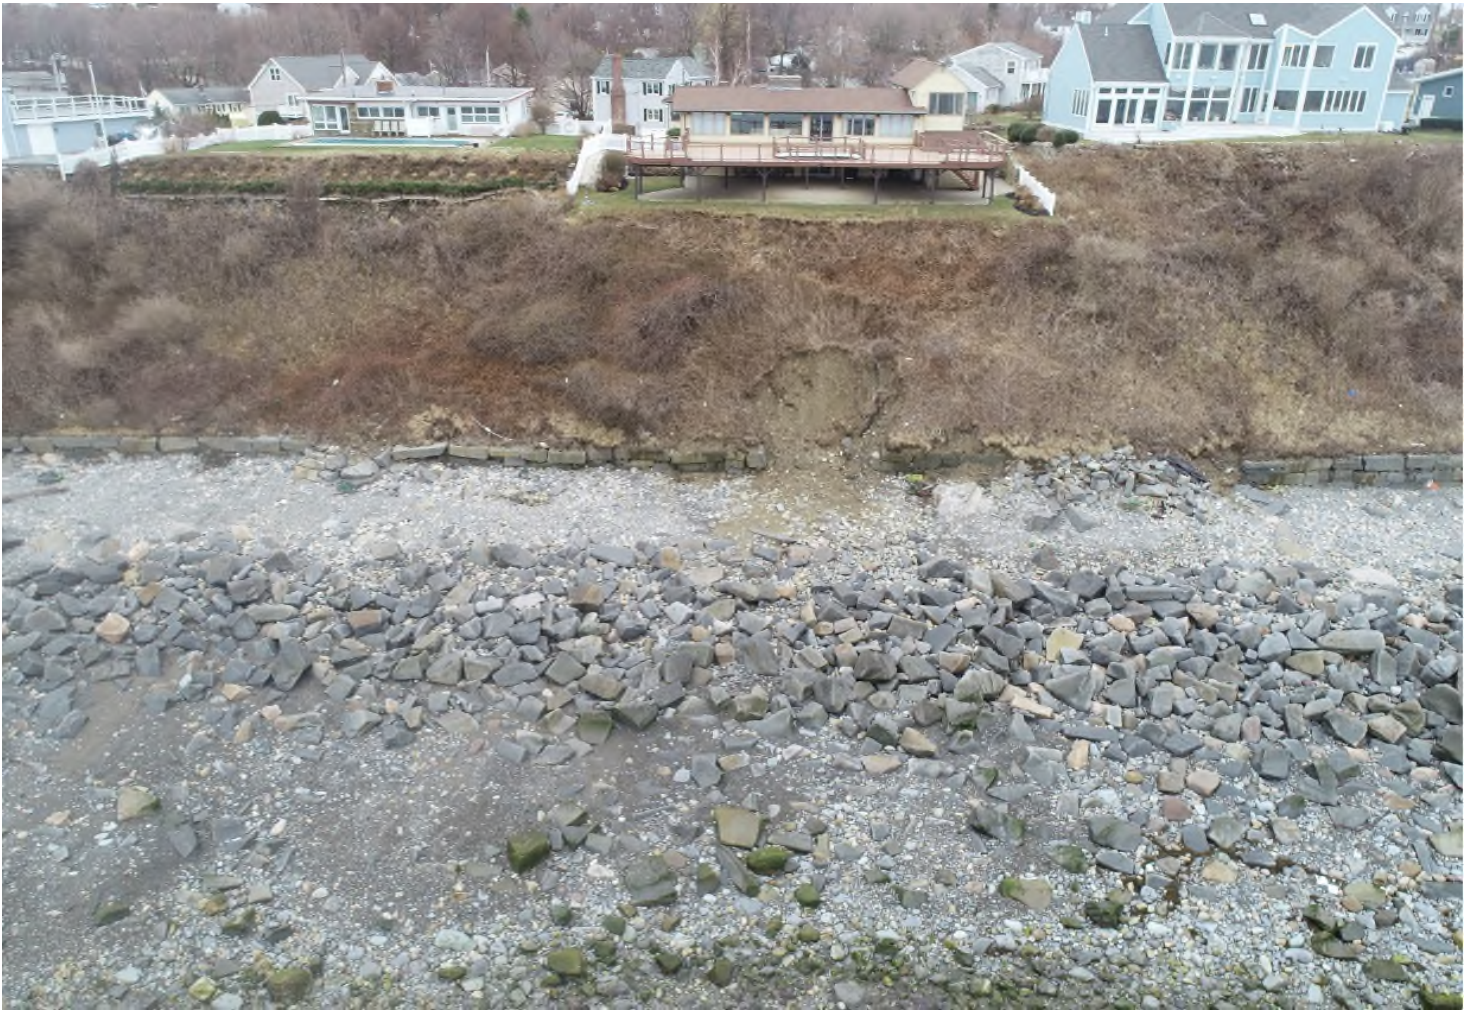
Figure 4: Birds-Eye View in April 2019 before July 2019 Slope Failure

Note: Photograph from Attachment B of GEI 2019 Report (Ref. 21).

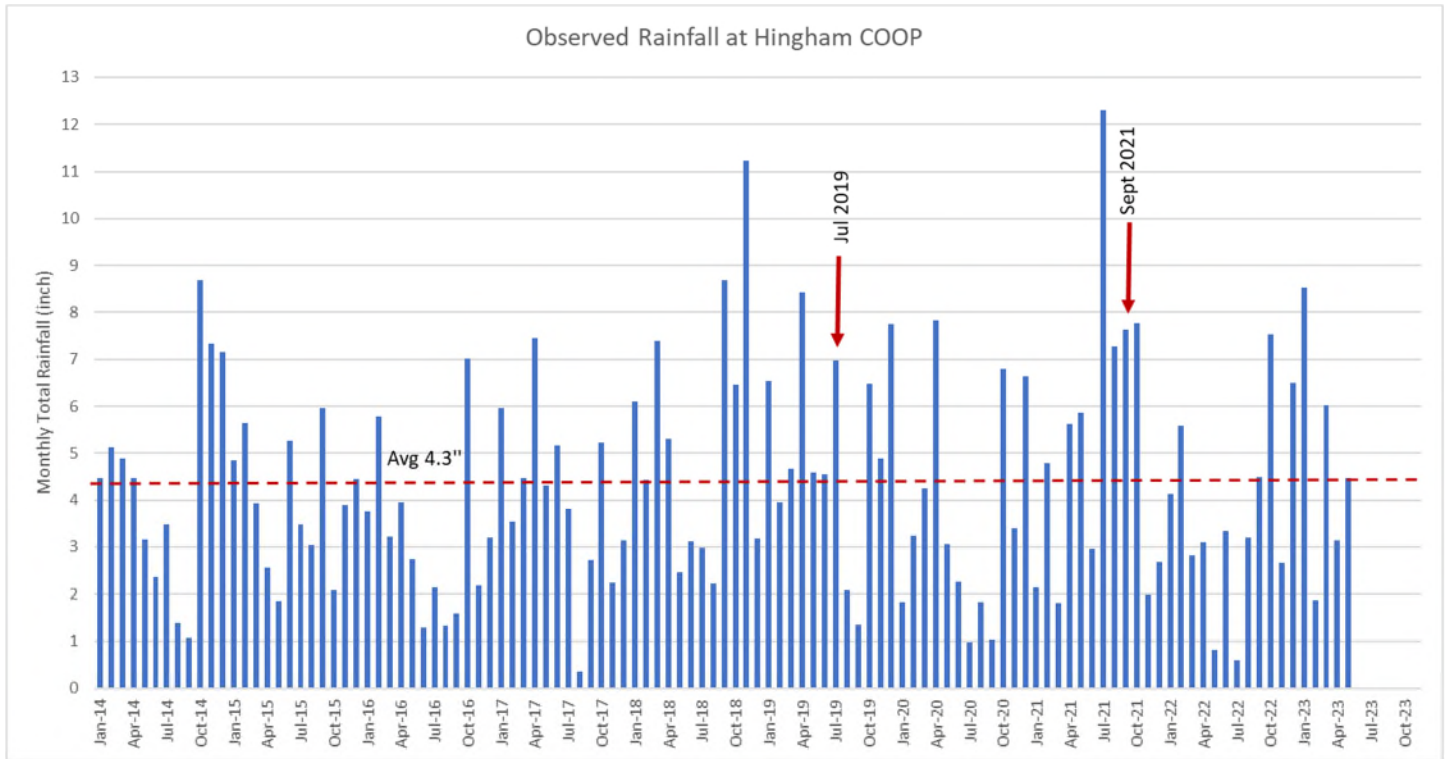
Figure 6: Monthly Rainfall Data 2014 through 2023

One of the key findings from the site visit is that the slope failure was judged to be closely correlated to intense rainfall events, per GZA's observations and understanding. GZA downloaded monthly precipitation data from National Oceanic and Atmospheric Administration (NOAA) at the Hingham COOP Station⁷ and plotted monthly total rainfall (in inches) in **Figure 6**. Both major failure incidents, July 2019 and September 2021, occurred following and/or during a few above-average wet months. Following the June 2023 site visit, GZA provided a hypothesis of the failure mechanism: heavy rainfall resulted in an elevated (or perched) groundwater table, which increased lateral pressure behind the slope (**Attachment II**). The construction activities at the Site over the years likely contributed to both incidents in GZA's opinion:

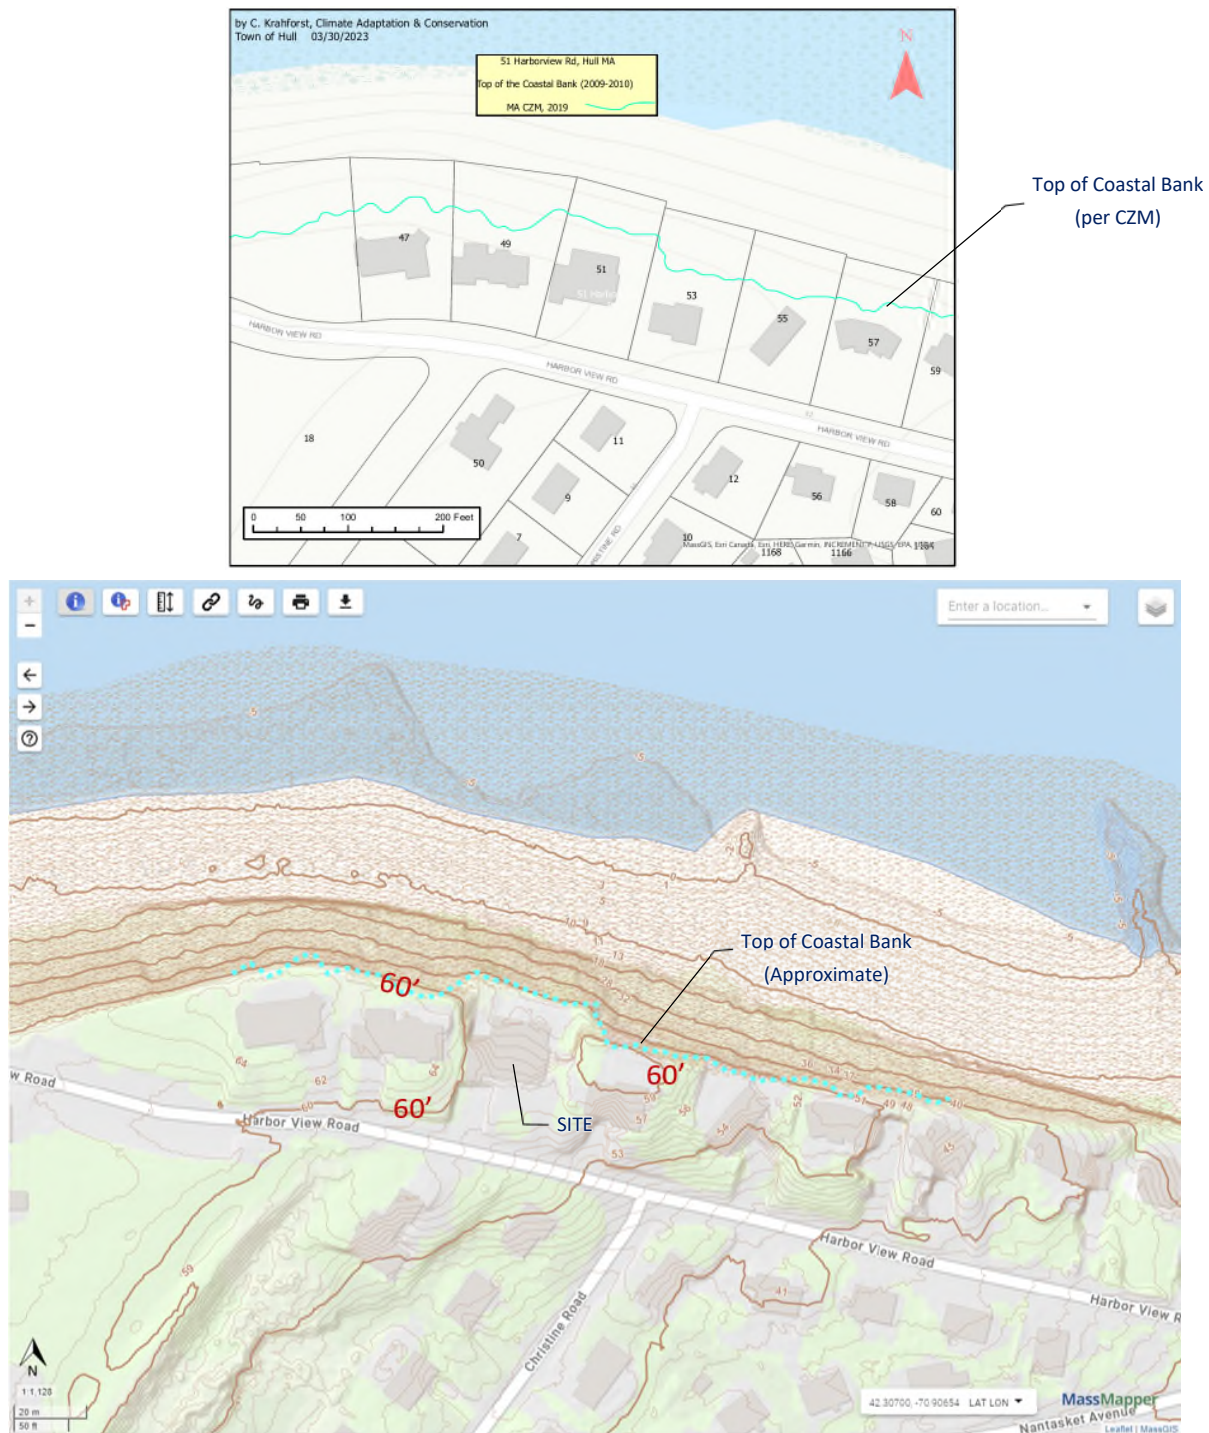
Figure 12: CDM Top of Coastal Bank Overlaid on MassGIS Topographic Contour Map

Figure 12 presents the Top of Coastal Bank in the vicinity of the project area, over existing topographic 1-foot contours per MassMapper. The Coastal Bank at the Site protrudes towards the North primarily due to its lower grades. Top of Bank elevations at 53 and 49 Harborview are close to 60 feet NAVD88, whereas the Top of Bank elevation at 51 Harborview is around 50 feet NAVD88. The grade difference creates a depression in the ground such that surface runoff from the neighboring properties naturally discharges towards the backyard (patio) of 51 Harborview. The stormwater issue will persist after the installation of the soil nail wall/project and need to be addressed properly during the design phase to minimize further erosion of the bank and underlying materials, for the stability and long-term integrity of the entire coastal bank in the general area.

Note: Top of Coastal Bank sketched based on the Map prepared by C. Kranforst. Approximate and for reference only.

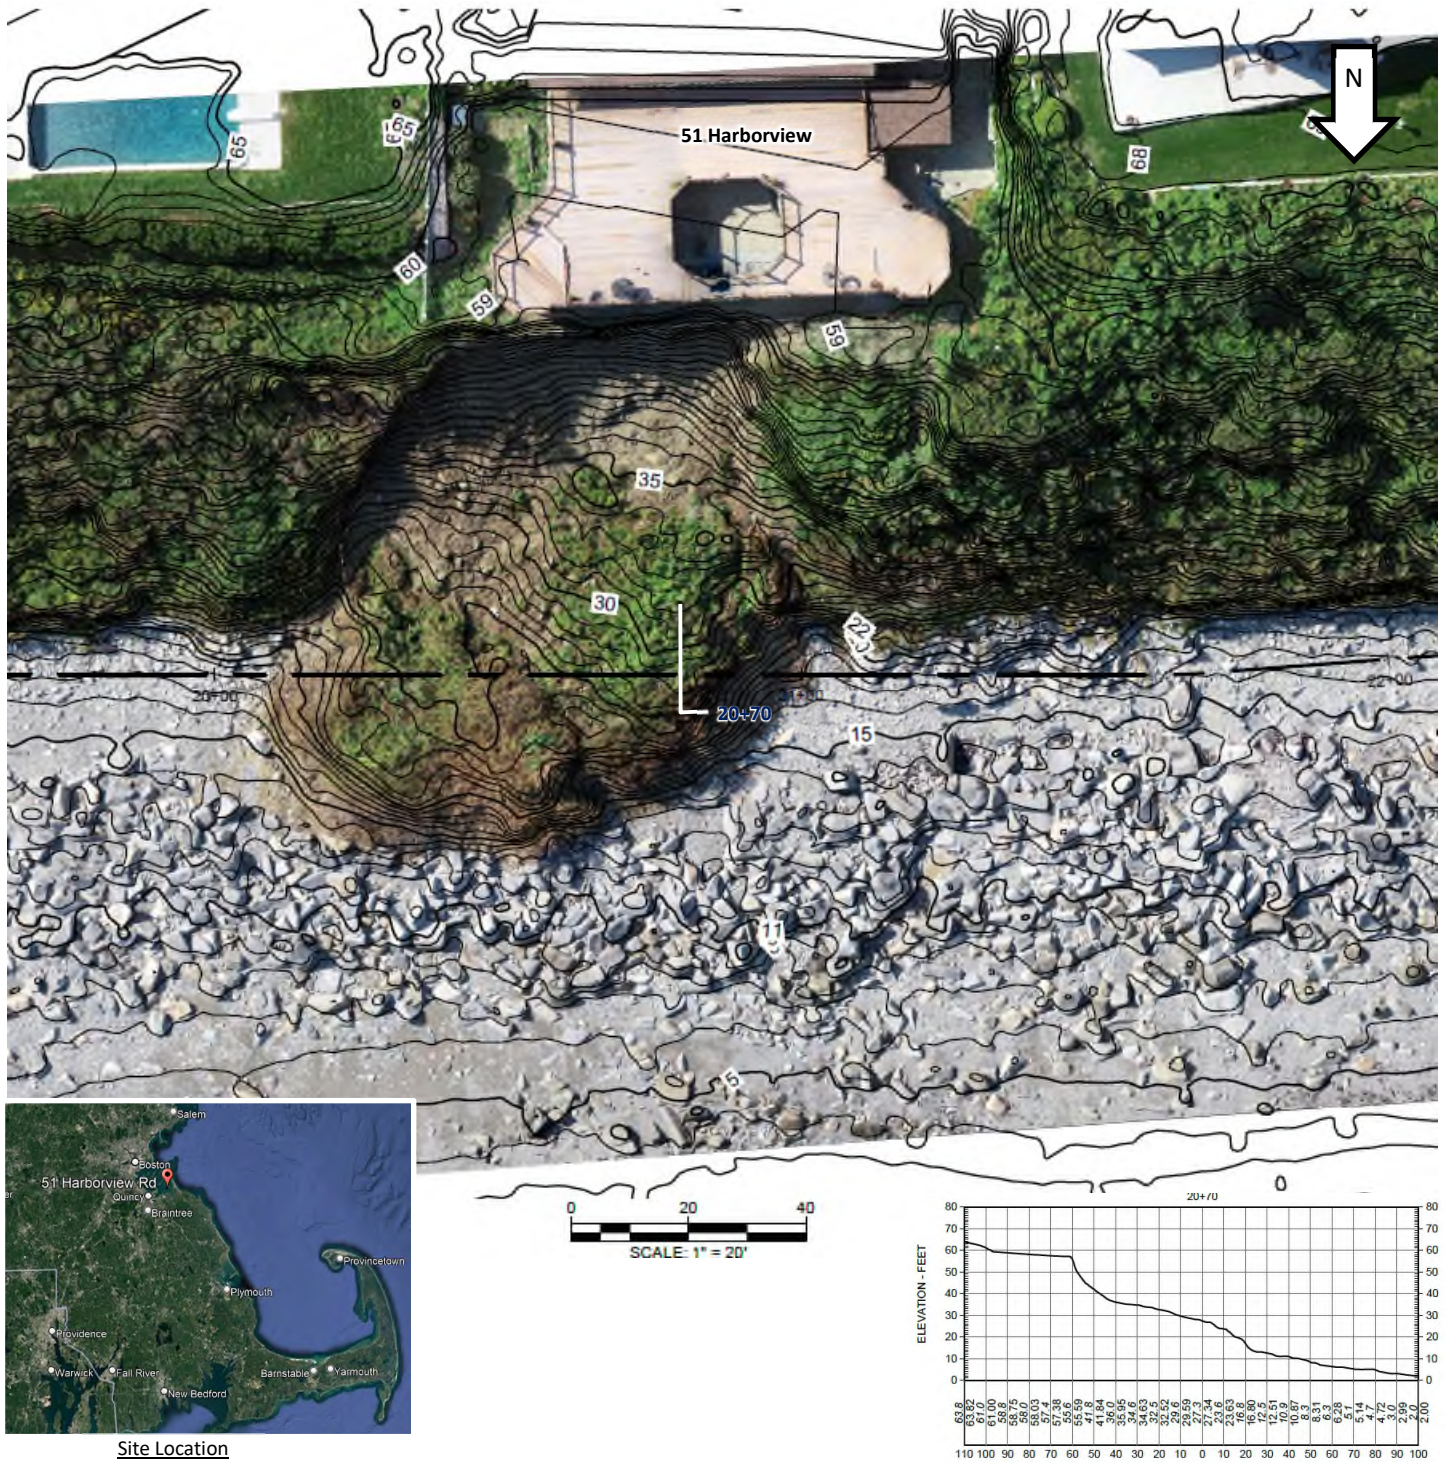
Figure 1: Topographic Plan with 1-foot Contours per Site Survey 2021

Note: Site survey plan and cross section at Station 20+70 prepared by GEI, dated October 2021.

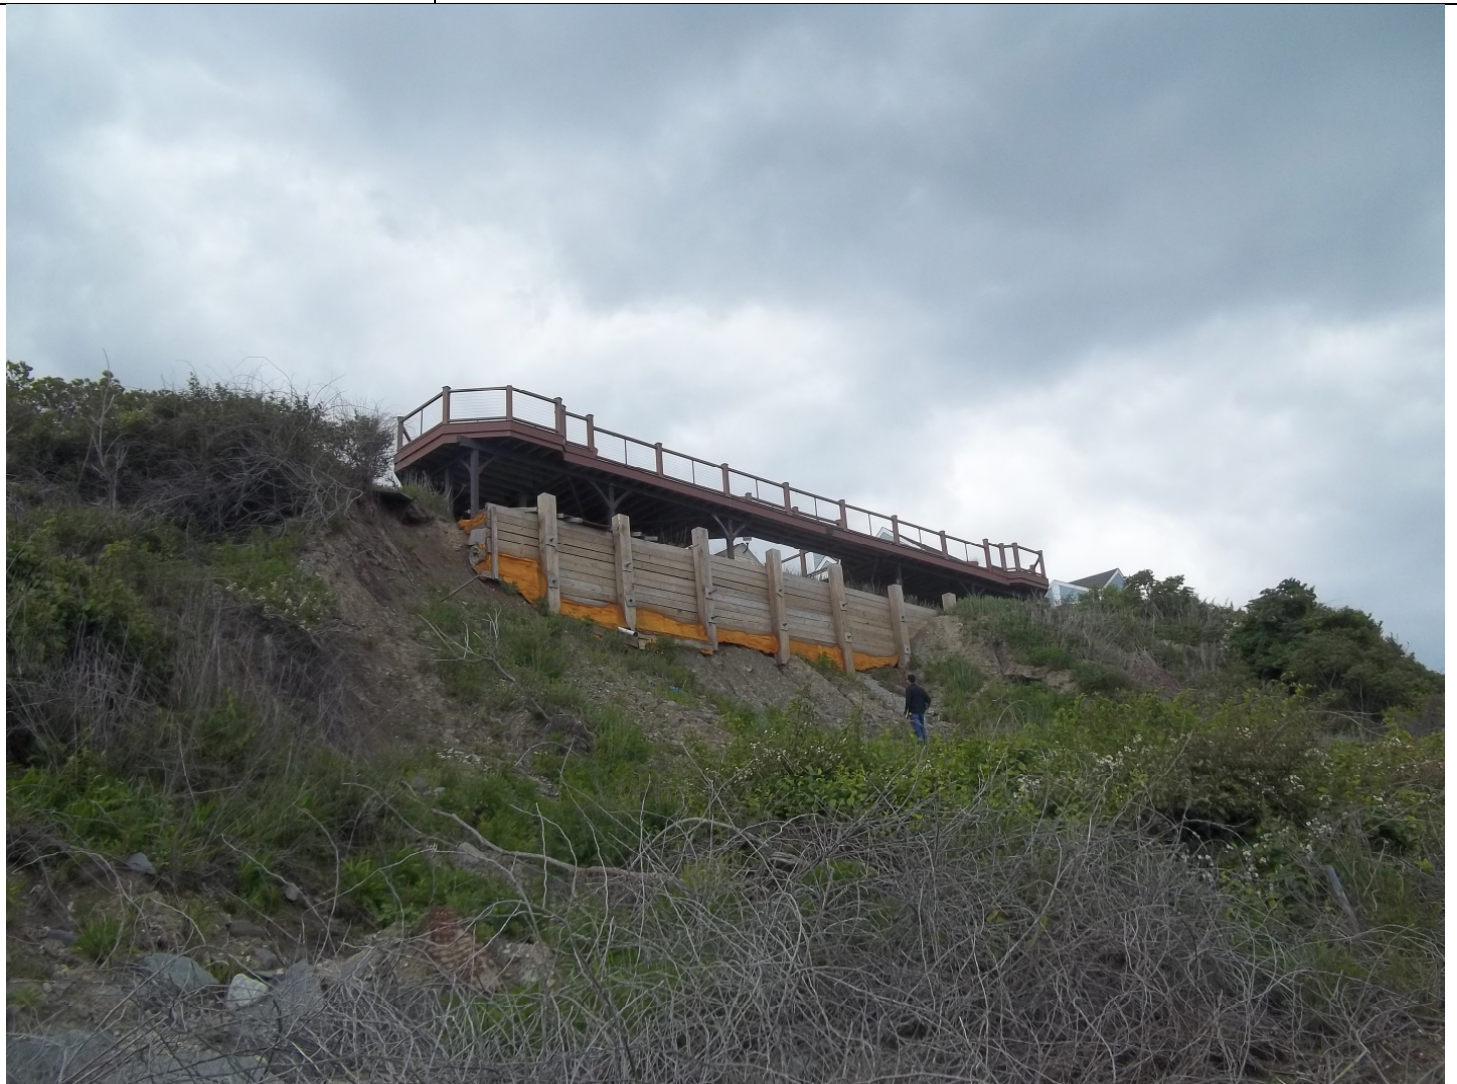
Photo 13 Overall view

- The slope failure is immediately adjacent to the Earth Retaining System (ERS), which consists of timber soldier piles and lagging wall system constructed in 2019 (Photos 1 through 3). A section of the ERS, approximately 50 feet long, is exposed from top to toe (Photo 13) and approximately 9 to 10 feet in exposed height.
- There is significant existing and likely ongoing erosion/scour at the toe of the ERS, where large openings are visible. Orange colored (insulation) foam was used likely as an attempt to

Viewed from toe
