51 Harborview NOI Review Summary

Conservation Commission Meeting

1/30/2024

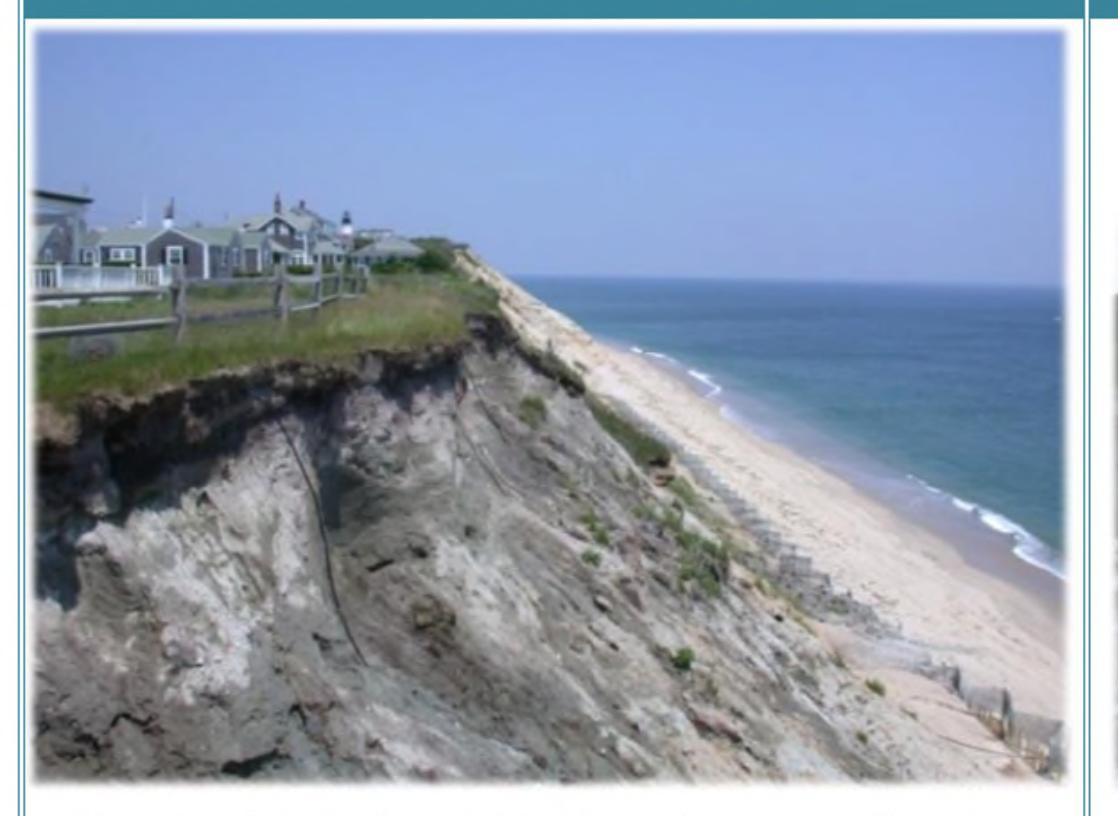
Photograph 2.14. Coastal bank serving as a sediment source and a vertical buffer. This eroding coastal bank acts as a sediment source to the adjacent beach. This bank also functions as a vertical buffer due to its significant height.

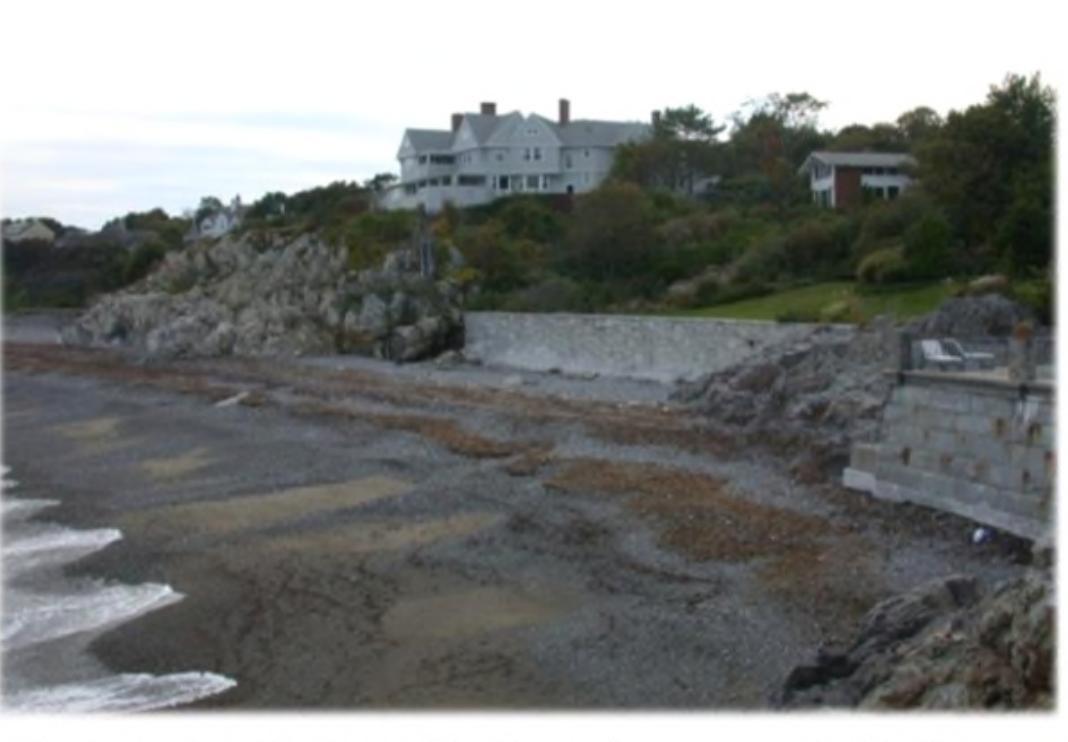
Photograph 2.15. Coastal bank serving as a vertical buffer. This rocky coastal bank and seawall act as a vertical buffer to protect inland areas. The base flood elevation is below the top of the coastal bank (top of wall) and erosion of materials above the wall (or rocky bank) has not occurred. This bank therefore does not serve as a sediment source due to its inability to erode by wave action and does function as a vertical buffer withstanding erosion from waves, wind, and rain.

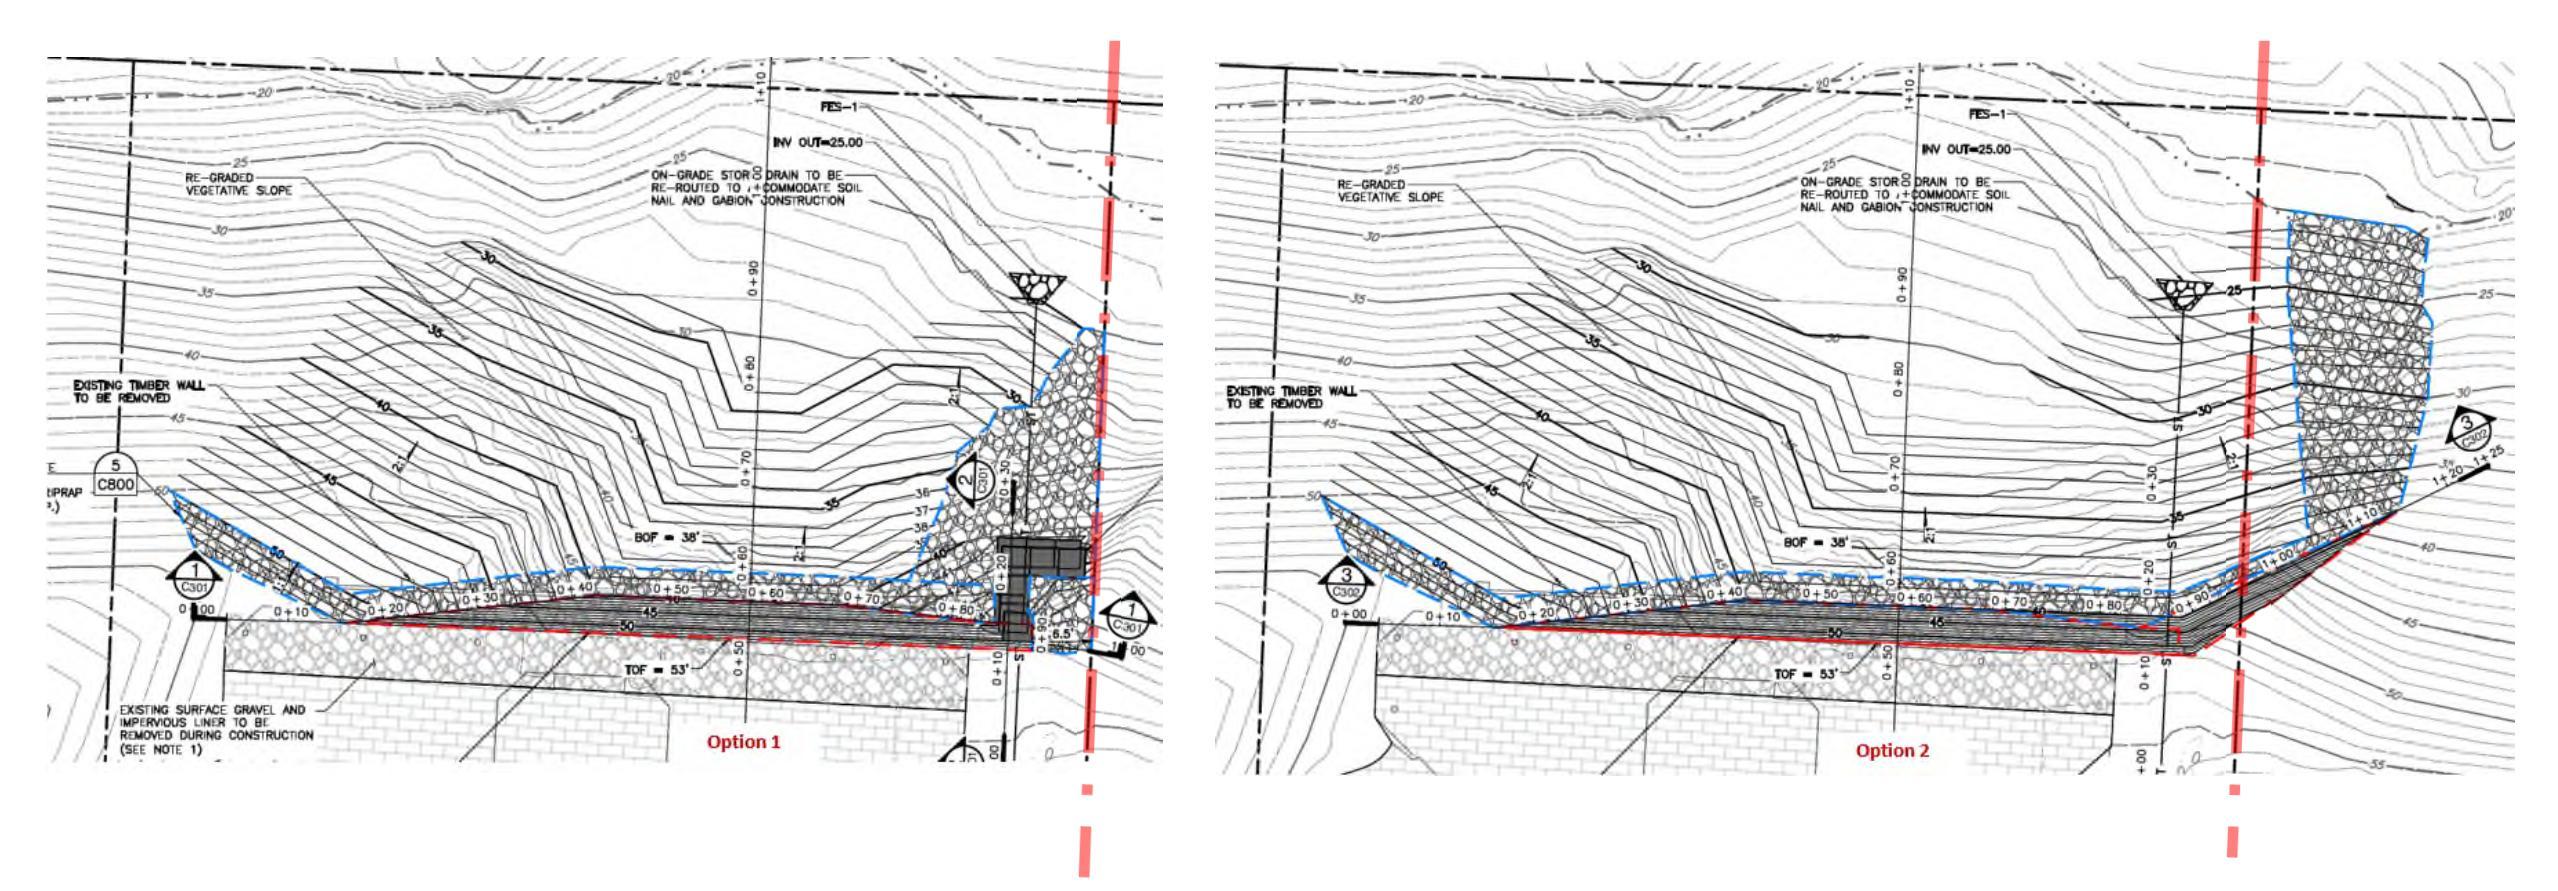
Option 1 using Gabion Baskets

Option 2 using Riprap with No Gabion Baskets

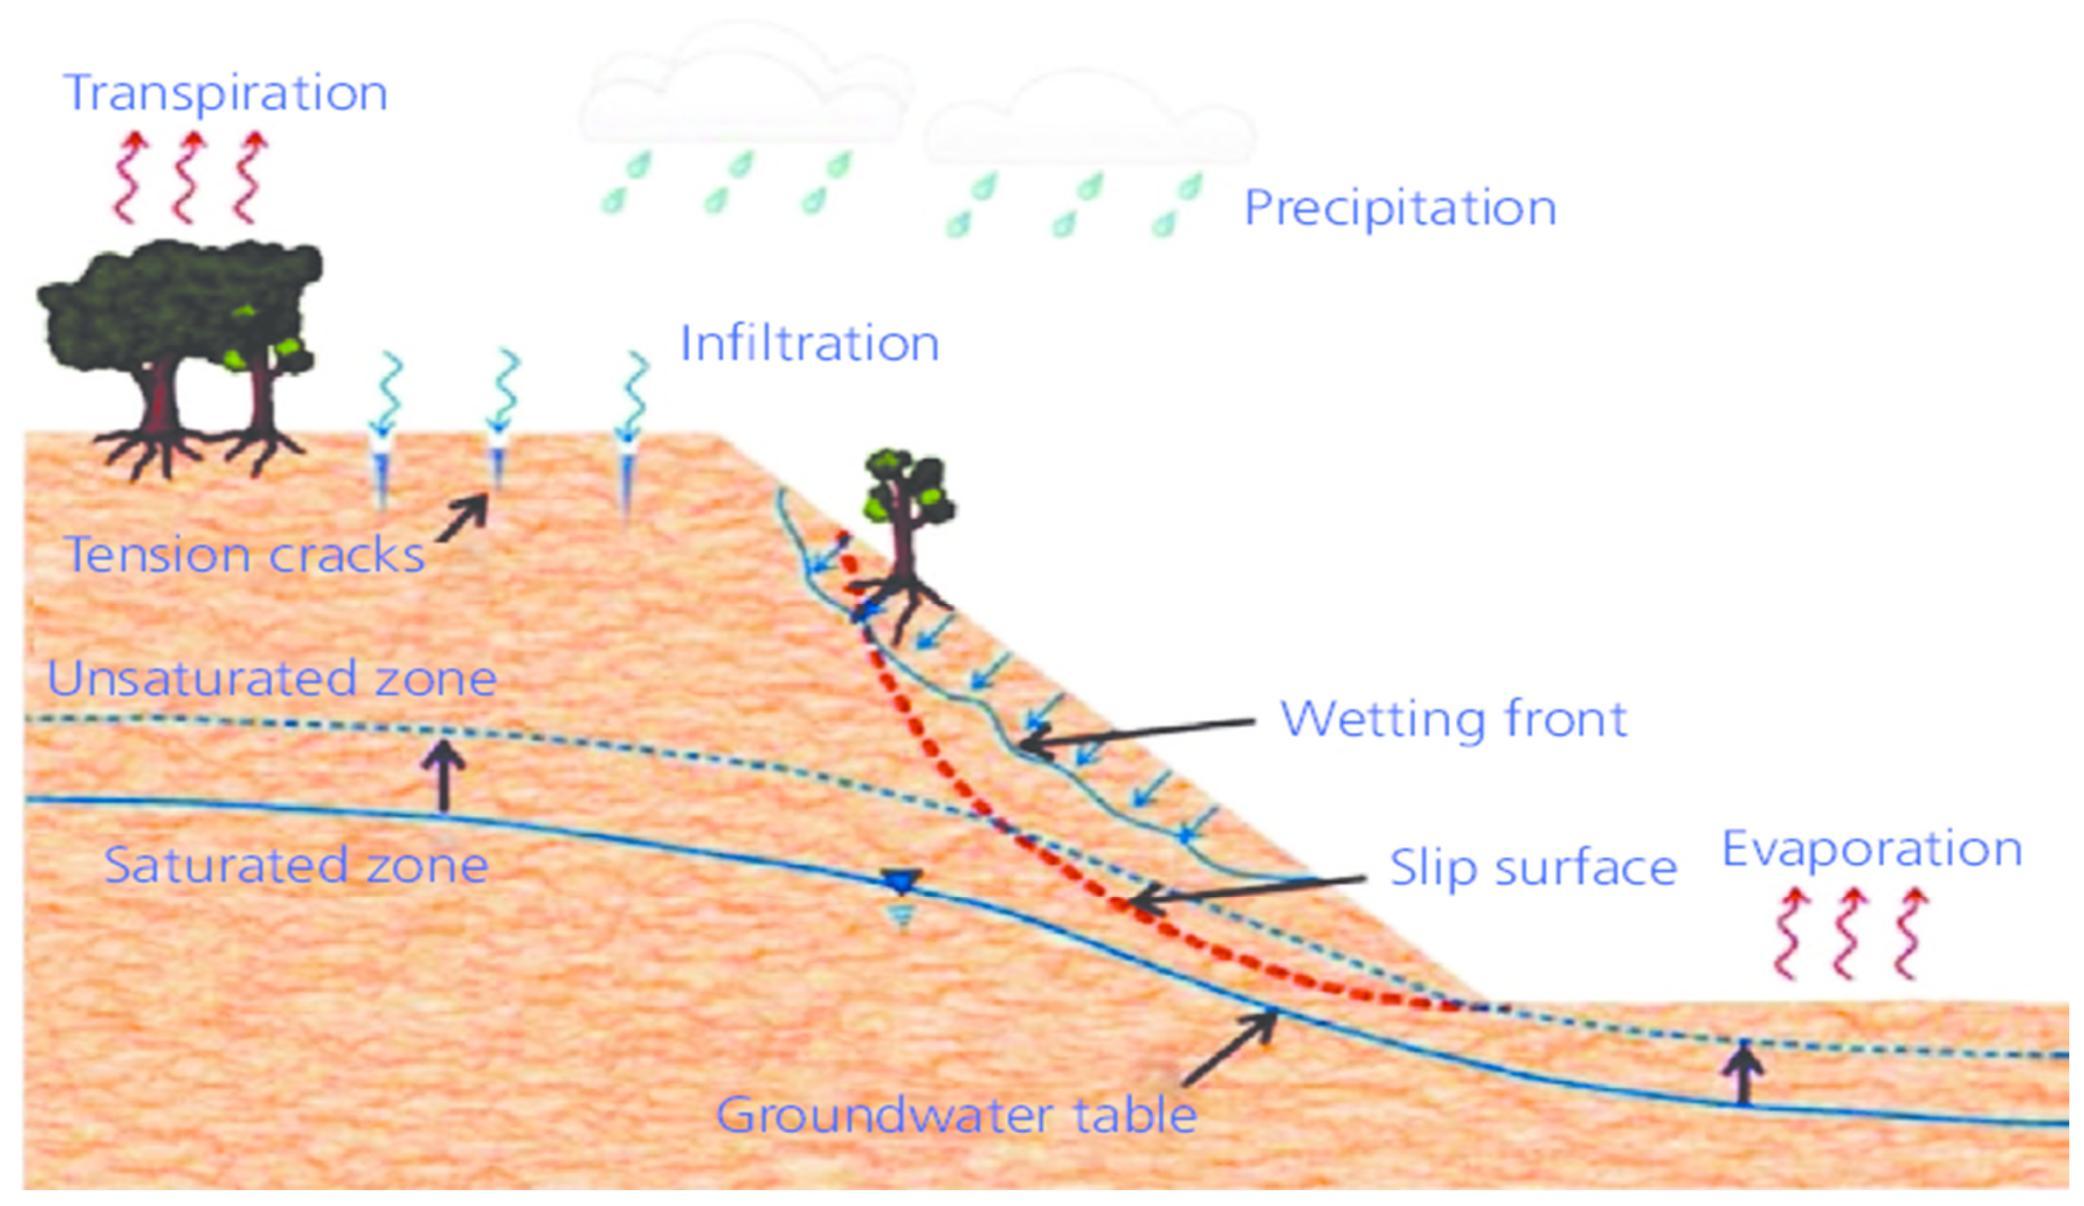
Mechanism of rainfall-induced slope failure (after Rahardjo et al., 2007) |...
