Proj.: Historic Fort Revere Water Tower Rehabilitation  
Re: Preliminary Assessment Report  
CBI Job No.: CB191842

Per our agreement, CBI Consulting, LLC, a Vidaris company (CBI), has completed a limited existing conditions assessment of the Historic Fort Revere Water Tower in Hull, MA. The purpose of our evaluation is to review the condition of the 117-year-old structure and to provide recommendations for repairs required to extend the useful life of the facility.

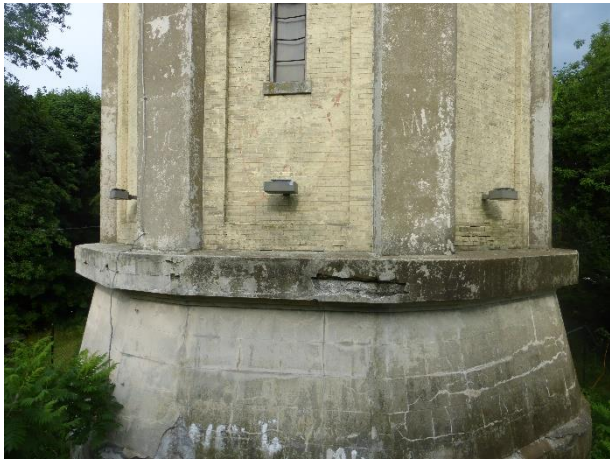
| 9. | | View of the reinforced concrete column and coated concrete brick masonry infill between the columns. |

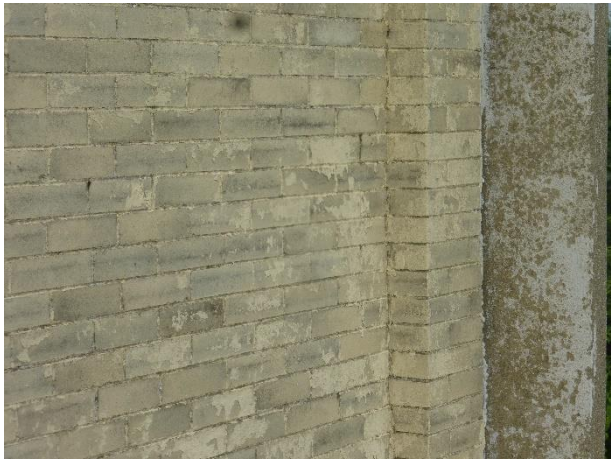
| 12. | | Photo of the interface between the coated concrete brick masonry and the concrete column. |

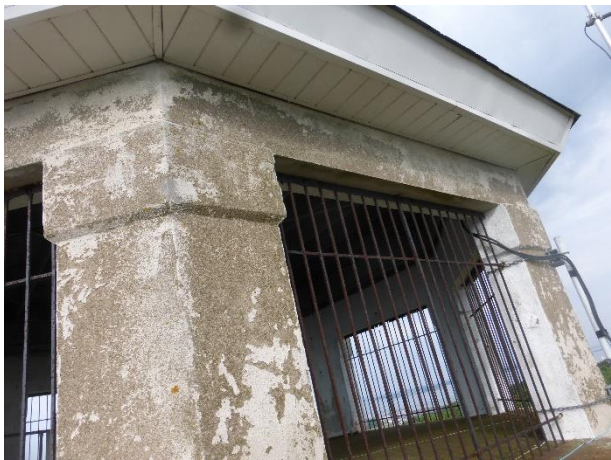
| 14. | | Exterior concrete columns at the observatory level. |

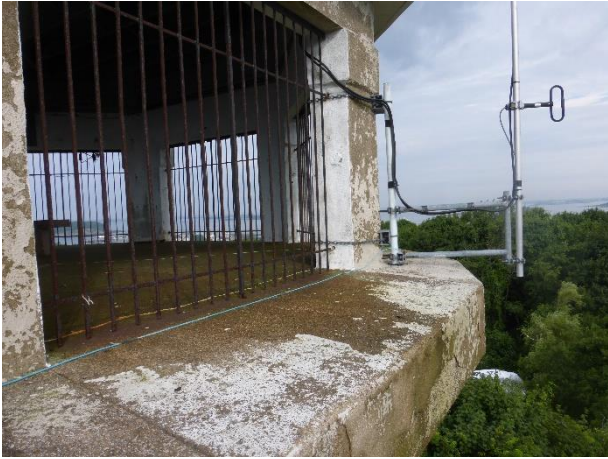
| 15. | | View of the exterior concrete columns at the observatory level. |

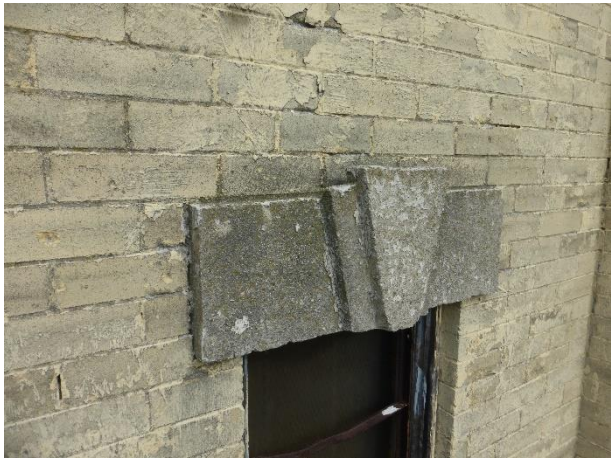
| 20. | | Typical view of the decorative concrete window header. |

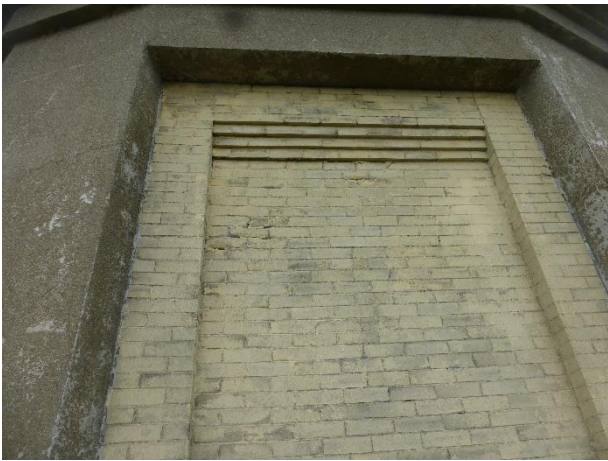
| 28. | | Photo looking upward at the top of the brick infill with a decorative corbel detail. |

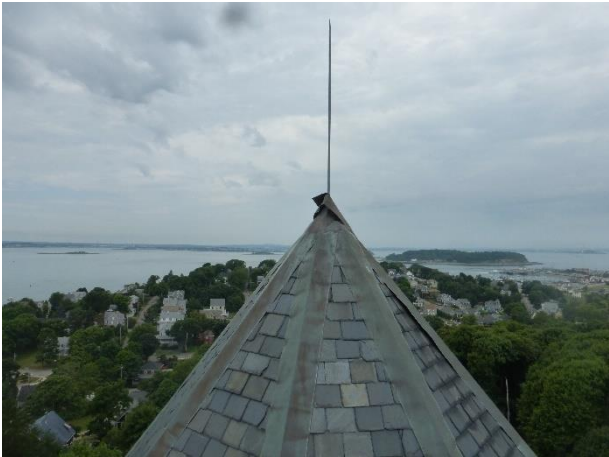
| 31. | | View at the top of the slate shingle roof. |

We recommend the removal and replacement of the existing slate roof and copper work. An adhered membrane should be installed below the slate shingles to improve the water tightness and reduce decay of the wood roof framing below. The wood framing requires further review to assess the condition and to evaluate the hold downs to the concrete structure. Currently the roof structure is concealed with a wood framed ceiling. The worn paint at the ceiling below the roof visible from the observation deck will need to be painted with a high-quality paint to protect against weather.

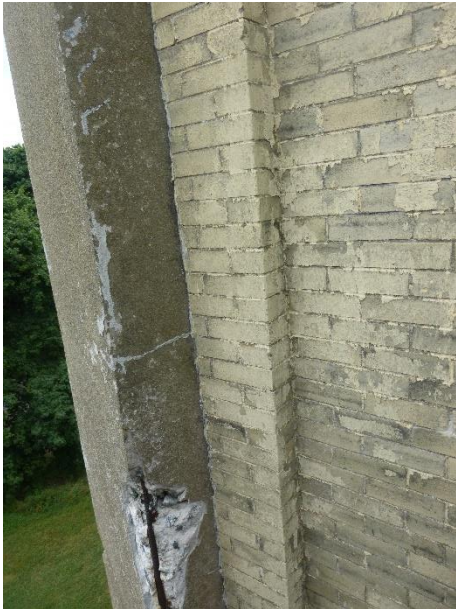
| 34. | | Typical concrete spalls at the steel reinforced concrete column, with exposed corroded reinforcement steel. |

In addition to the completion of the life safety and accessibility requirements, CBI recommends that the deteriorated and delaminated concrete throughout the interior and exterior surfaces of the tower be removed and the concrete be repaired. Concrete repairs shall also be performed at the outside face of the water tank. Concrete repairs will require removal of corrosion at exposed steel reinforcement, existing steel reinforcing with excessive corrosion will require reinforcement to be supplemented with new reinforcement to improve the performance of the steel reinforced cast in place concrete. Exposed steel reinforcement encountered will be treated with a rust inhibitor coating prior to the installation of restoration mortar.

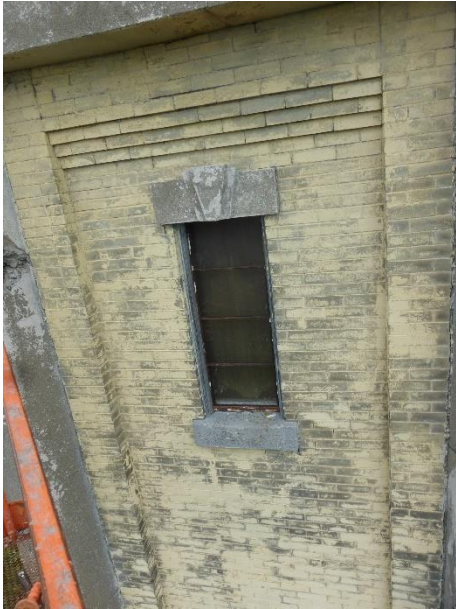
| 35. | | <p>View of the top window below the observatory level.</p> <p>Note most of the brick coating has worn away.</p> |

We recommend that the remaining existing exterior coating at the brick masonry and concrete surfaces be removed and a breathable weatherproof coating system be installed.

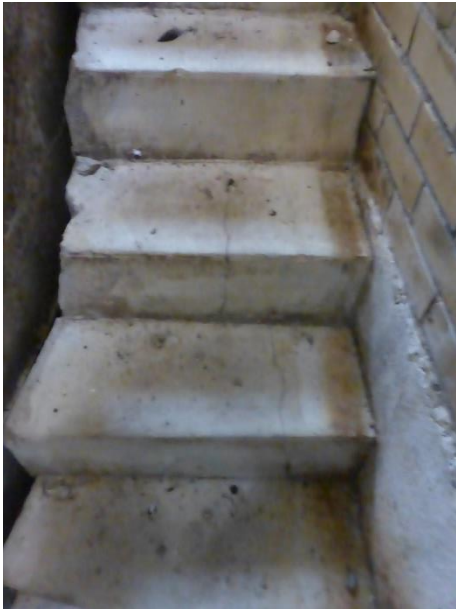
| 47. | | Photo of a continuous crack along a run of steps. |

In our opinion that the cast in place concrete service stairs and platforms are in poor condition and are unsafe for use. We recommend that the stairs and platforms be removed and replaced. The replacement stairs can be either new cast in place concrete, or a metal stairs system, coated with a marine grade coating.

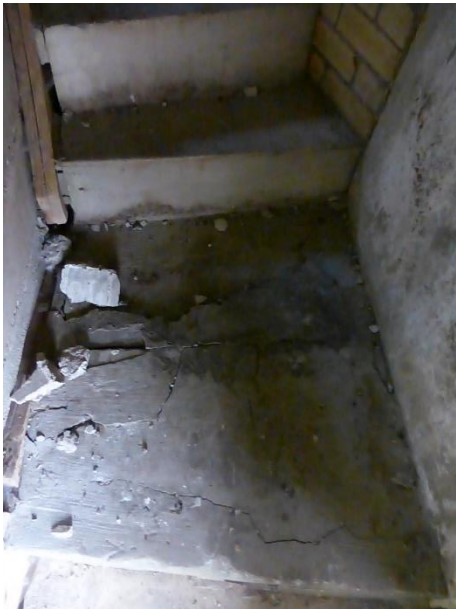
| 49. | | Photo of a failed patch at the stair landing. |

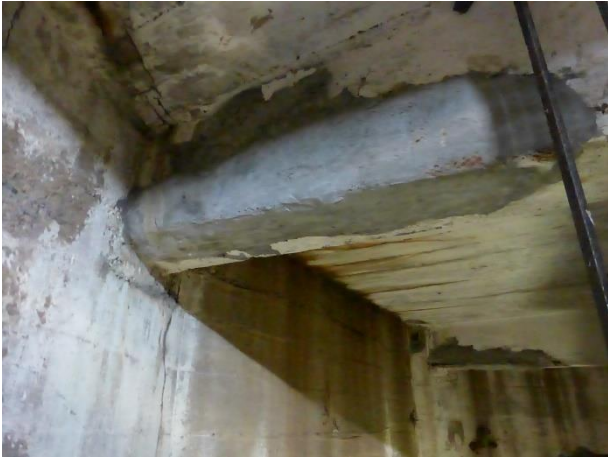
| 53. | | Photo of the delaminated beam end at one (1) of the reinforced beams supporting the observatory level, |

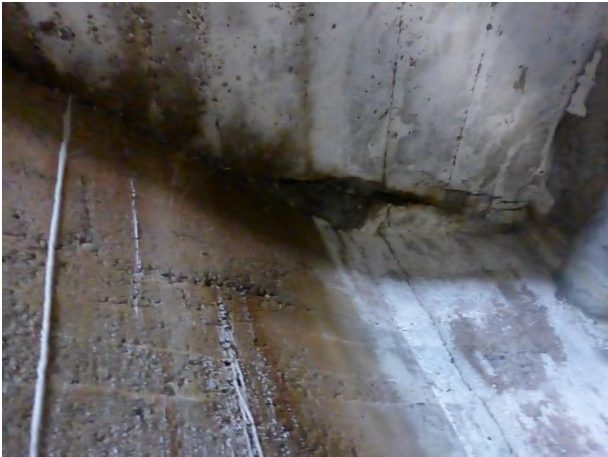
| 54. | | Photo of the underside of the observation level at the perimeter.<br><br>Note rust staining from steel reinforcement due to water infiltration and salts chlorides. |

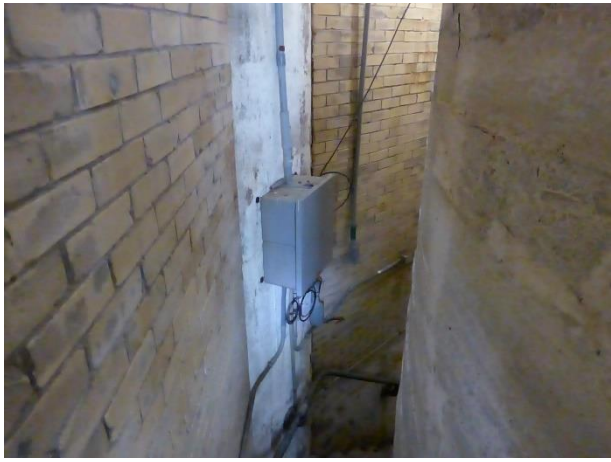
| 61. | | View of the interior stair. The electrical box is used for the communication equipment that is housed at the observatory. |

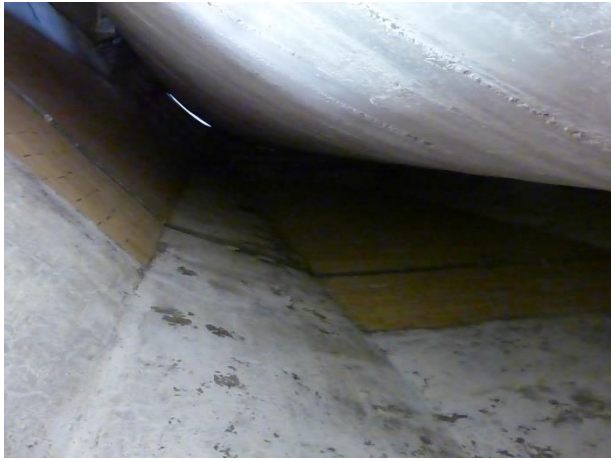
| 63. | | Upward view between the inside face of the exterior wall and face of the concrete water tank. |

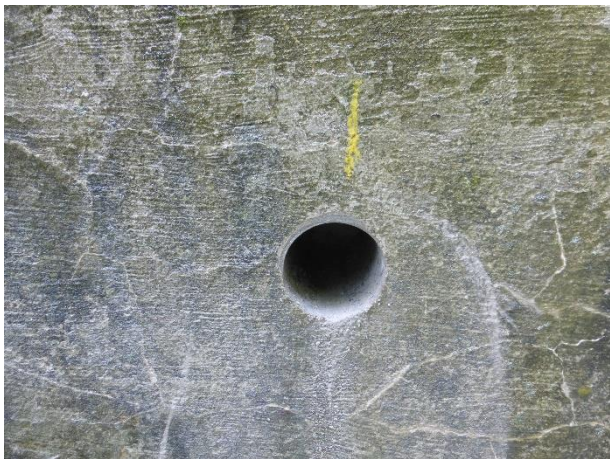
| Photo No. | Investigation | Description |
|---|---|---|
| 73. | | Concrete core location #1 through the base of the tower. |

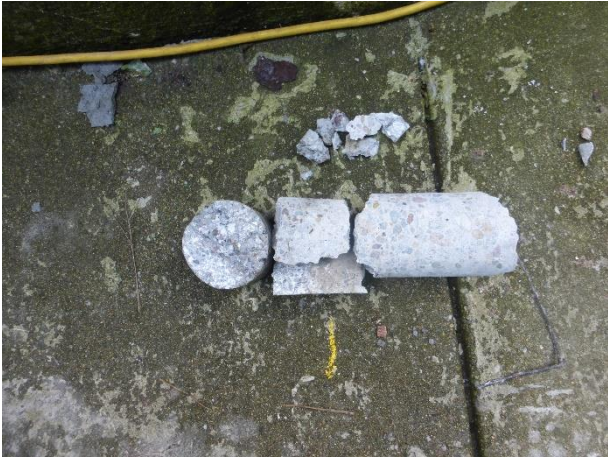
| 74. | | View of the retrieved concrete core location #1. |

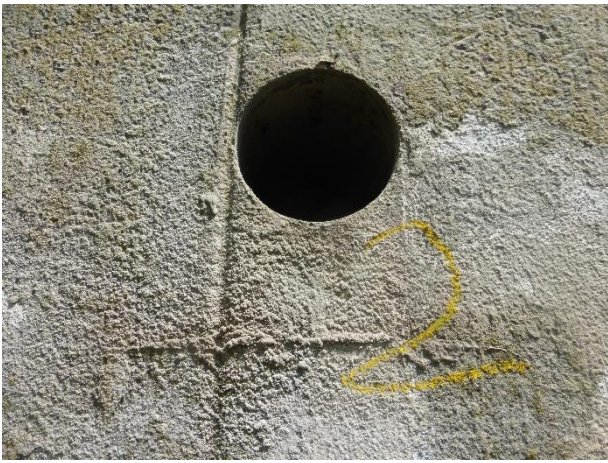
| 75. | | Concrete core location #2 through the base of the tower. |

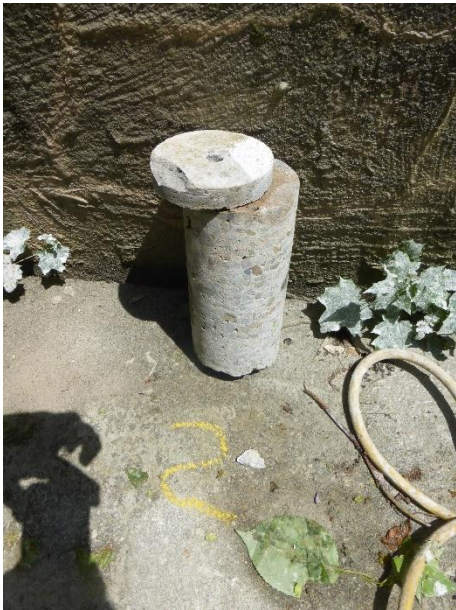
| 76. | | View of the retrieved concrete core location #2. |

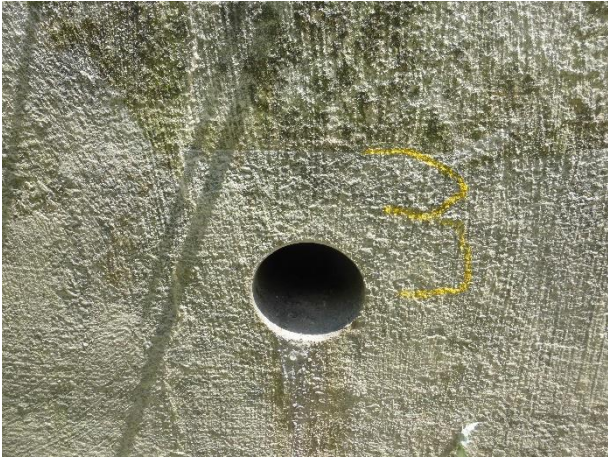
| 77. | | Concrete core location #3 through the base of the tower. |

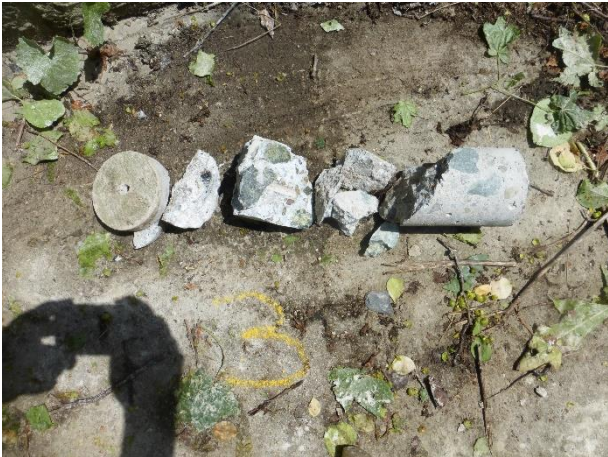
| 78. | | The retrieved concrete core location #3. |

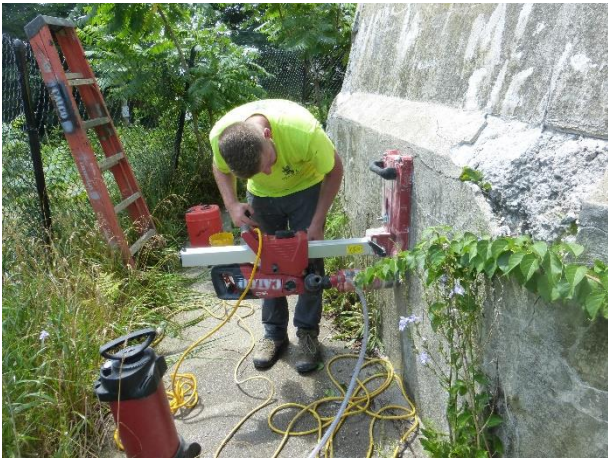
| 79. | | View of the on-going coring through the base of the water tower. |

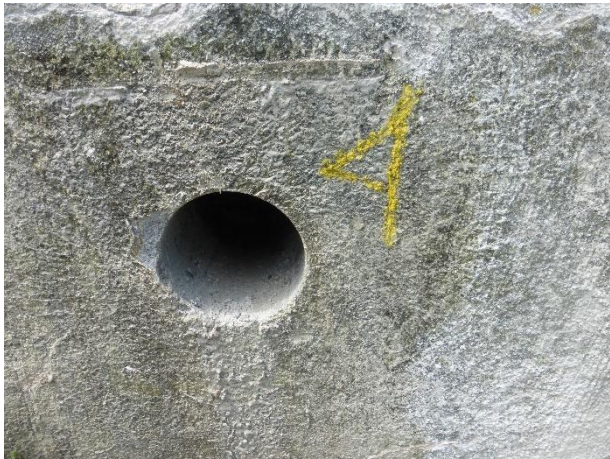
| 80. | A photograph of a concrete wall with a circular hole. To the right of the hole, the number '4' is painted in yellow. | Concrete core location #4 through the base of the tower. |

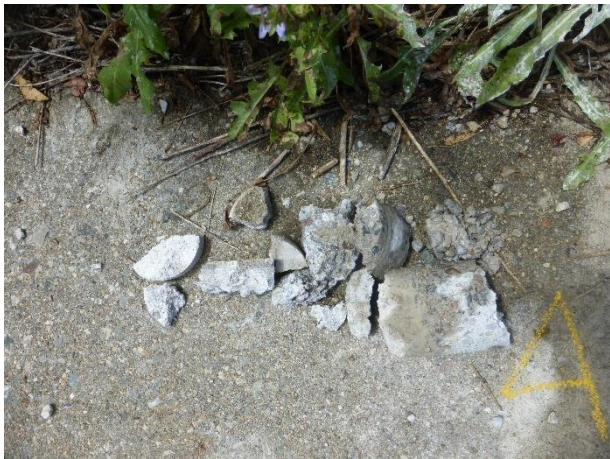
| 81. | A photograph of a pile of broken concrete fragments on the ground. To the right of the pile, the number '4' is painted in yellow. | The retrieved concrete core location #4. |

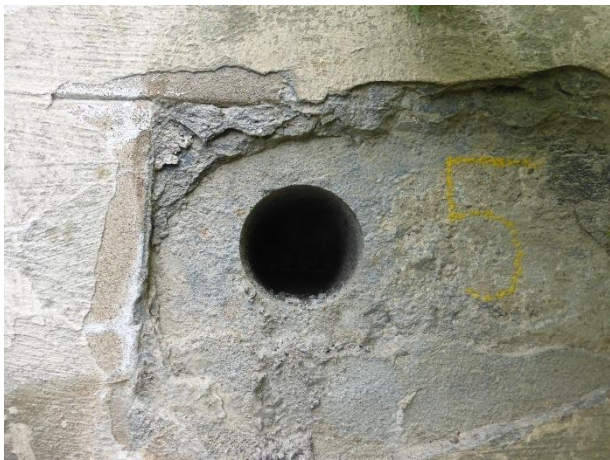
| 82. | A photograph of a concrete wall with a circular hole. To the right of the hole, the number '5' is painted in yellow. | Concrete core location #5 through the base of the tower. |
