Proj.: Historic Fort Revere Water Tower Rehabilitation
Re: Preliminary Assessment Report
CBI Job No.: CB191842

**Historic Fort Revere Water Tower Rehabilitation
Photo Index
CBI Job No.: CB191842
August 31, 2020**

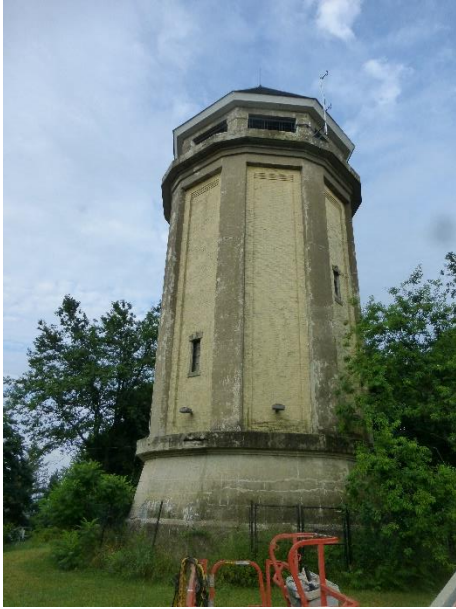
Photo No.	Exterior Review	Description
1.

Typical elevation of the water tower.
2.

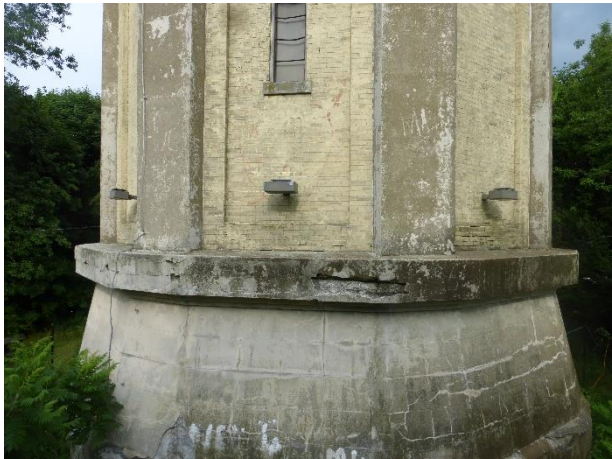
9.

View of the reinforced concrete column and coated concrete brick masonry infill between the columns.
10.

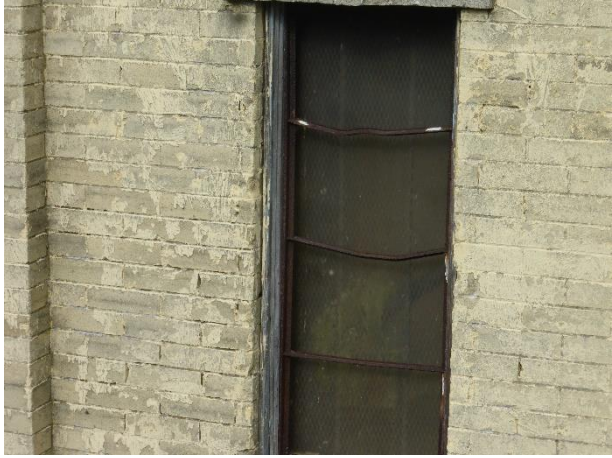
Typical view of a dilapidated window possibly original to the construction of the water tower.
11.

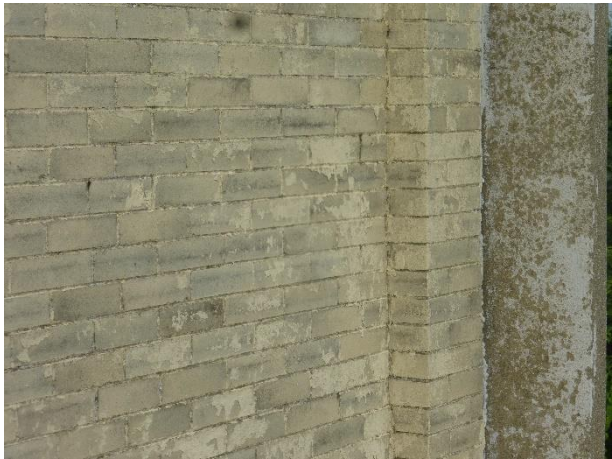
12.

Photo of the interface between the coated concrete brick masonry and the concrete column.
13.

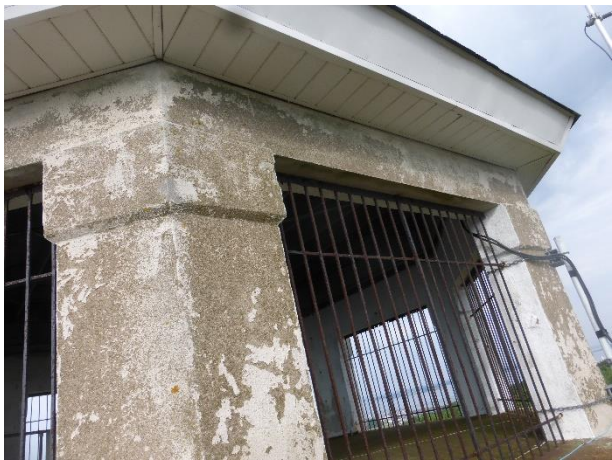
Exterior concrete columns at the observatory level.

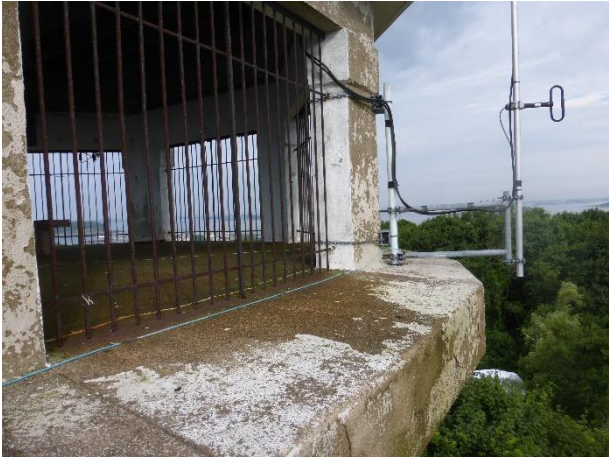
15.

View of the exterior concrete columns at the observatory level.
16.

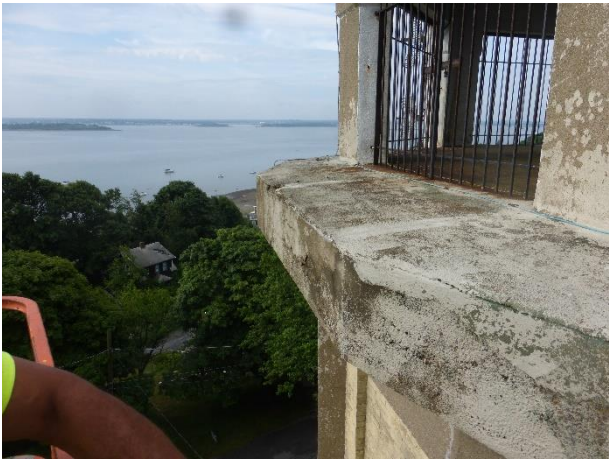
View of the delaminated concrete at the observatory level.
17.

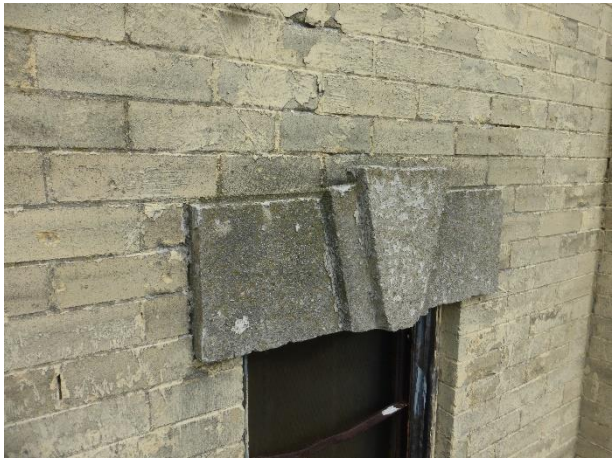
Typical view of the decorative concrete window header.

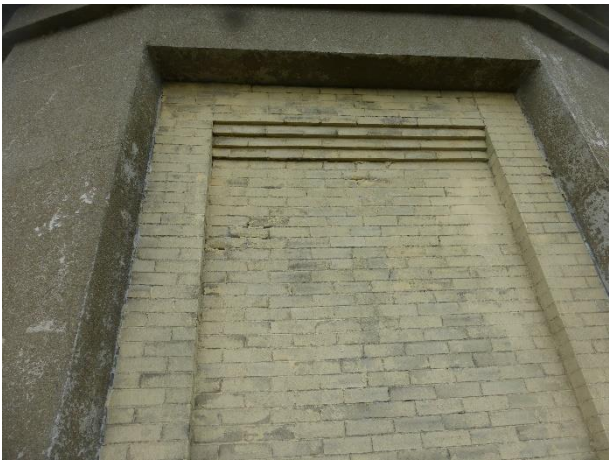
Photo looking upward at the top of the brick infill with a decorative corbel detail.
29.

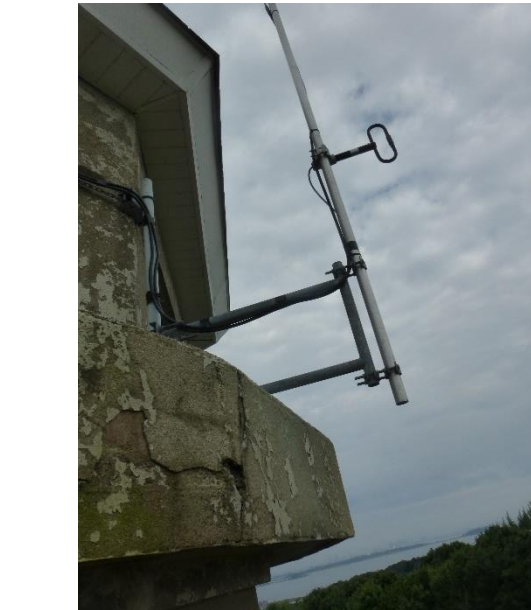
Photo of the antenna that is used by the Town of Hull for emergency services.

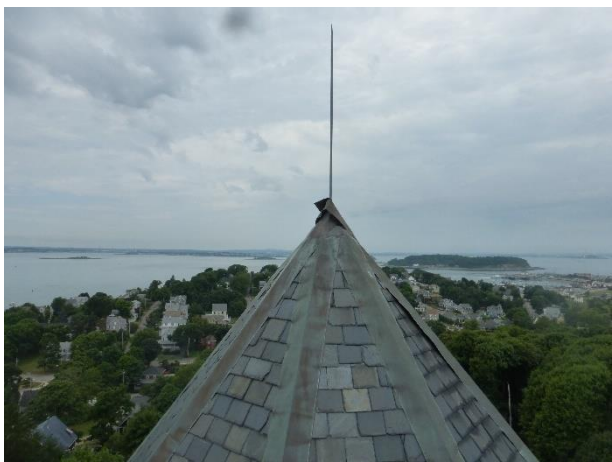
View at the top of the slate shingle roof.
32.

A)	Remove and replace slate shingles	SF	1,200	\$ 90.00	\$ 108,000.00
B)	Repair deteriorated sheathing	SF	150	\$ 25.00	\$ 3,750.00
C)	Replace deteriorated trim	LF	200	\$ 30.00	\$ 6,000.00

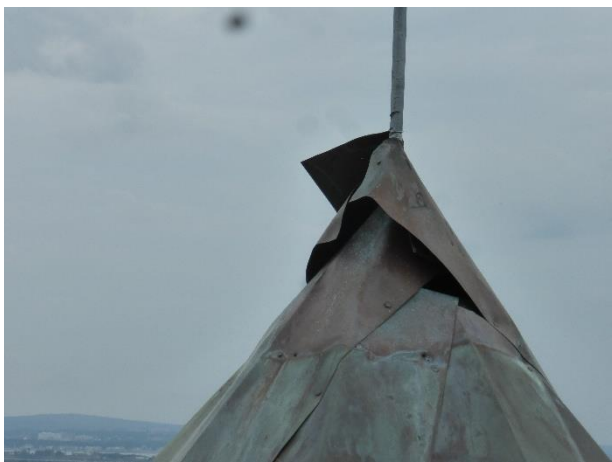
Distorted copper cap.

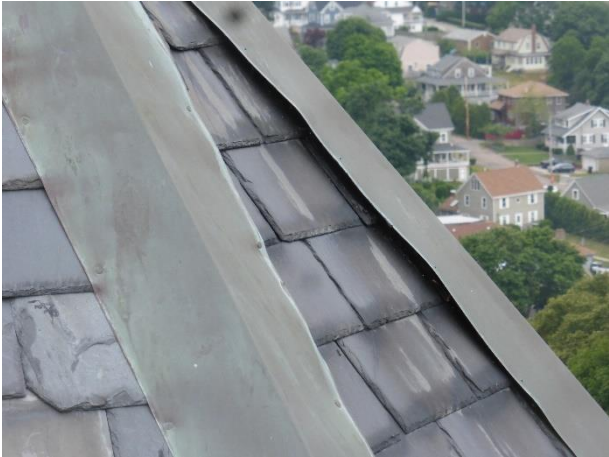
33.

Open gaps at the copper hips and slate roofing shingles.
34.

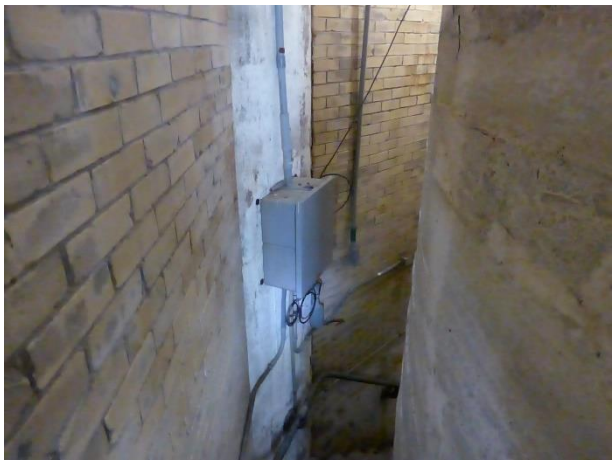
View of the interior stair. The electrical box is used for the communication equipment that is housed at the observatory.

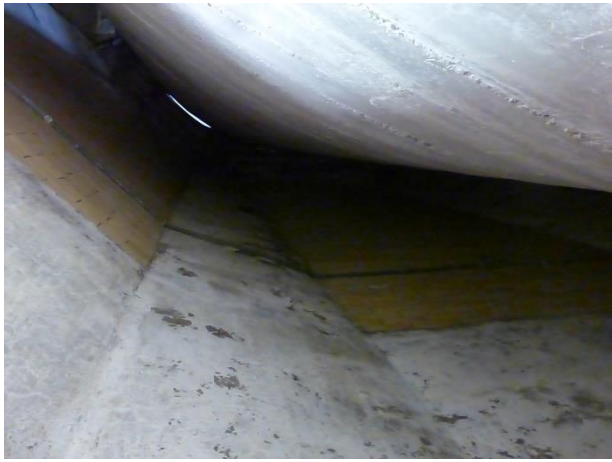
Upward view between the inside face of the exterior wall and face of the concrete water tank.
64.

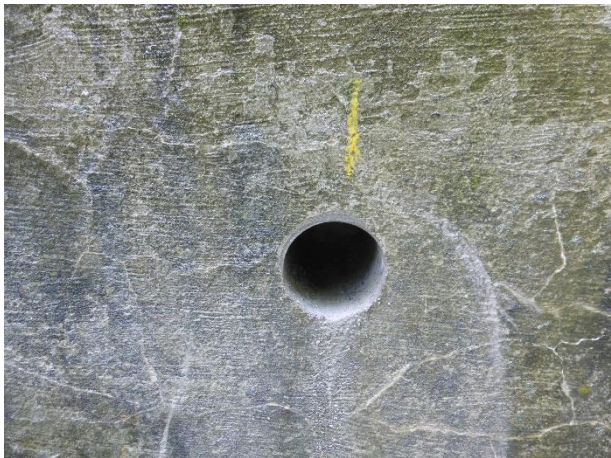
Concrete core location #1 through the base of the tower.

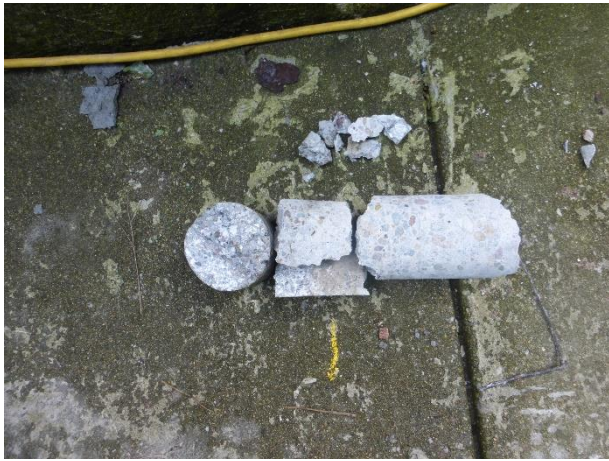
74.

A photograph showing a retrieved concrete core sample. The sample is a light-colored, cylindrical piece of concrete, broken into three main sections. It is lying on a dark, textured surface, possibly a concrete wall or floor. A yellow cable is visible in the upper left corner of the image.	View of the retrieved concrete core location #1.

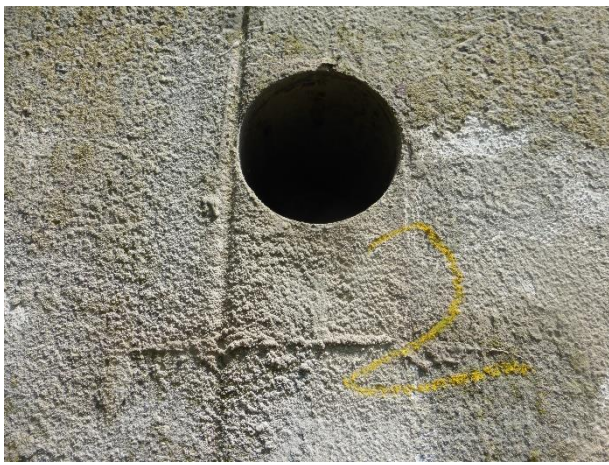
75.

A photograph showing a circular hole drilled into a concrete wall. The hole is dark and appears to be the location of a concrete core sample. A yellow number '2' is painted on the concrete surface to the right of the hole.	Concrete core location #2 through the base of the tower.

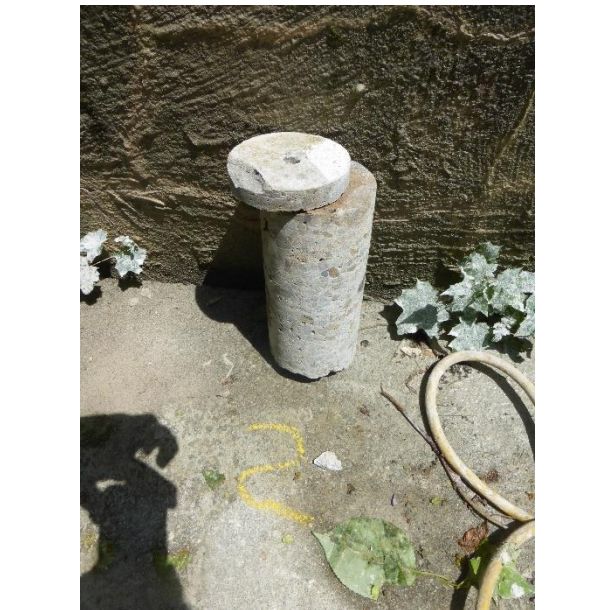
76.

A photograph showing a retrieved concrete core sample. The sample is a light-colored, cylindrical piece of concrete, standing upright on a concrete surface. A yellow number '2' is painted on the concrete surface to the left of the sample. A yellow cable is visible in the lower right corner of the image.	View of the retrieved concrete core location #2.

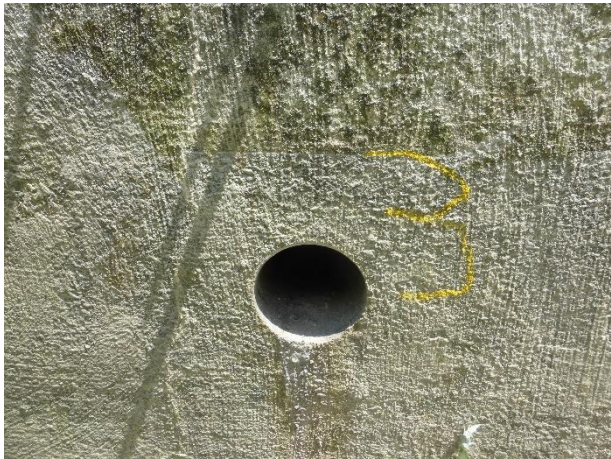
77.

Concrete core location #3 through the base of the tower.
78.

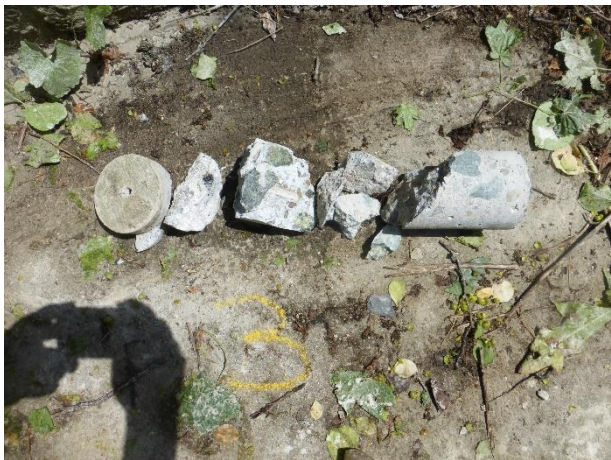
The retrieved concrete core location #3.
79.

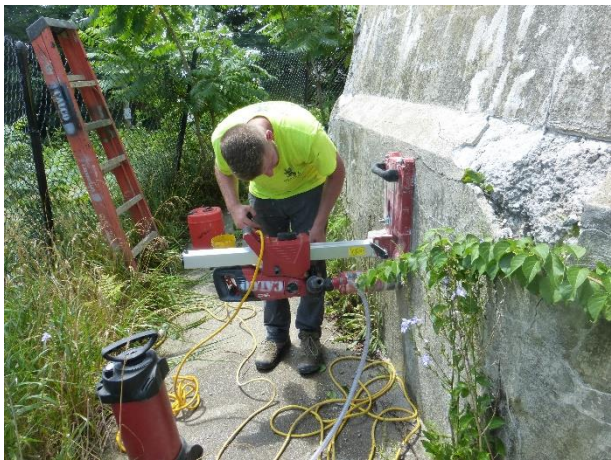
View of the on-going coring through the base of the water tower.

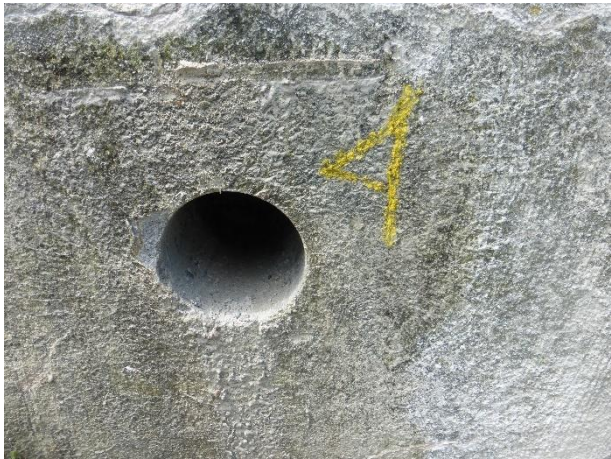
80.

A photograph showing a circular concrete core hole in a weathered concrete surface. A yellow number '4' is painted on the concrete to the right of the hole.	Concrete core location #4 through the base of the tower.
81.

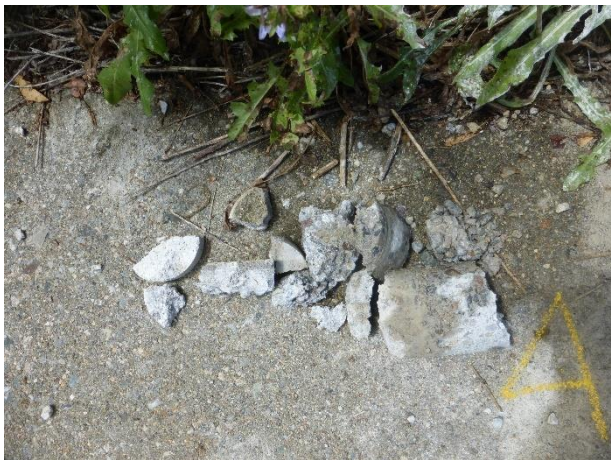
A photograph showing the retrieved concrete core sample from location #4. The sample is broken into several pieces of light-colored concrete, lying on a dirt and gravel surface. A yellow number '4' is painted on the ground to the right of the sample.	The retrieved concrete core location #4.
82.

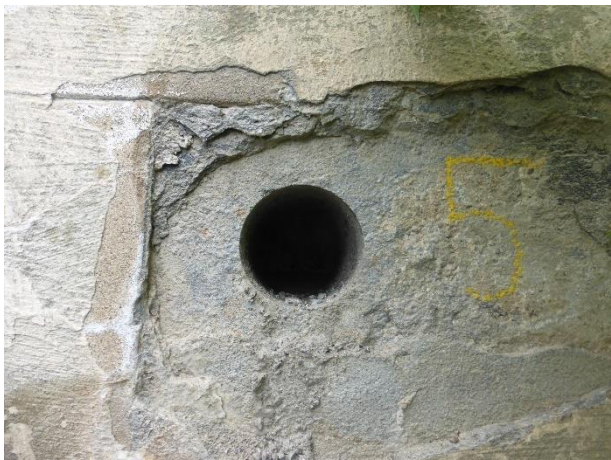
A photograph showing a circular concrete core hole in a weathered concrete surface. A yellow number '5' is painted on the concrete to the right of the hole.	Concrete core location #5 through the base of the tower.
